# Significant Loss of Safety-Related Electrical Power at Forsmark Unit 1

## Briefing For Nuclear Power Engineering Committee Institute of Electrical & Electronics Engineers

Thomas Koshy, Chief  
Mechanical & Electrical Engineering Branch  
Office of Research, USNRC

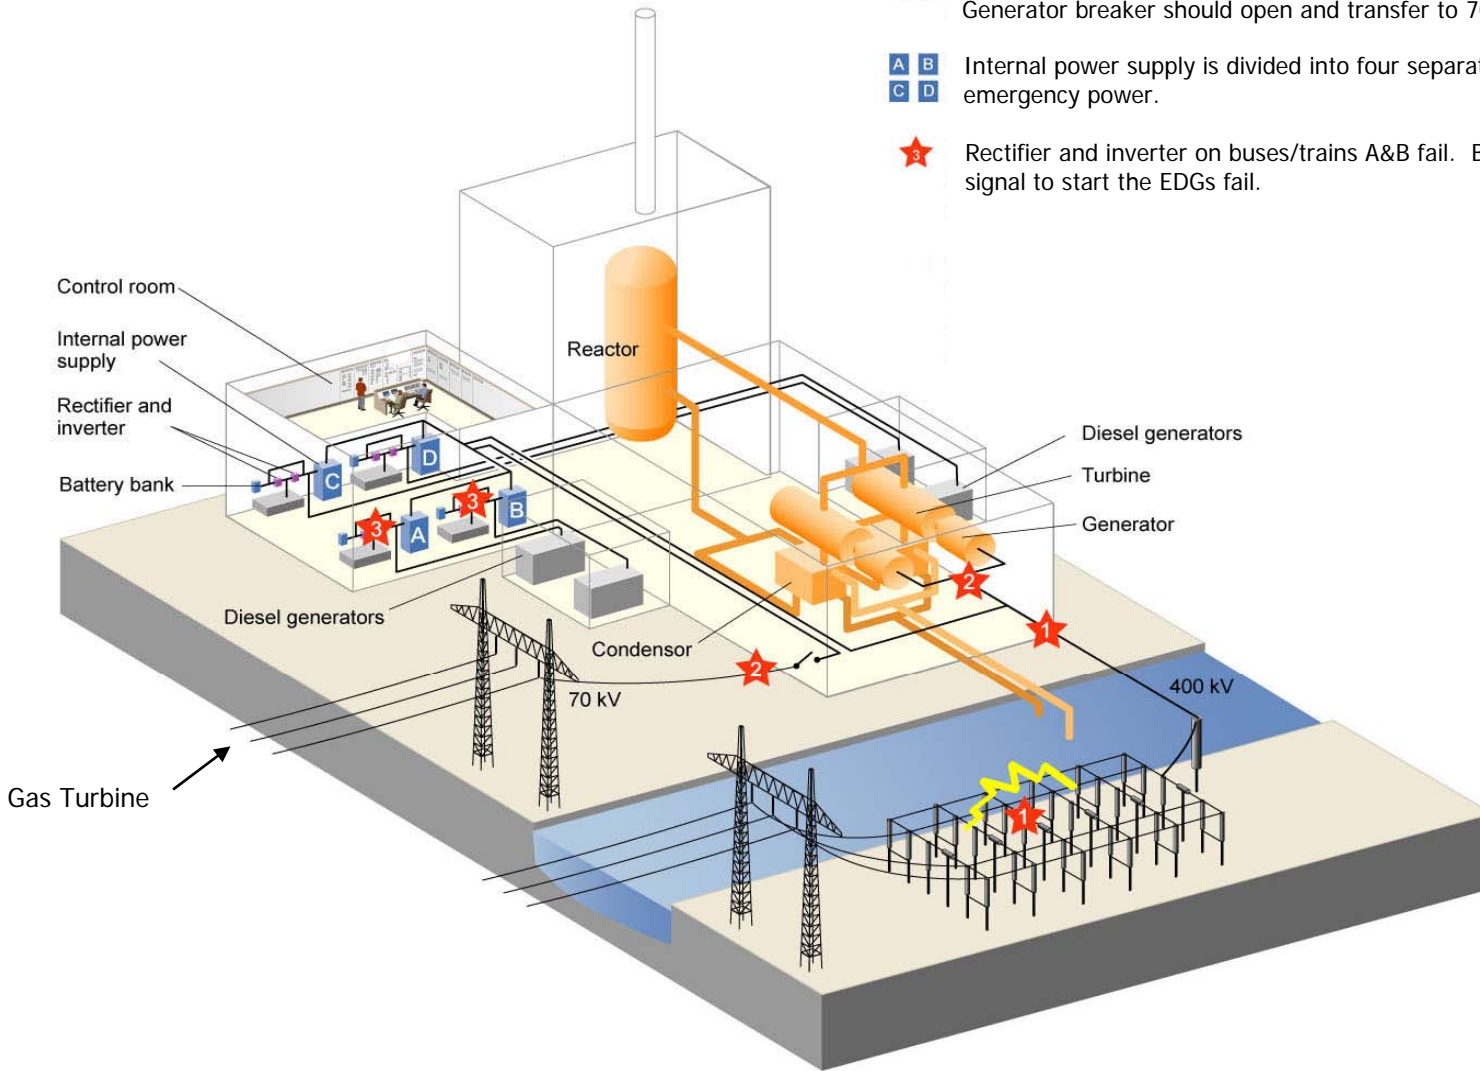
- ★ Maintenance work in the switchyard causes an arc and a short circuit. Unit 1 is disconnected from the grid and reactor scrams.
- ★ Failure in the generator protection results in generator breaker not opening. Generator breaker should open and transfer to 70kV offsite power.

Internal power supply is divided into four separate buses/trains (A,B,C,D) for emergency power.
- ★ Rectifier and inverter on buses/trains A&B fail. Buses A&B loss power and the signal to start the EDGs fail.
