Overview of Fukushima accident

**Nov. 9, 2011
Orland, Florida**

Main Sequence of the accident of Unit1, Unit2 and Unit3 of Fukushima Dai-ichi NPS

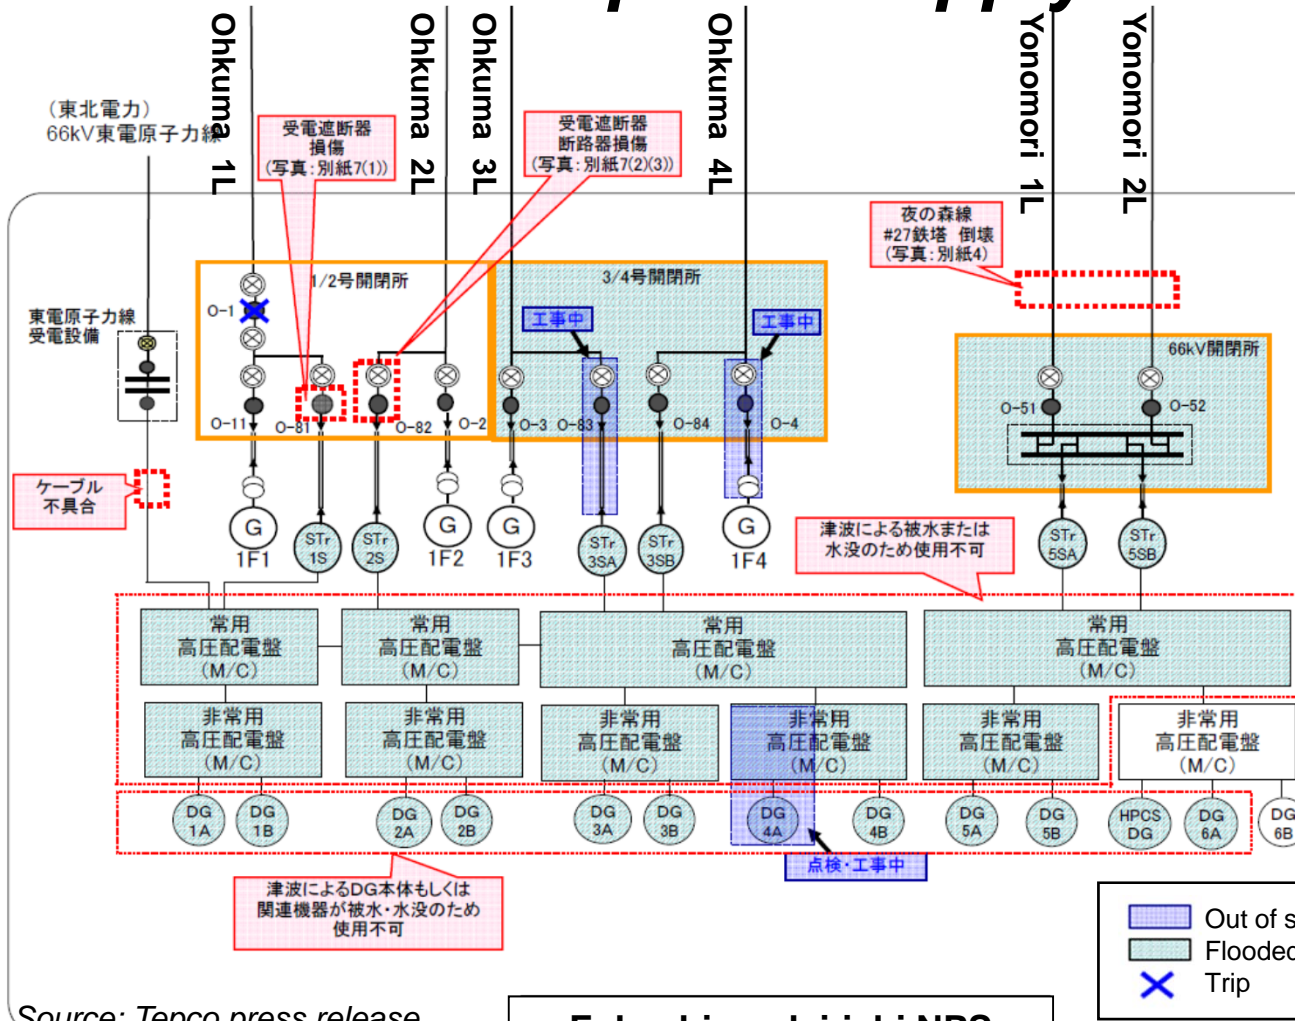
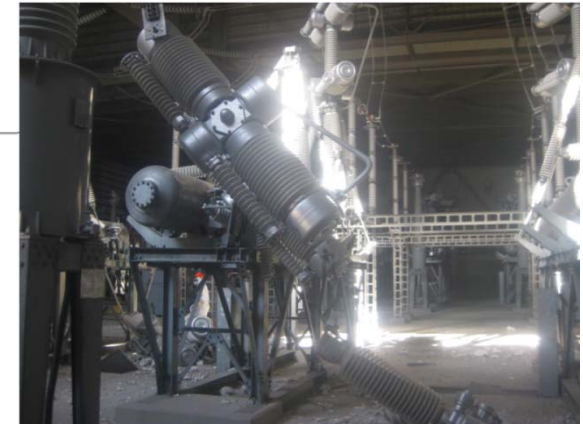
Breaker damaged

Ohkuma 1L,2L : Breakers broke due to the earthquake

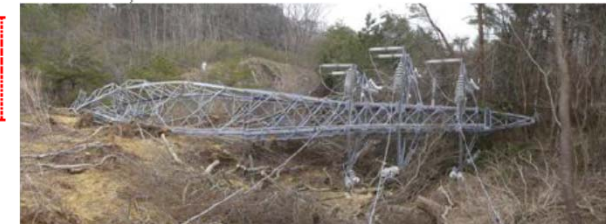
Collapsed pylon

Yonomori 1L,2L : Pylons collapsed due to landslide

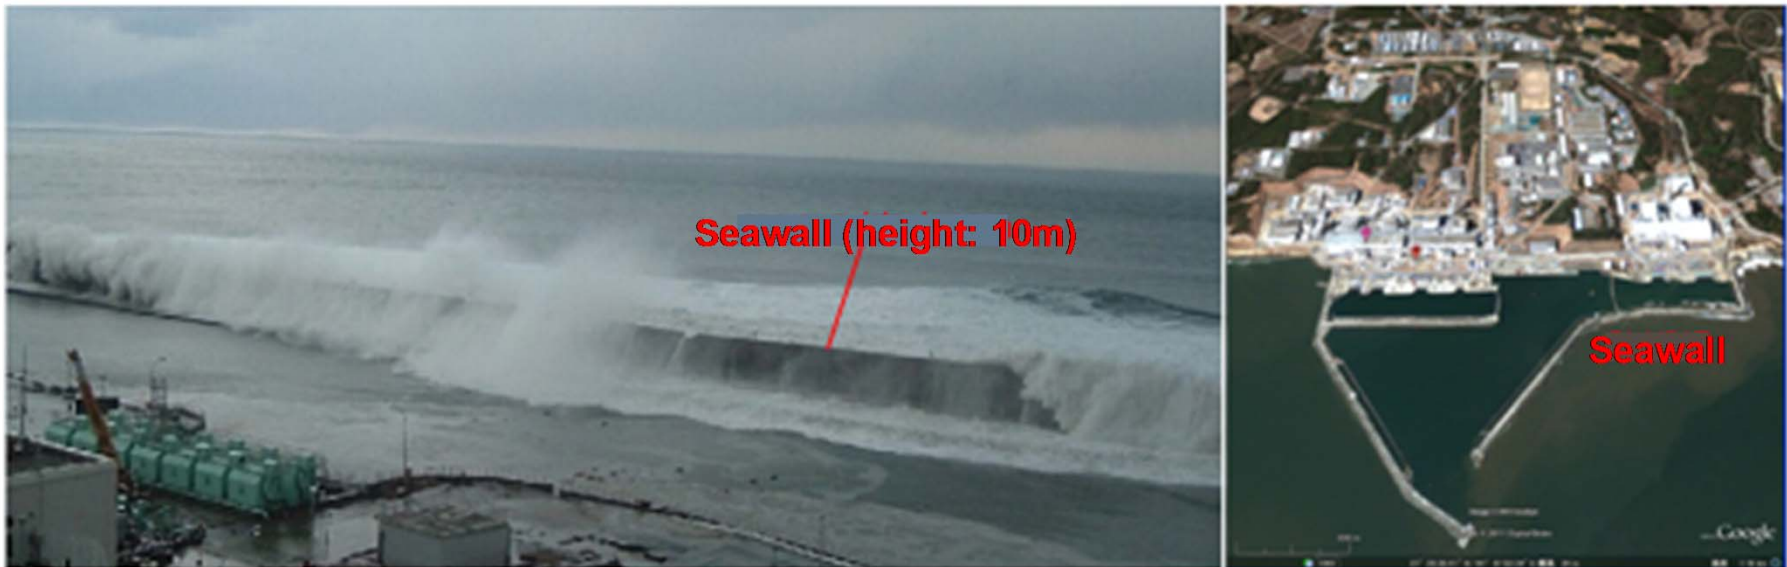
Tsunami getting over seawall

The first major tsunami reached about 49 minutes later after the earthquake

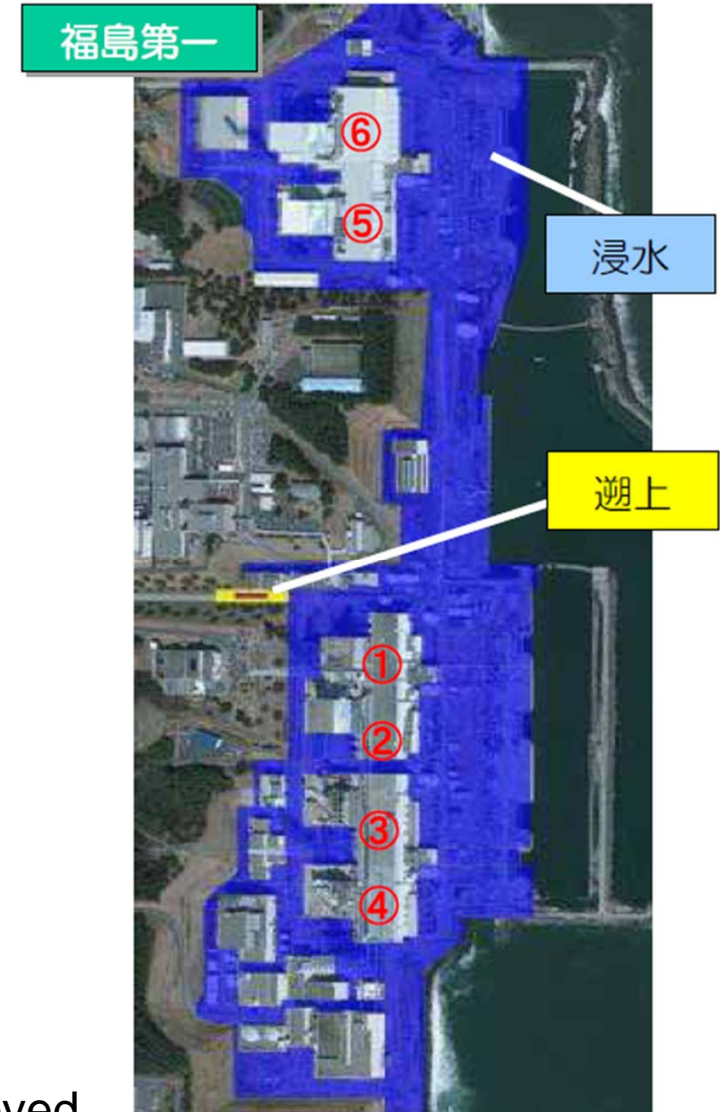
- Many components installed near the sea were destroyed
- Seawater pumps for ultimate heat sink and fuel tanks for emergency diesel generators were washed away

Flooded area by tsunami⁸

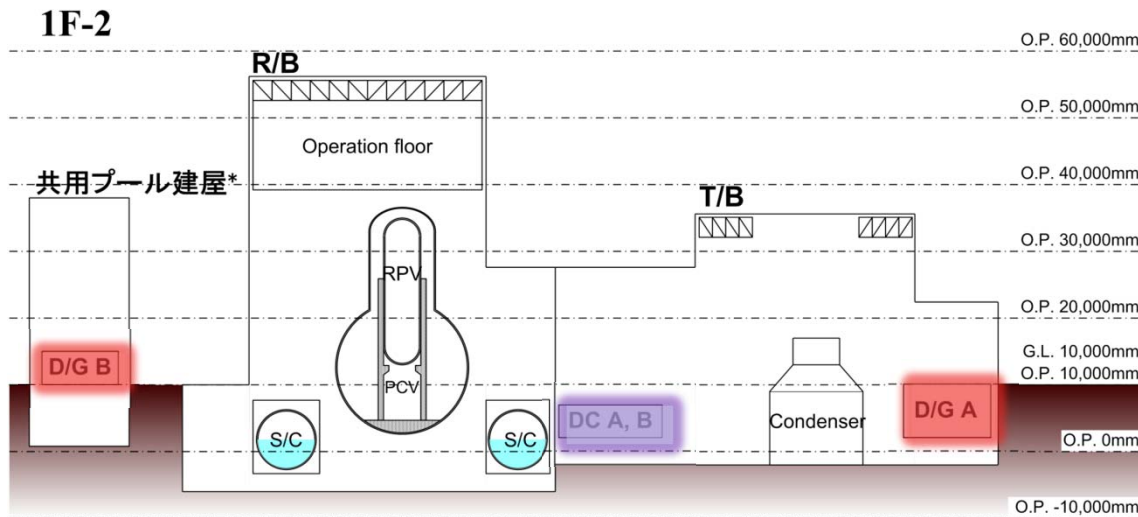
Unit 1, 2, 3 and 4

- Elevation of the ground is 10m
- The Emergency Diesel Generators and Metal Clad Switchgear installed in the basement floor of the reactor buildings and the turbine buildings were flooded

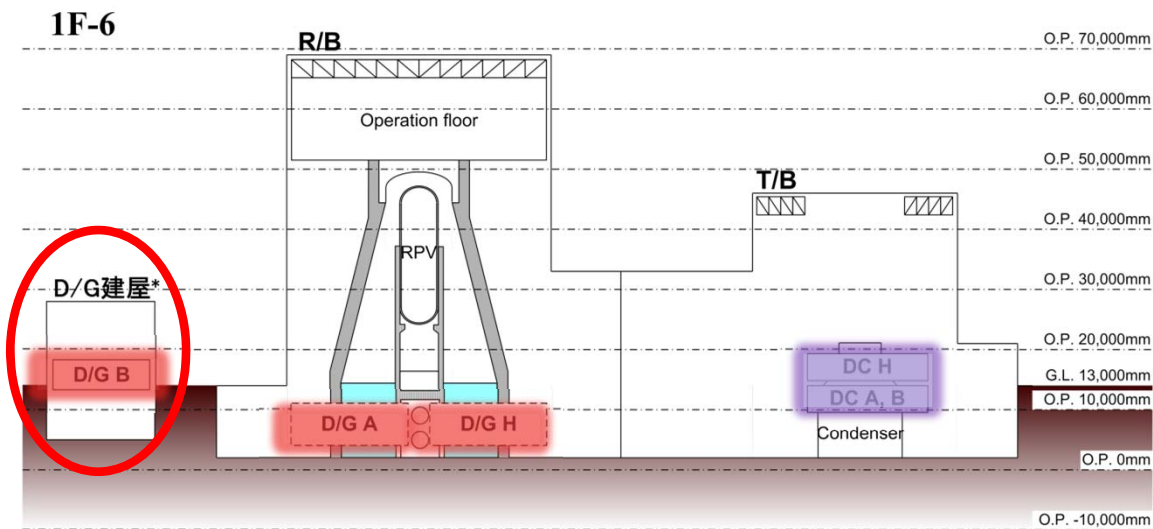
Unit 5 & 6

- Elevation of the ground is 13m
- One air-cooled EDG of Unit 6 which is located on the ground level and Metal Clad Switchgear were not lost
- Temporary sea water pump installed after the earthquake was operable, making use of power source from survived EDG

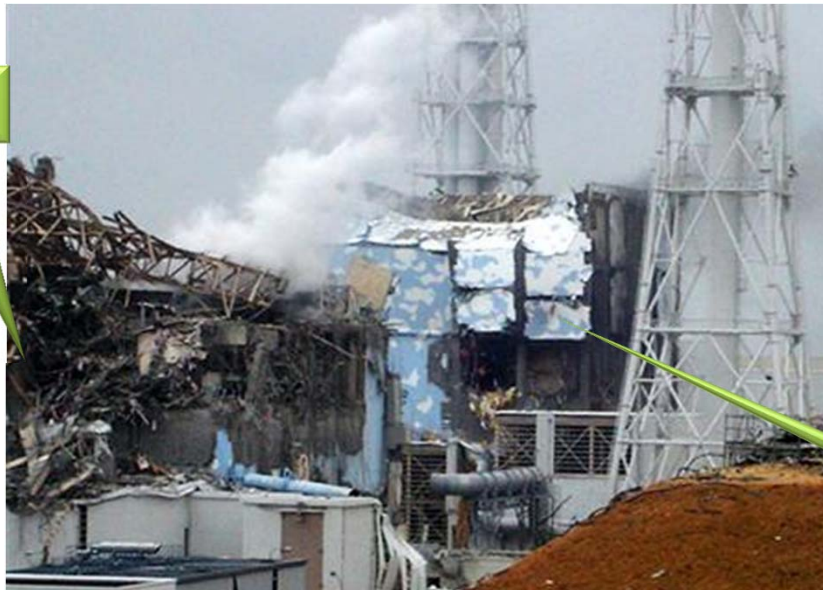
Unit 3

Damage of reactor buildings
