LOCA and Post-LOCA Qualification of PEEK insulated cables

Sven-Olof Palm, Forsmarks Kraftgrupp AB

2015-04-17, IEEE SC2, Sand Key, Florida

The success story about an EPA qualification

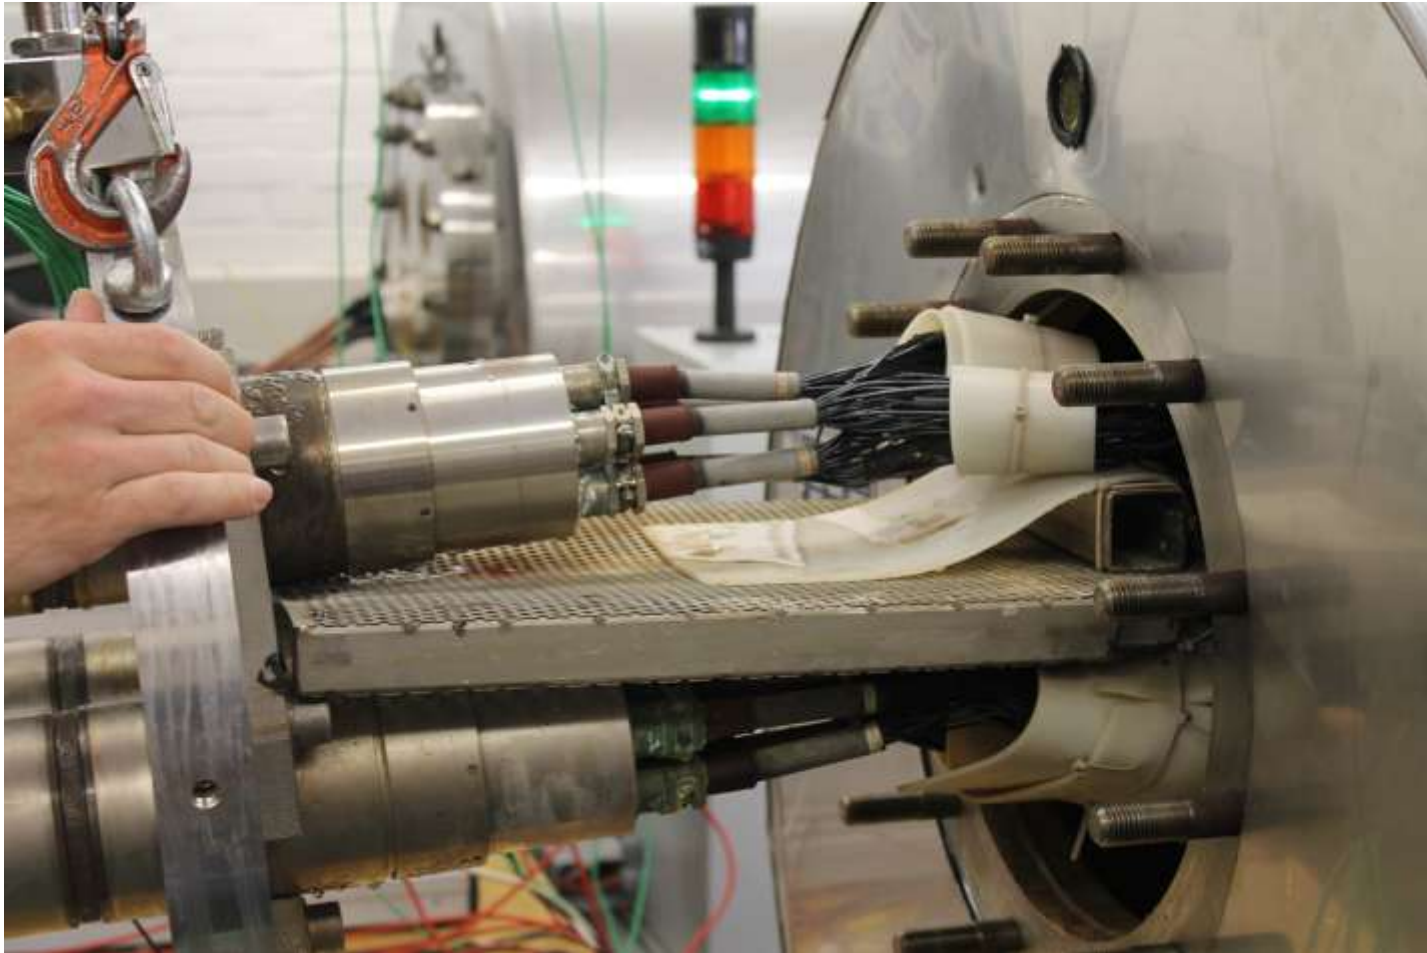
Test specimens after Post-LOCA

Problem started to occur at submergence

- **Fluctuating leakage current after submergence**
- **For 660 V the problem started immediately after submergence**
- **For 250 V the first problem occurs later**

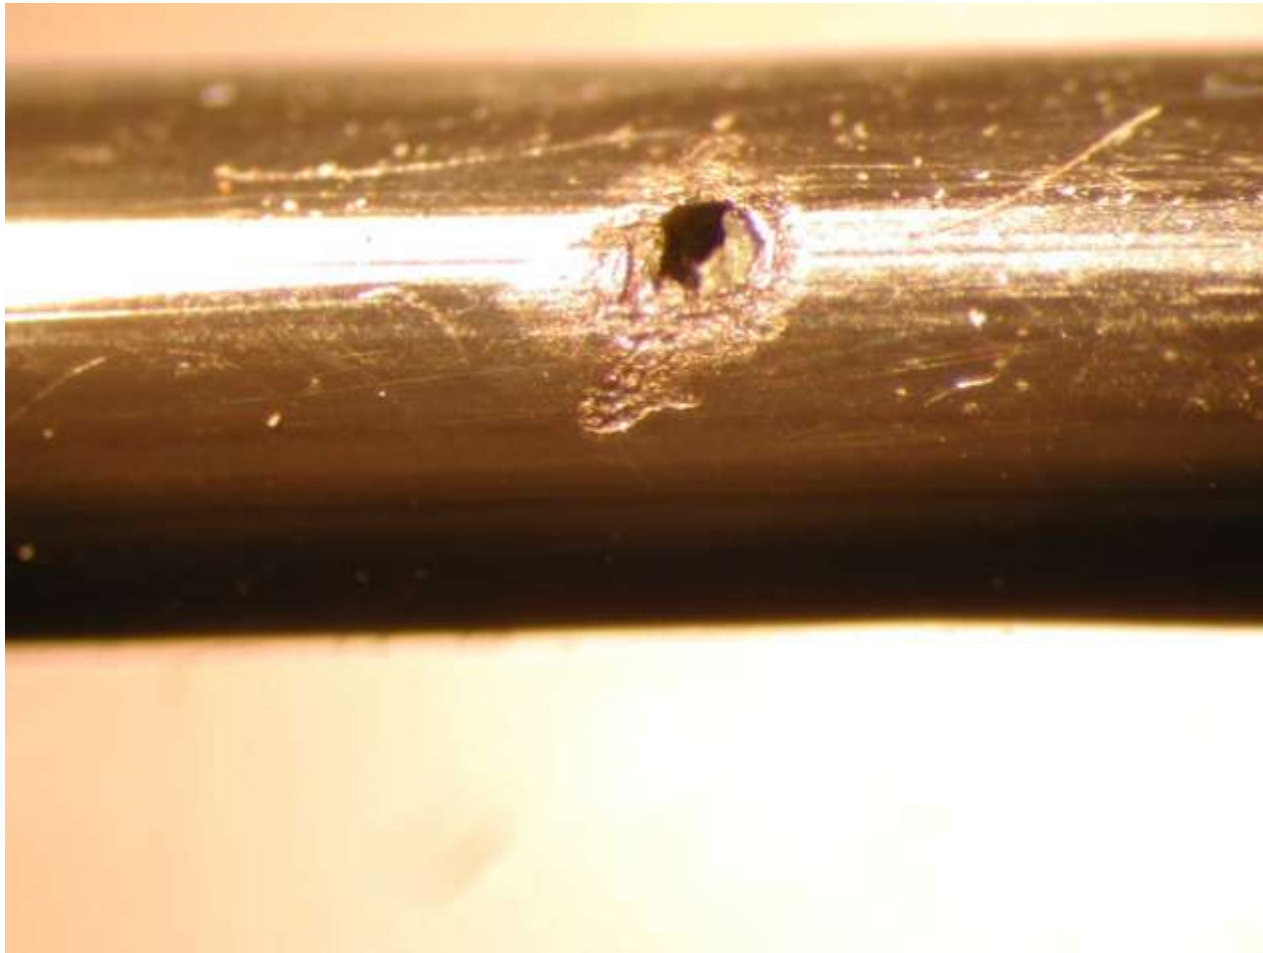
Result of LOCA test with submergence on PEEK insulated wires.

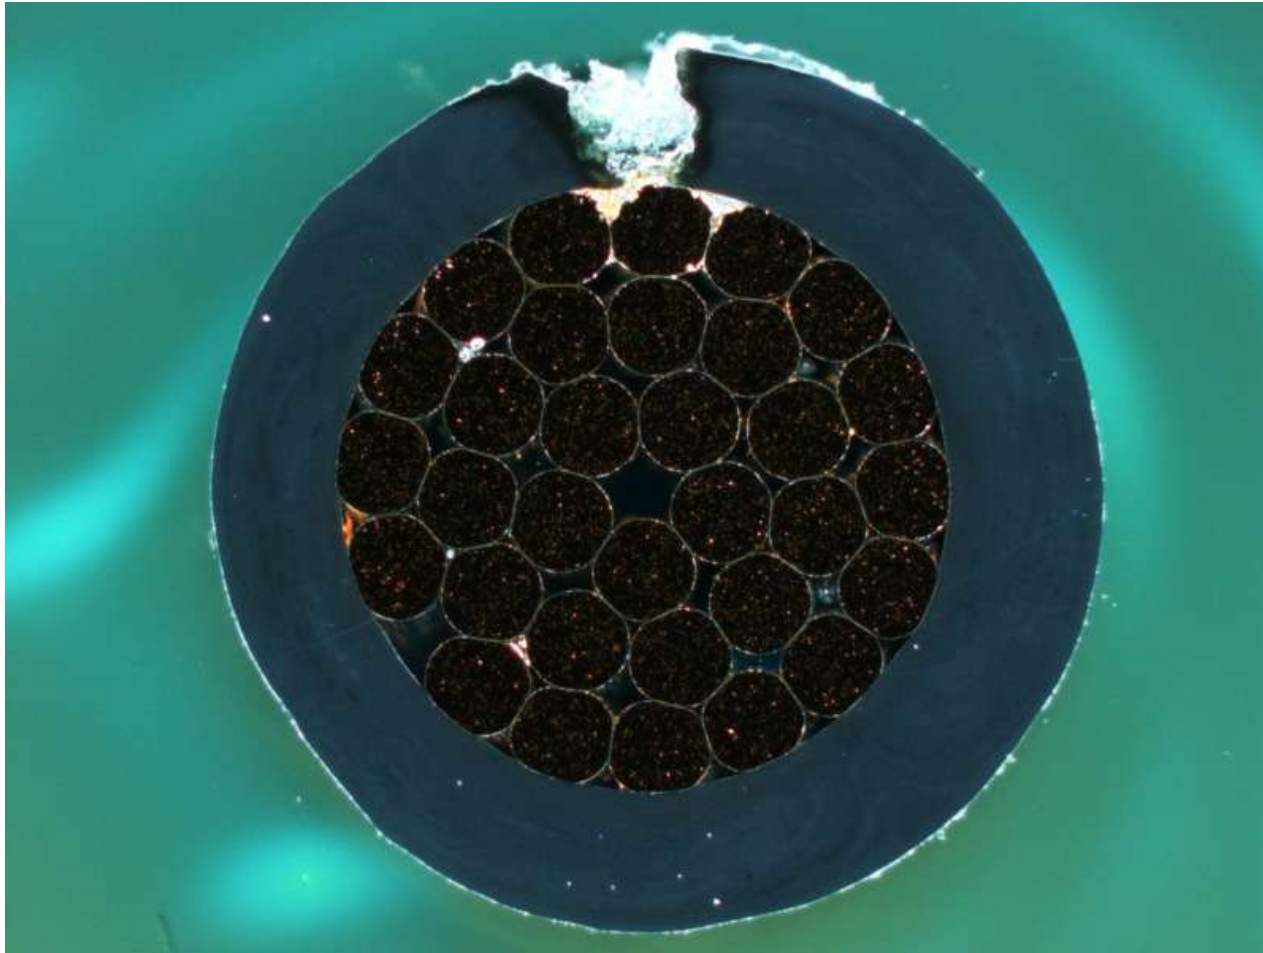
- **Were carbon black the reason to the problem?**

PEEK with Carbon Black pigmentation

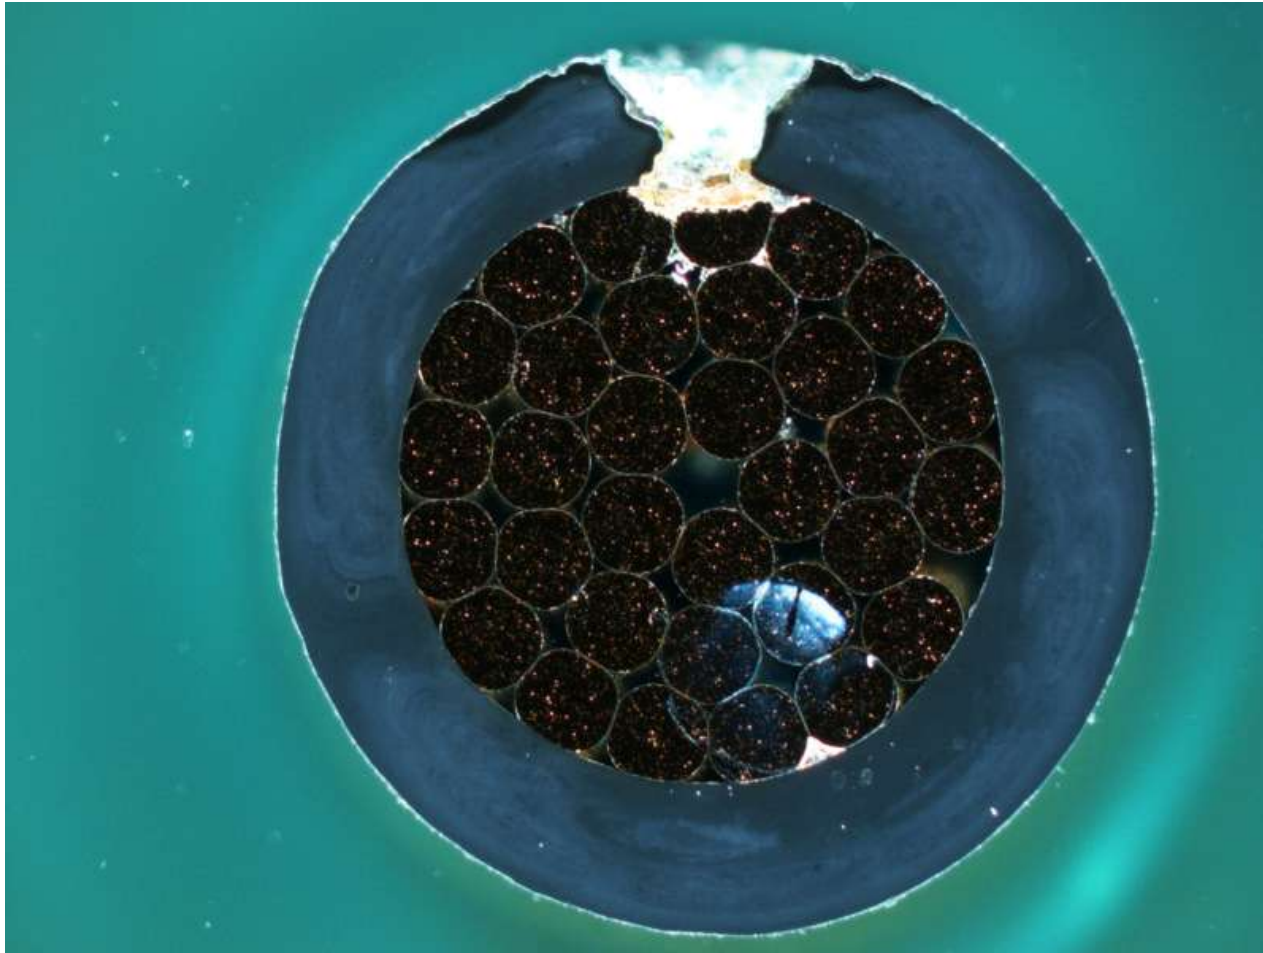
PEEK with Carbon Black pigmentation

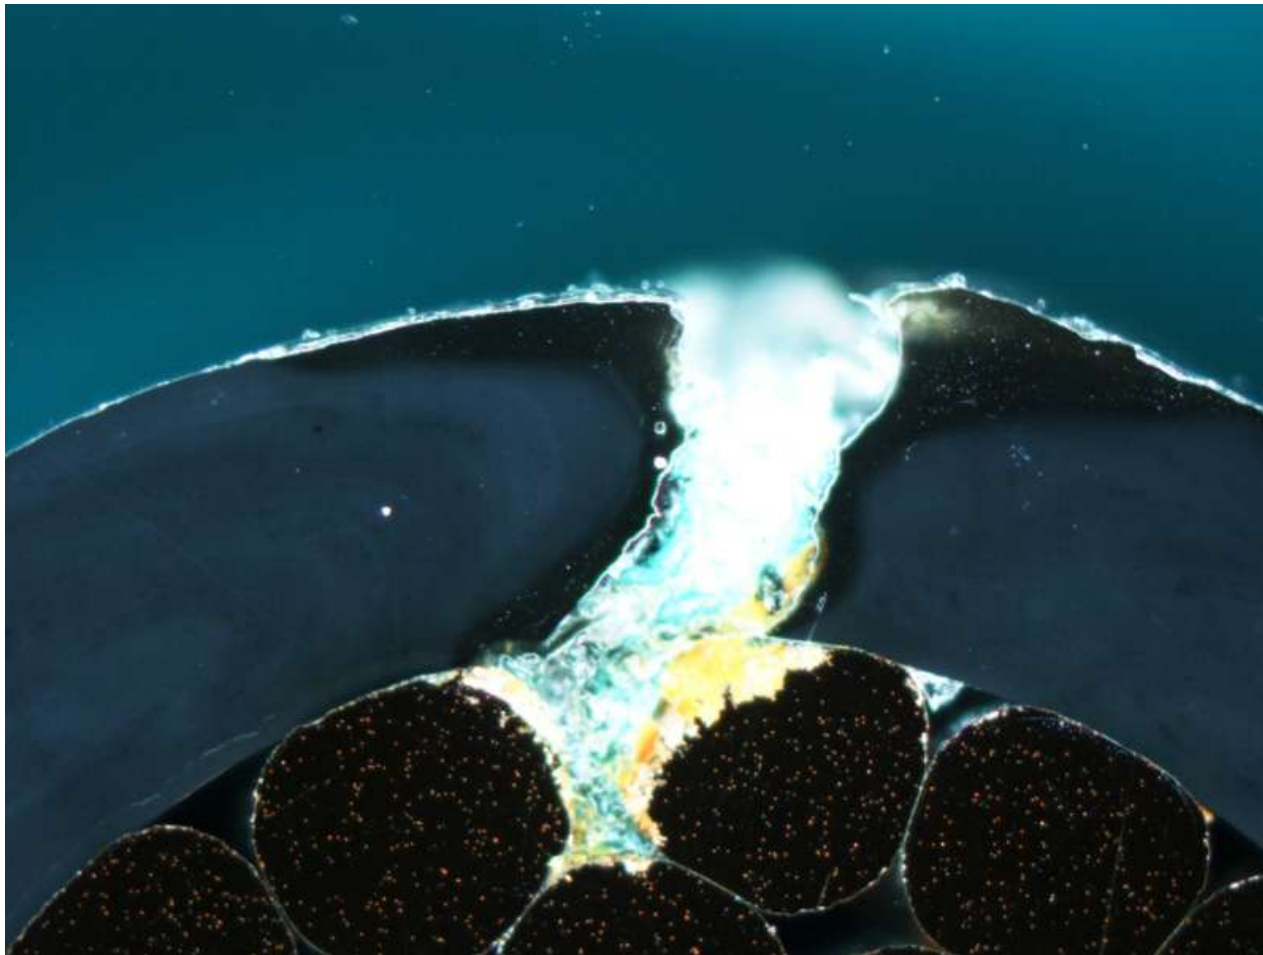
PEEK with Carbon Black pigmentation

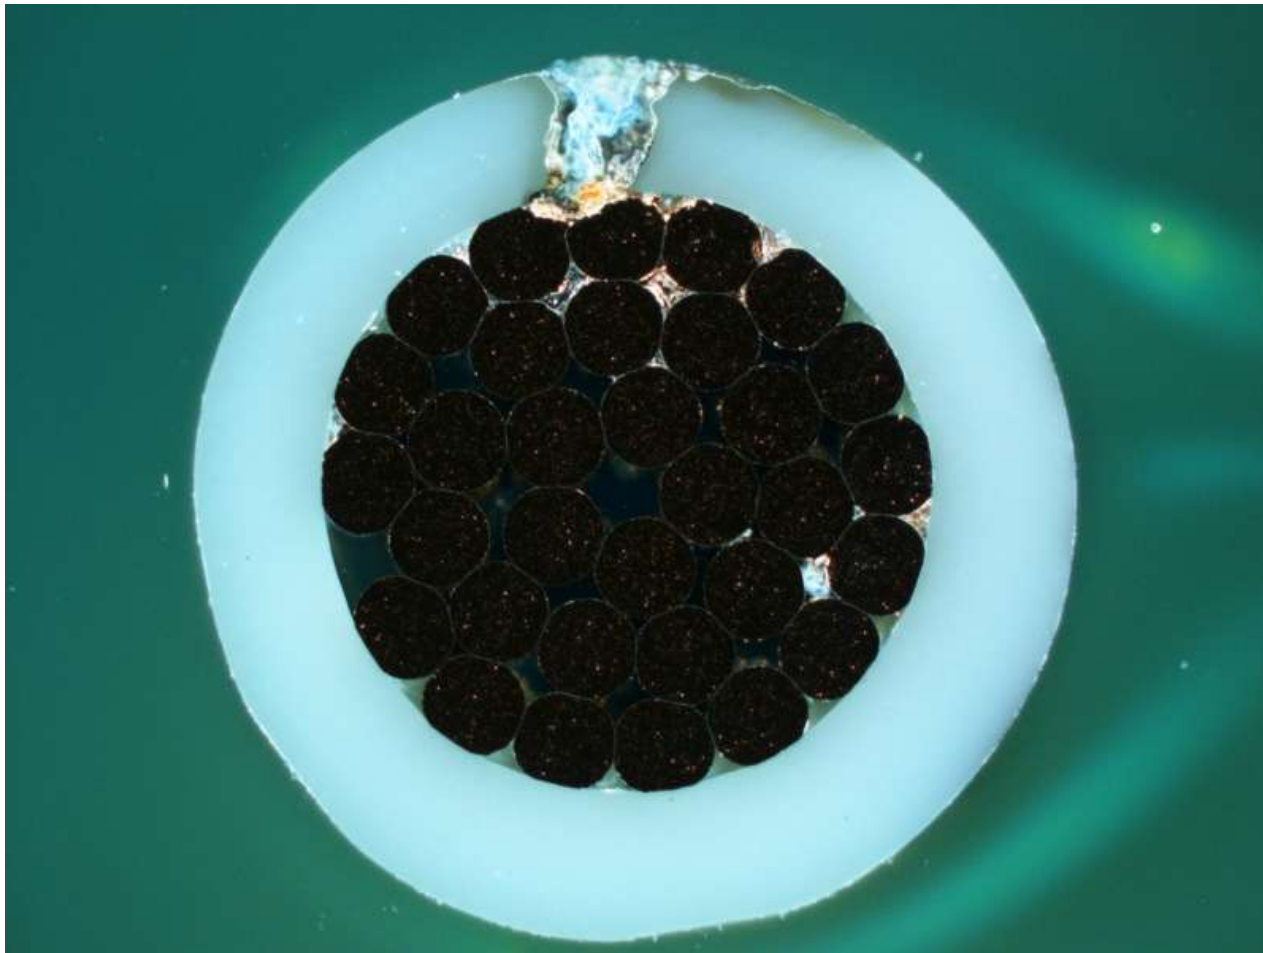
PEEK without any pigmentation

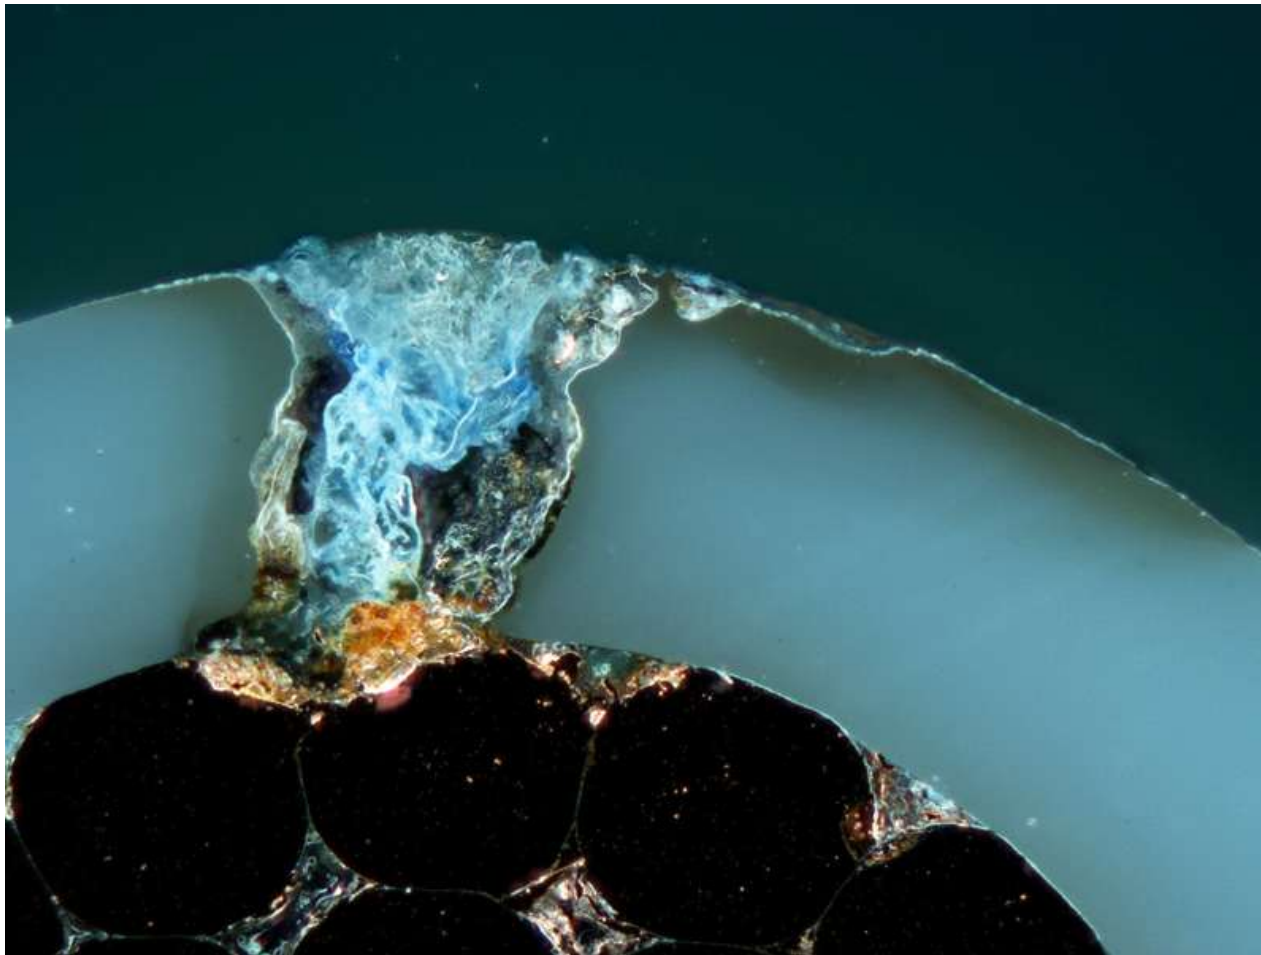
PEEK without any pigmentation
