Fifty Years of Transformer Problems

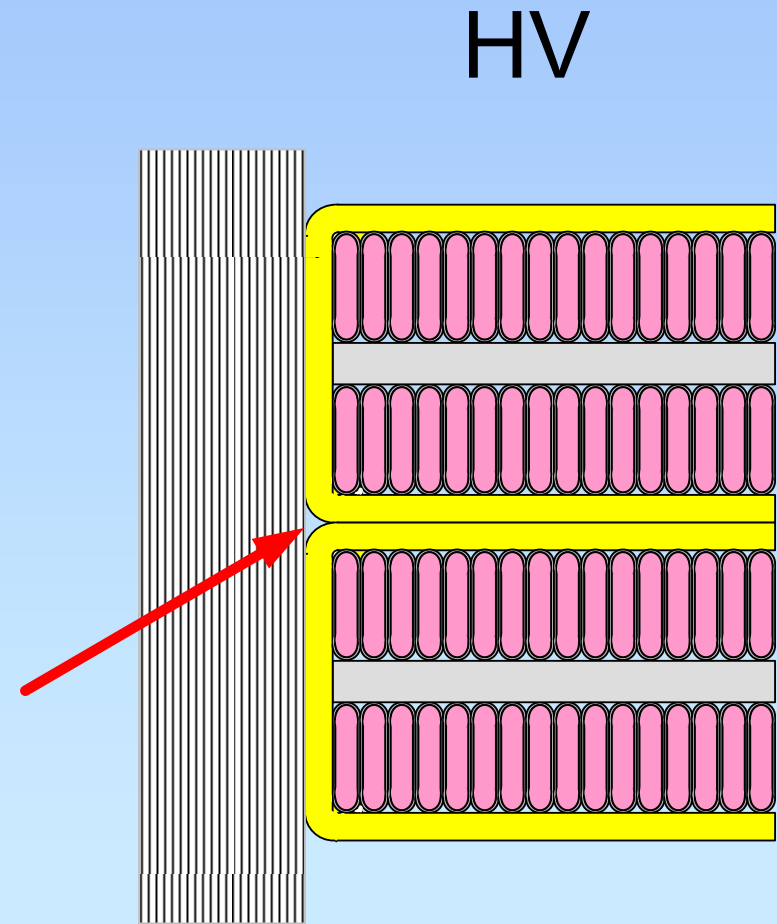
HV Winding with 'extra insulation'

The "solid" H / L insulation resulted in a high stress occurring on the inside of the HV, so additional crepe tape (yellow) was applied.

Partial discharge in N_2 occurred at the back of the coil (red arrow). & black staining was found.

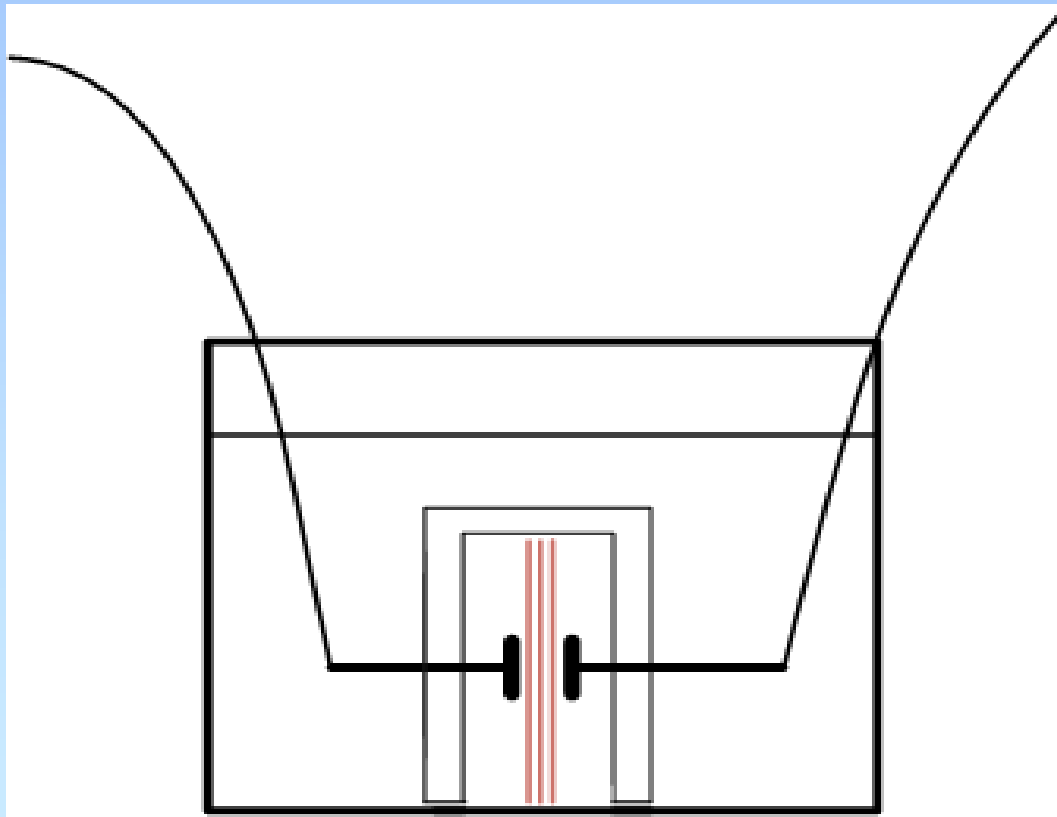
Model for tests

The black stain was copper oxide.

Lab work revealed that the partial discharge in the N₂ produced an amine compound, which is a derivative of Ammonia, and can dissolve copper oxide from the HV conductors.

The amine with Copper Oxide migrated through the crepe paper, and once diluted with the bulk oil, promptly deposited the Copper Oxide on the outside of the coils.

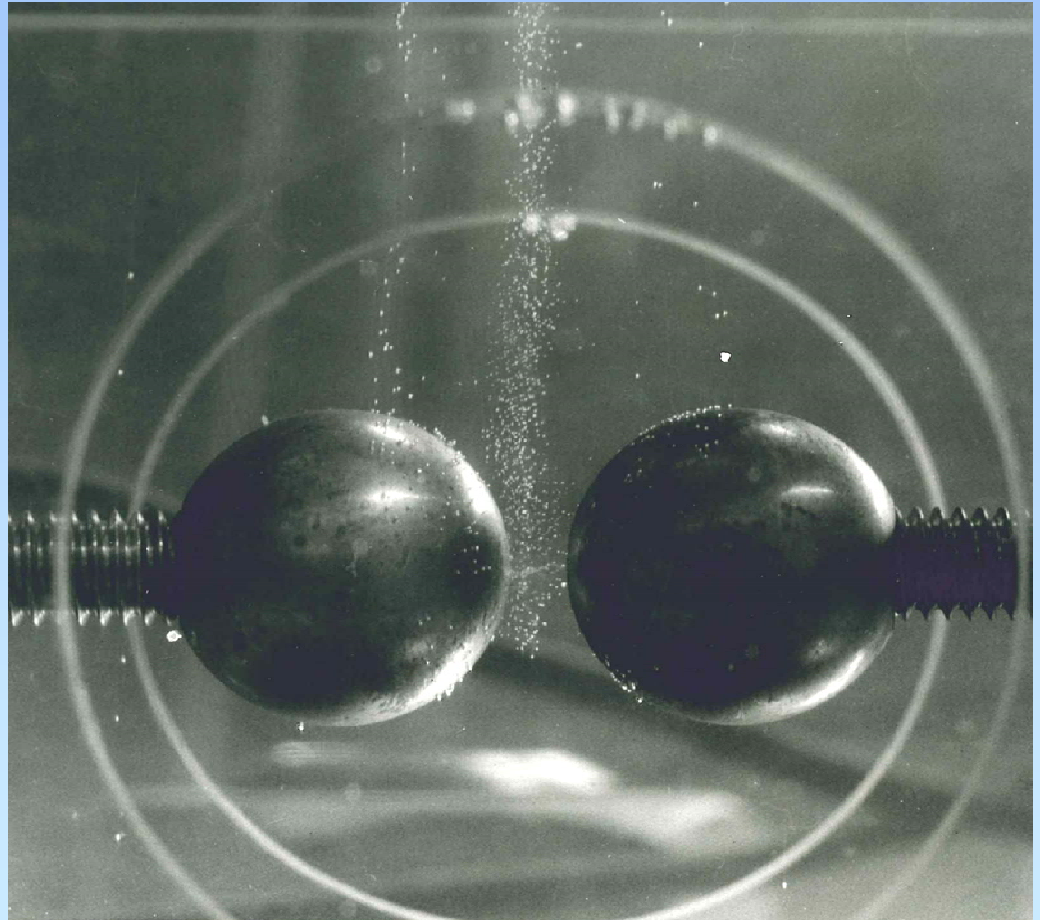
12 mm dia
spheres with
10 kV applied,
in oil super-
saturated with
 N_2 .

Bubbles created
spontaneously

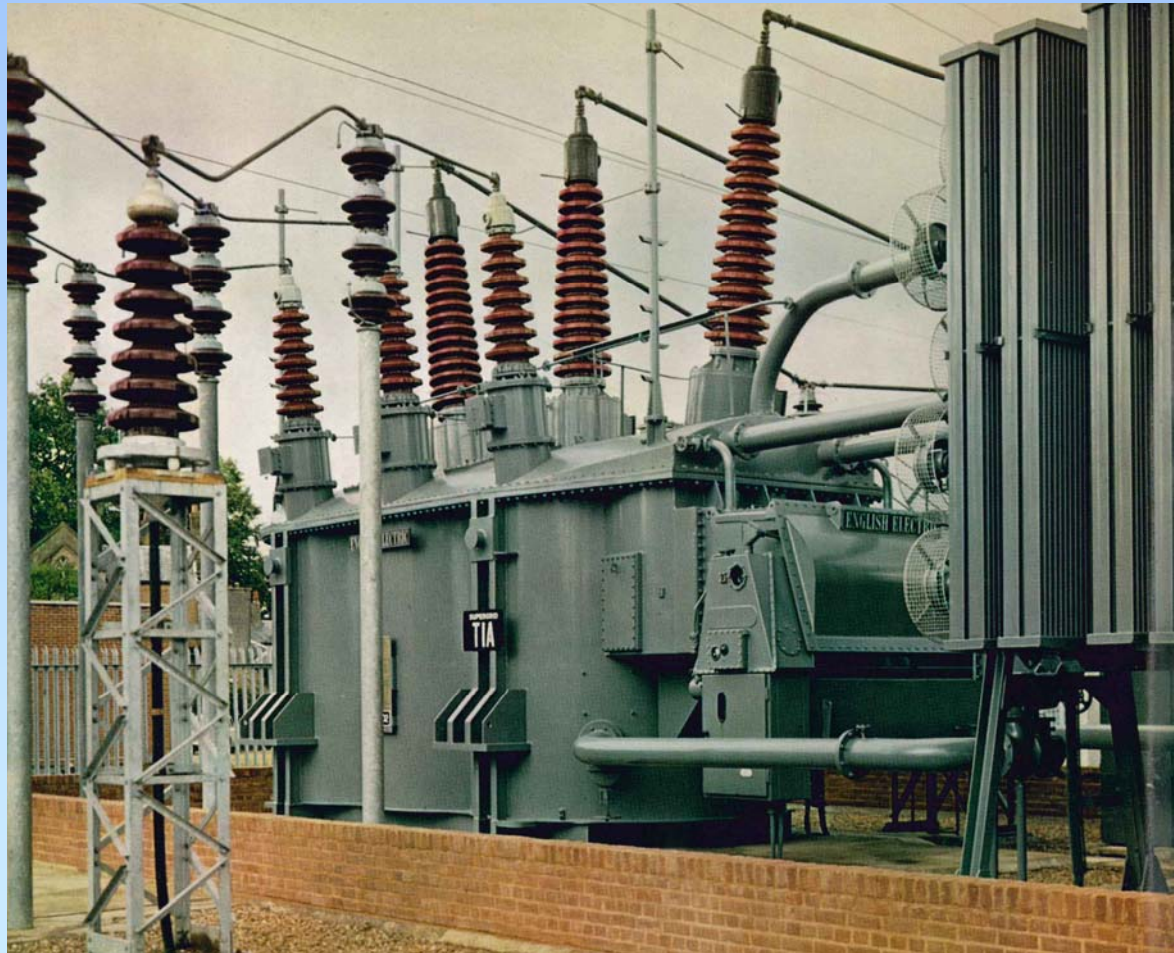
275/132 kV Autotransformer at Iver Station (Buckinghamshire)

The cause of the high power factor was found to be due to inadequate processing at site.

So we carried out RIV tests, using an ERA equipment, on all the Company's 275 kV transformers in the country.

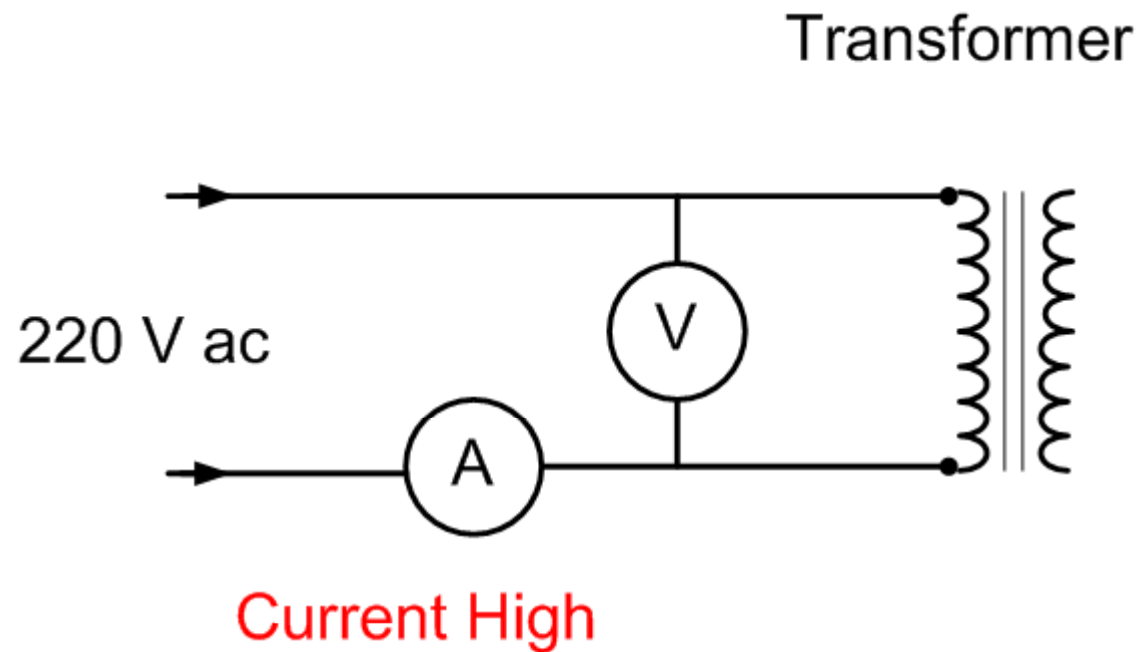
Mag. Current High

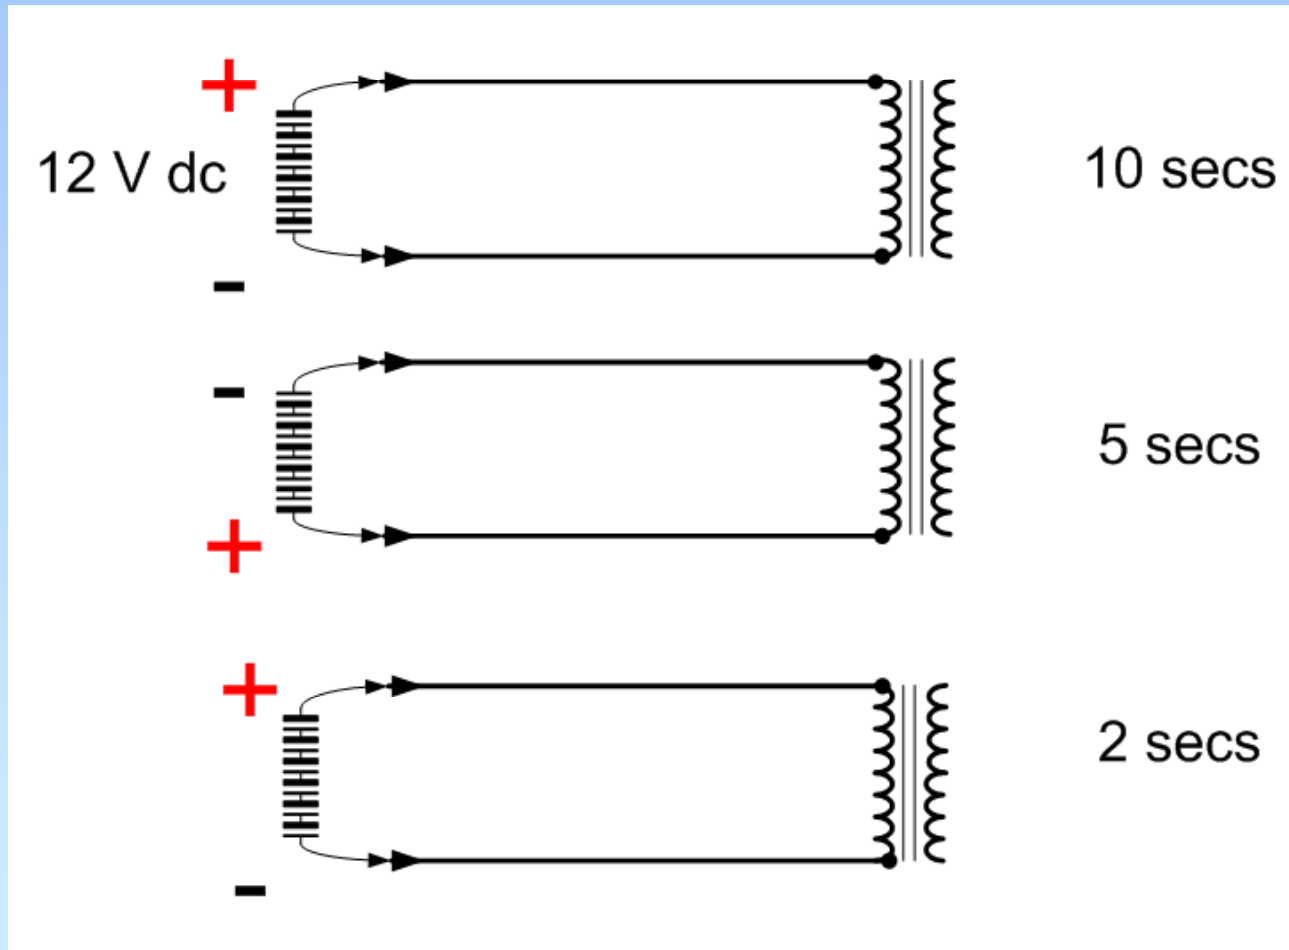
Core de-magnetized with battery

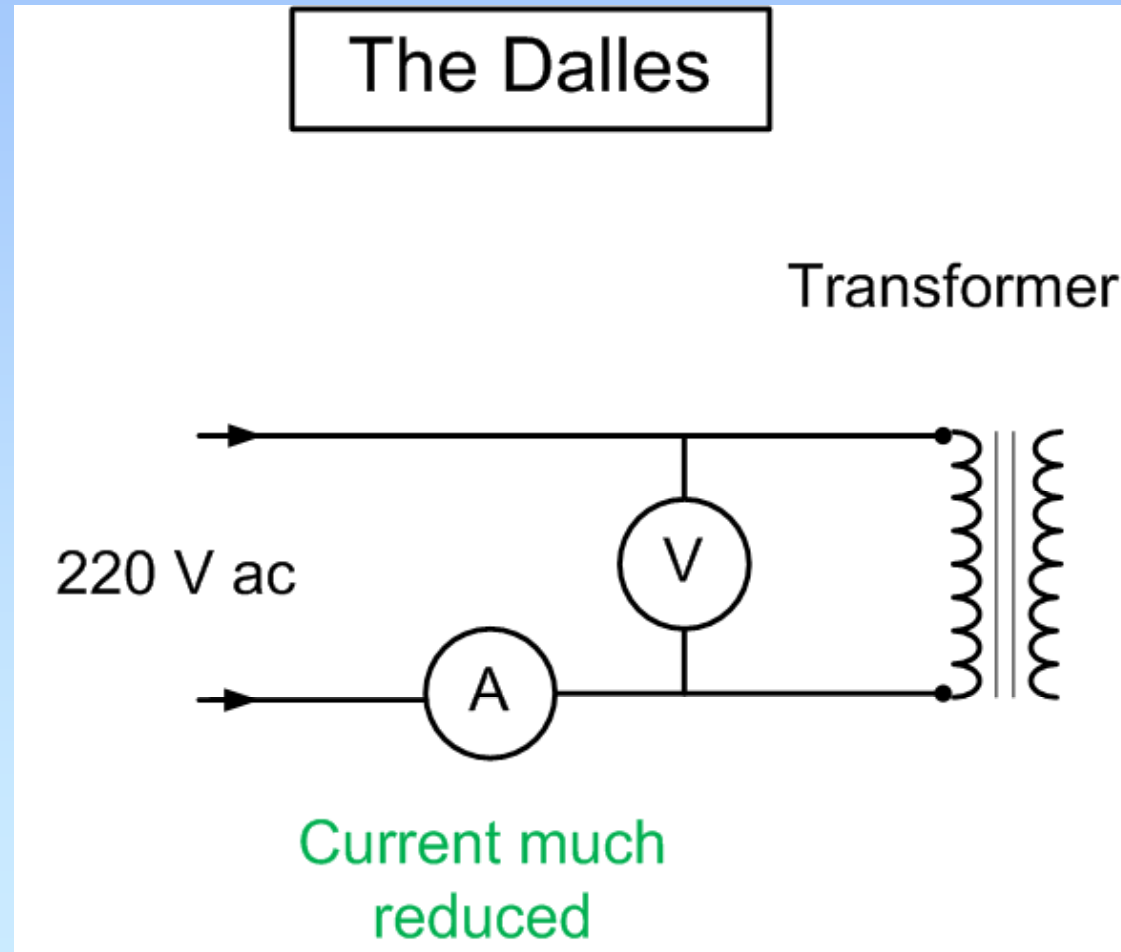
Mag. Current much reduced

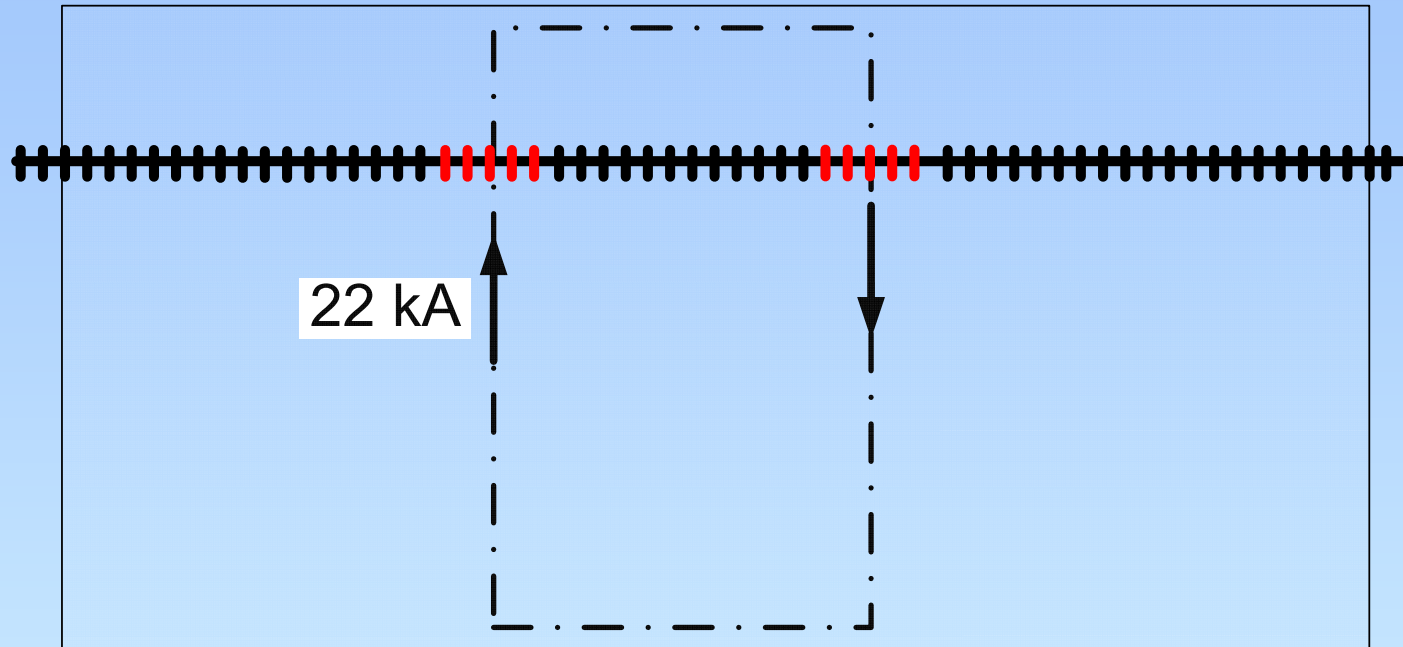
High Current Loop caused a current to circulate round the tank (21)

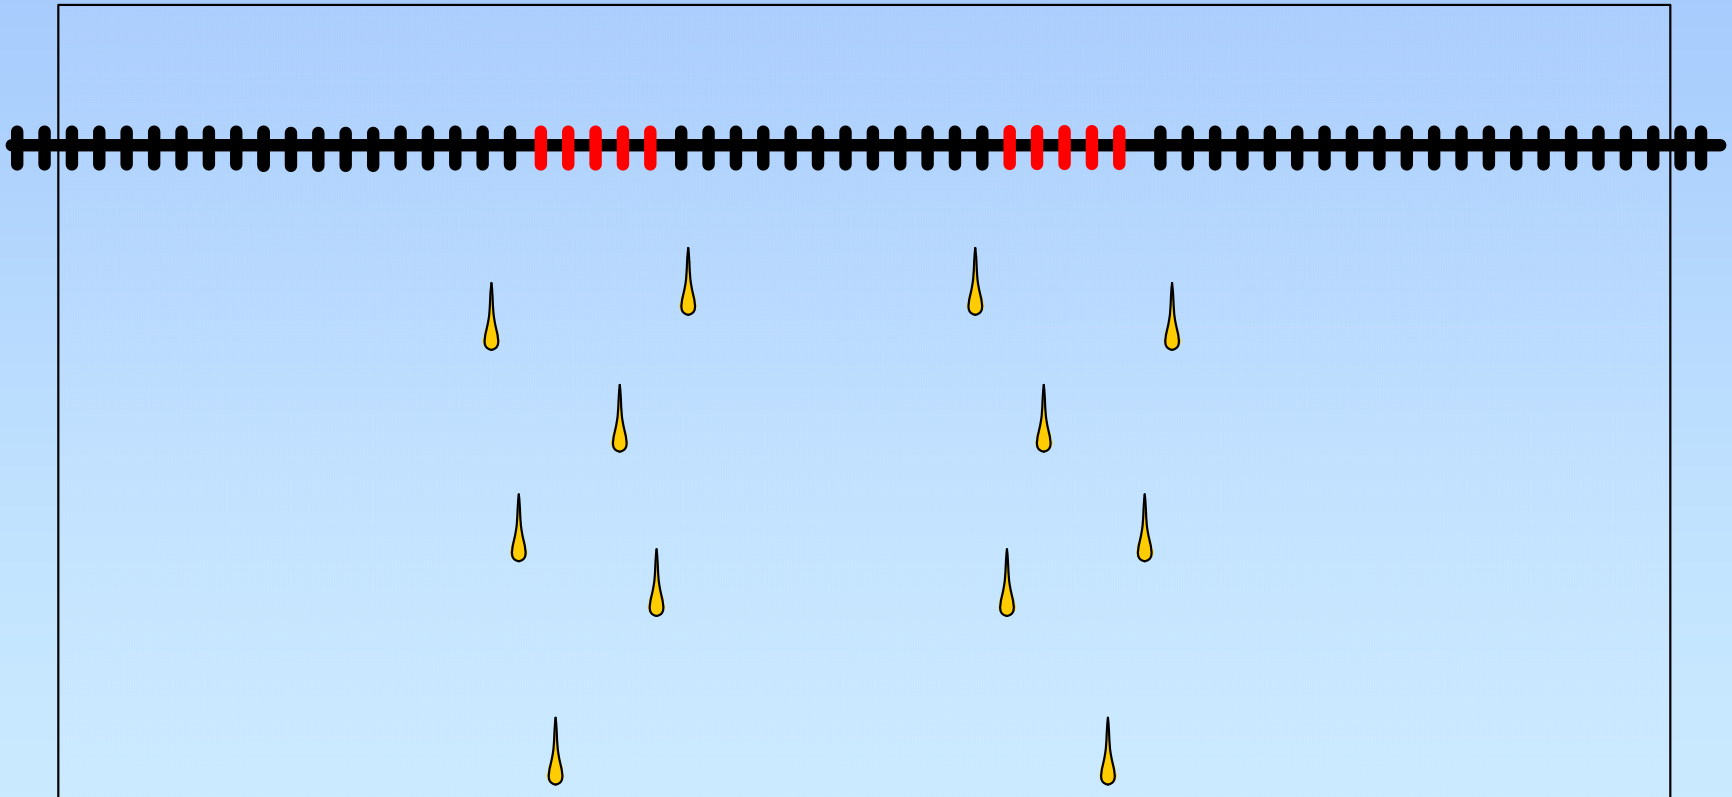
The Cover Bolts became so hot the tank / cover gasket burnt, and oil ran down the side of the tank! (22)

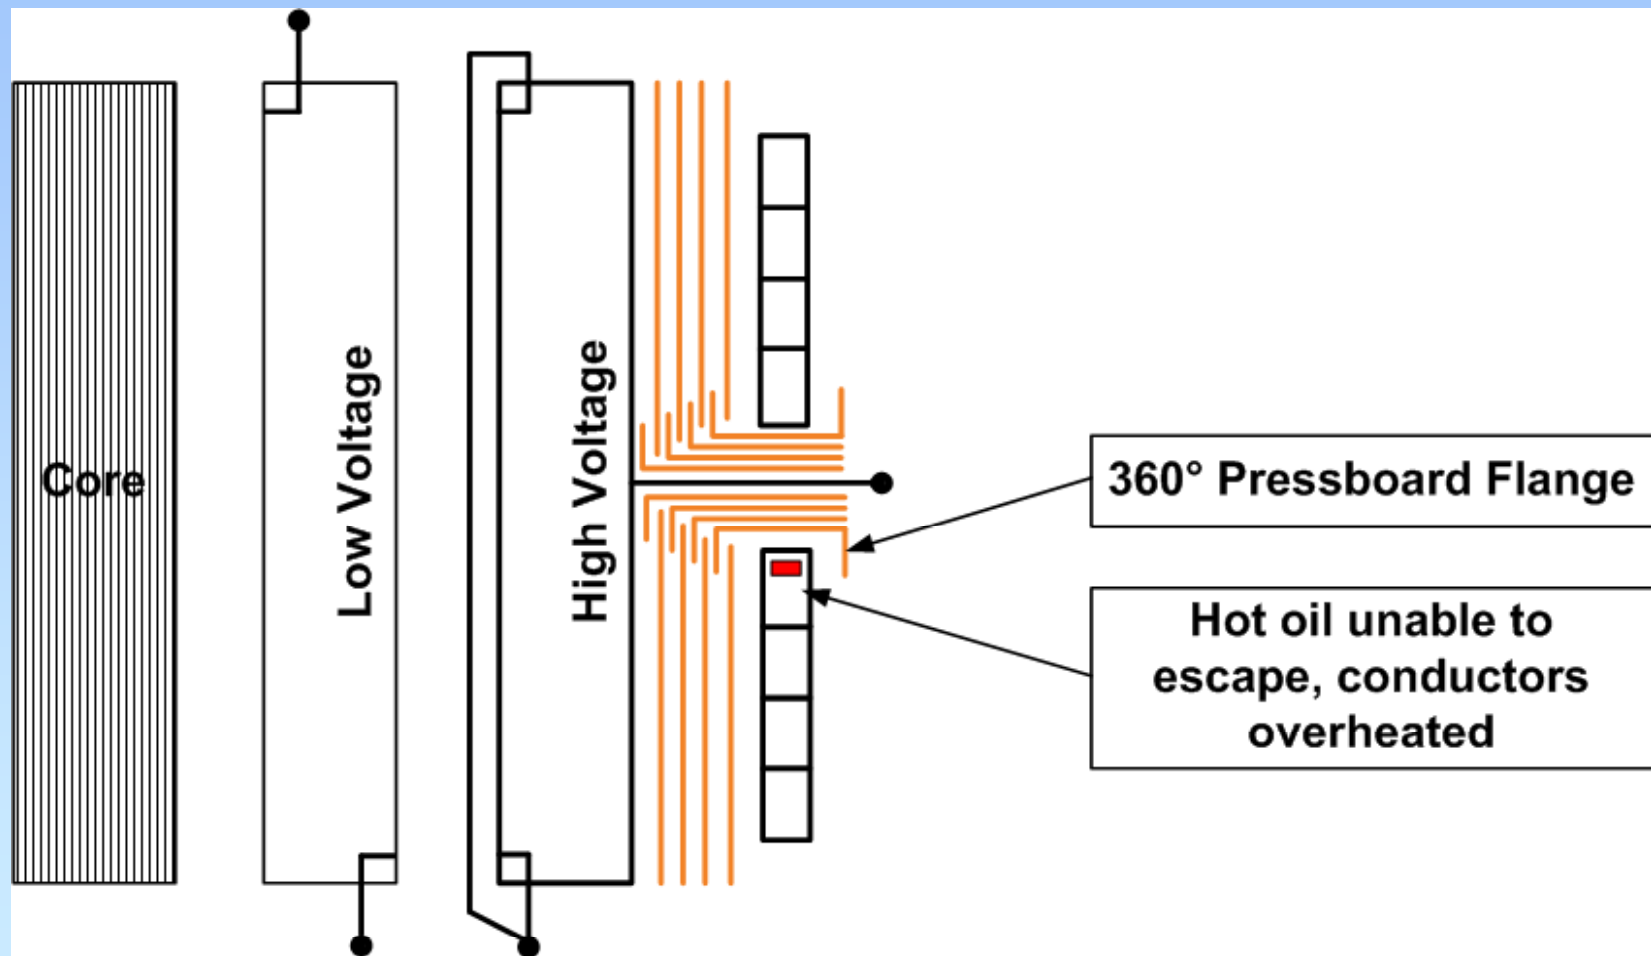
[1] 570 MVA Generator Transformer. Conductors at the top of the bottom tapping section inadequately cooled

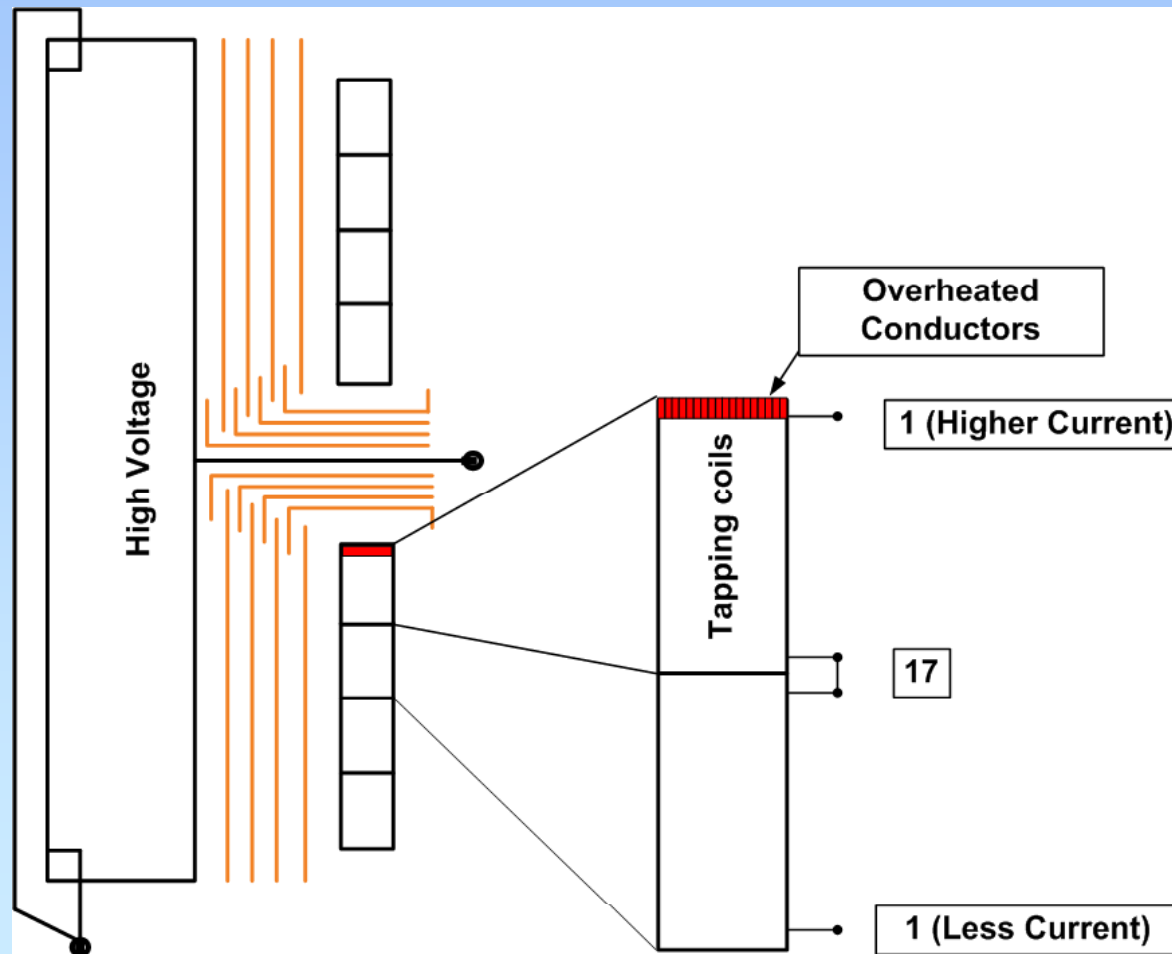
Parallel Tapping Coils

Because of the radial component of the leakage flux the four tap sections did not share the current equally.

➤ A re-design was required !

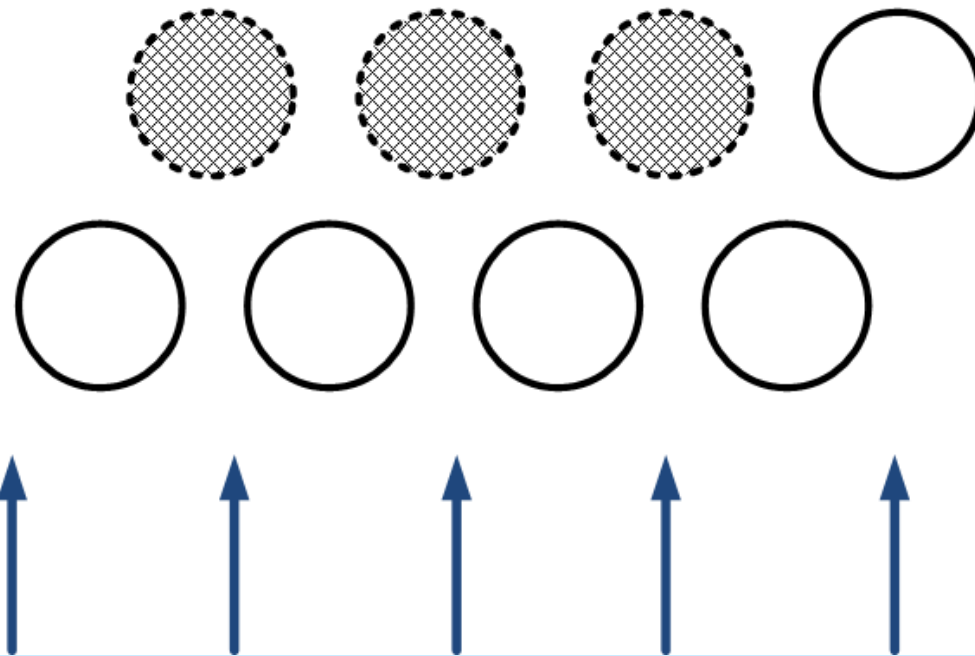
Gale force wind

Cooling Towers Collapsed !!

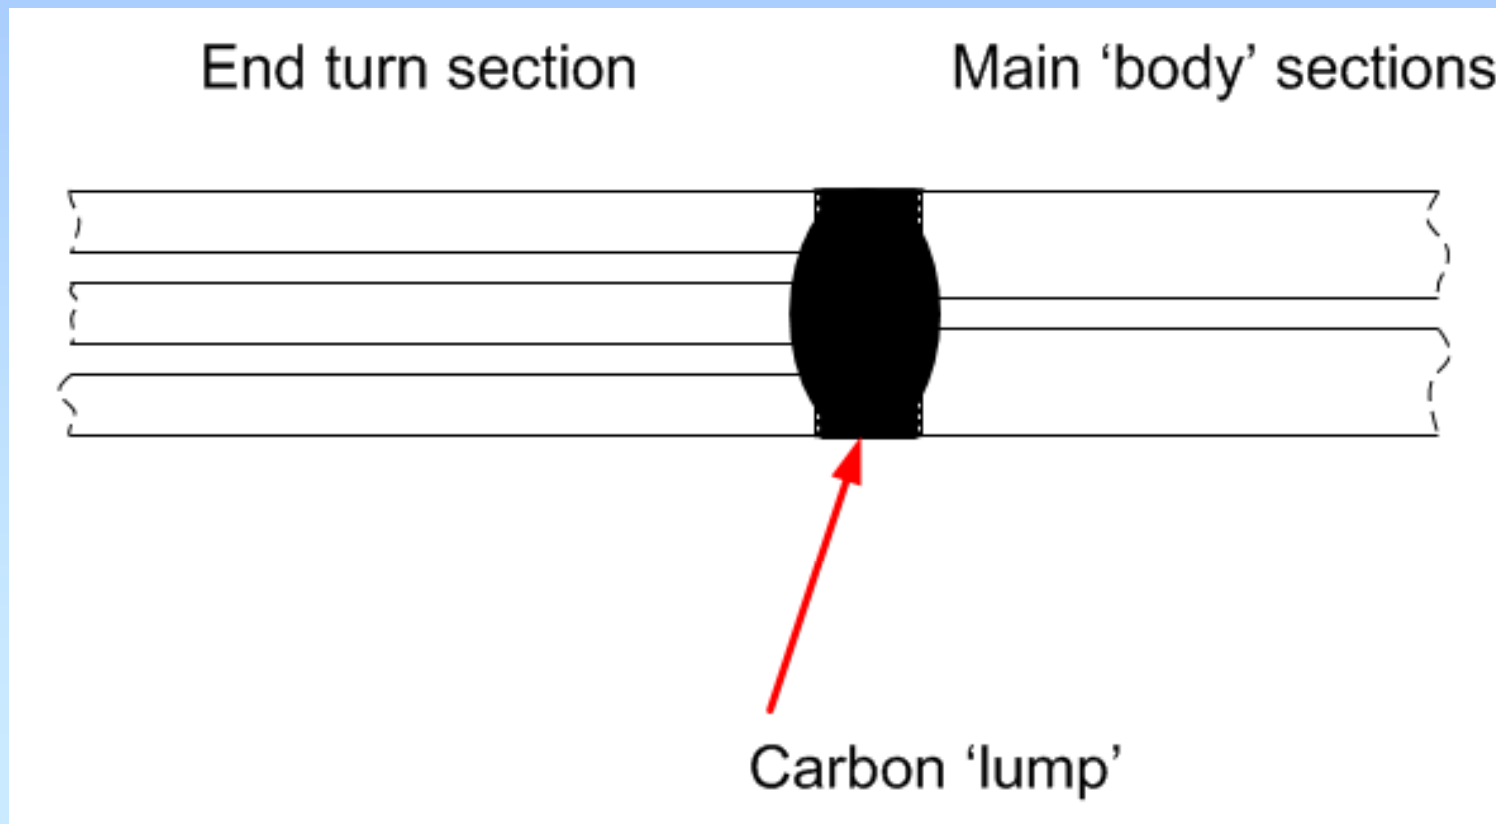
Junction between CTC cables allowed
for circulating current (red)

High temperatures allowed oil to
“breakdown”, producing H_2 plus C, H_2
“attacked” Cu O to produce H_2O (steam)

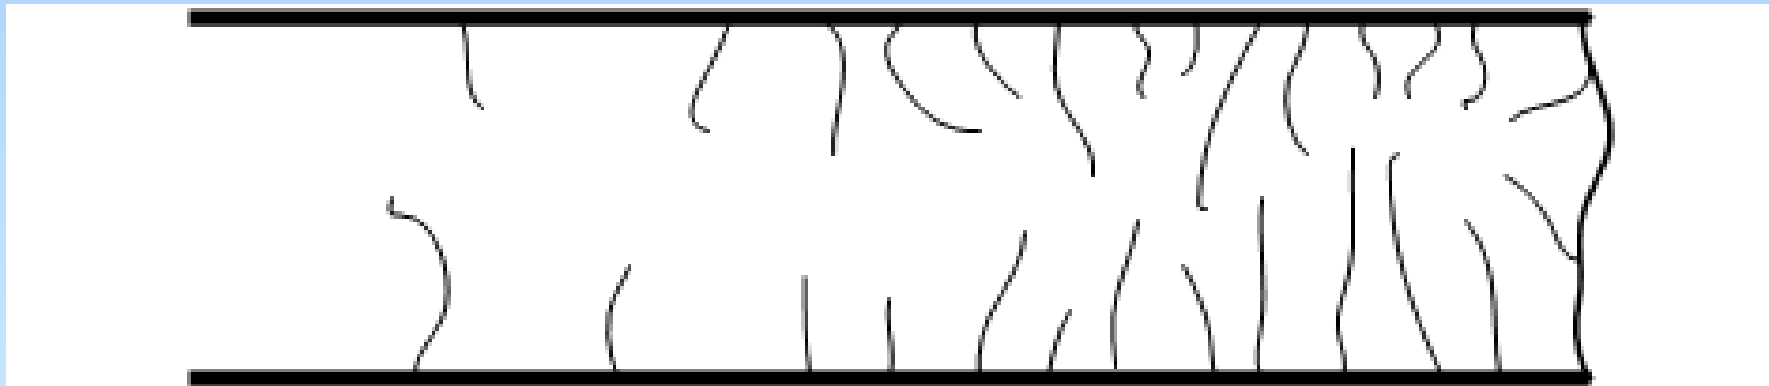
The end of the individual conductor strands had been broken by escaping steam, so under magnification it looked like a series of "rivers" and formed.

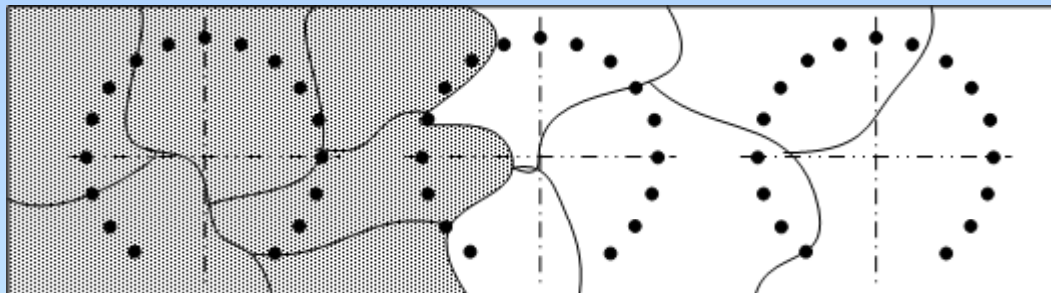
Tapchanger Barrier Board Failure

- Products of the failure on both sides of the board, indicating mechanical failure before electrical failure

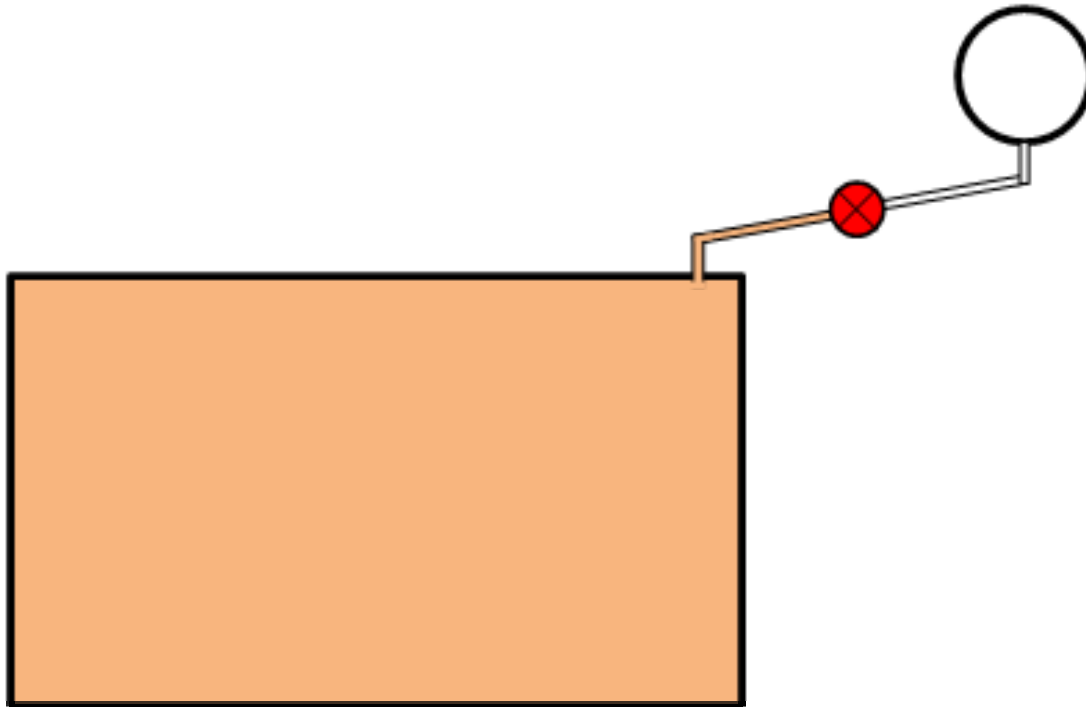
- From inside the transformer tank, looking into a cooling tube showed a “tide mark”

On questioning, it was admitted that the valve to the conservator had been always closed

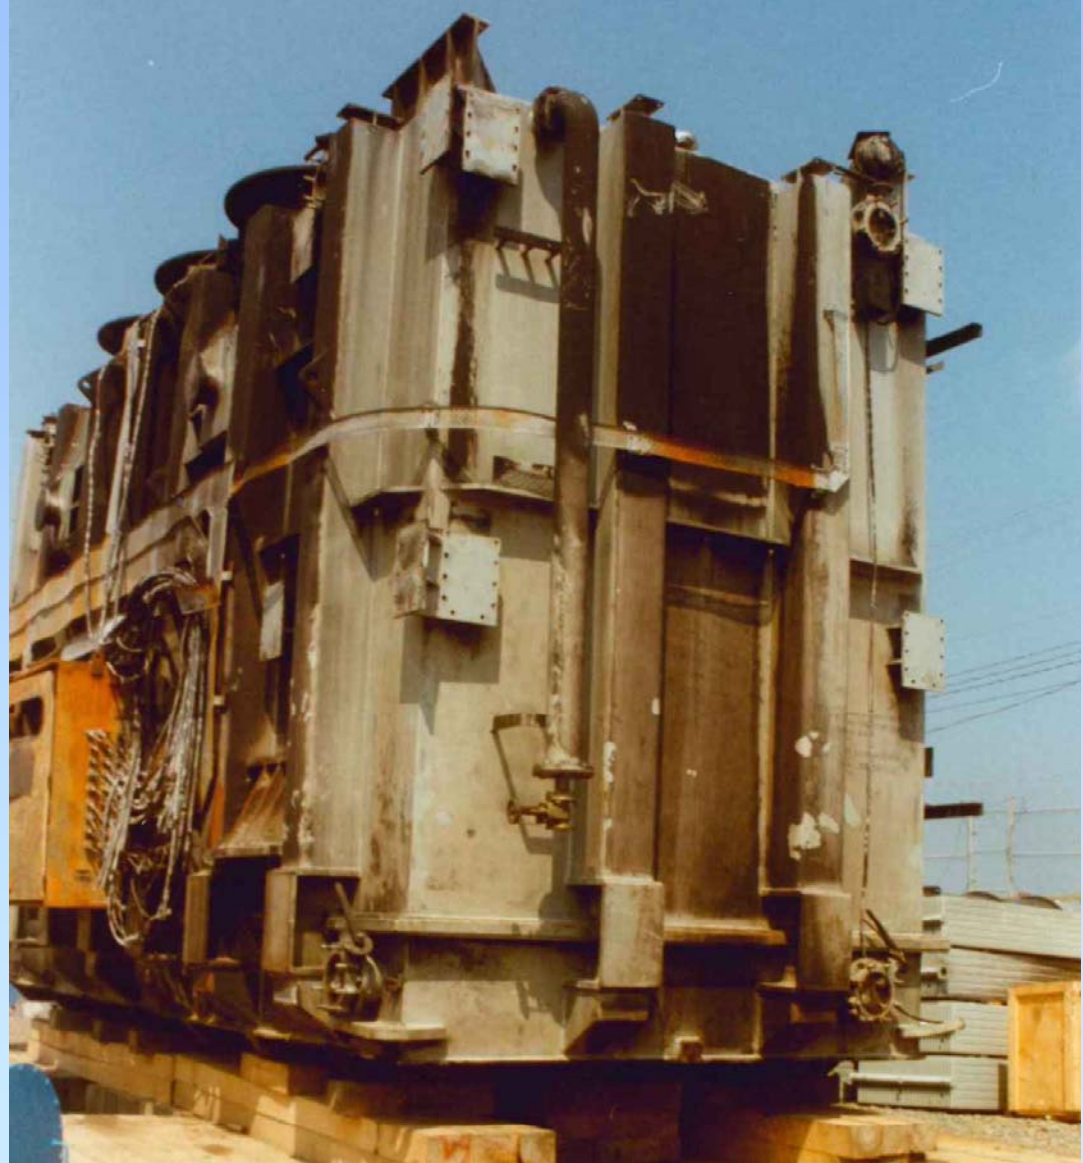
➤ Generator
Transformer
Tank after
LV Winding
Failure and
Fire

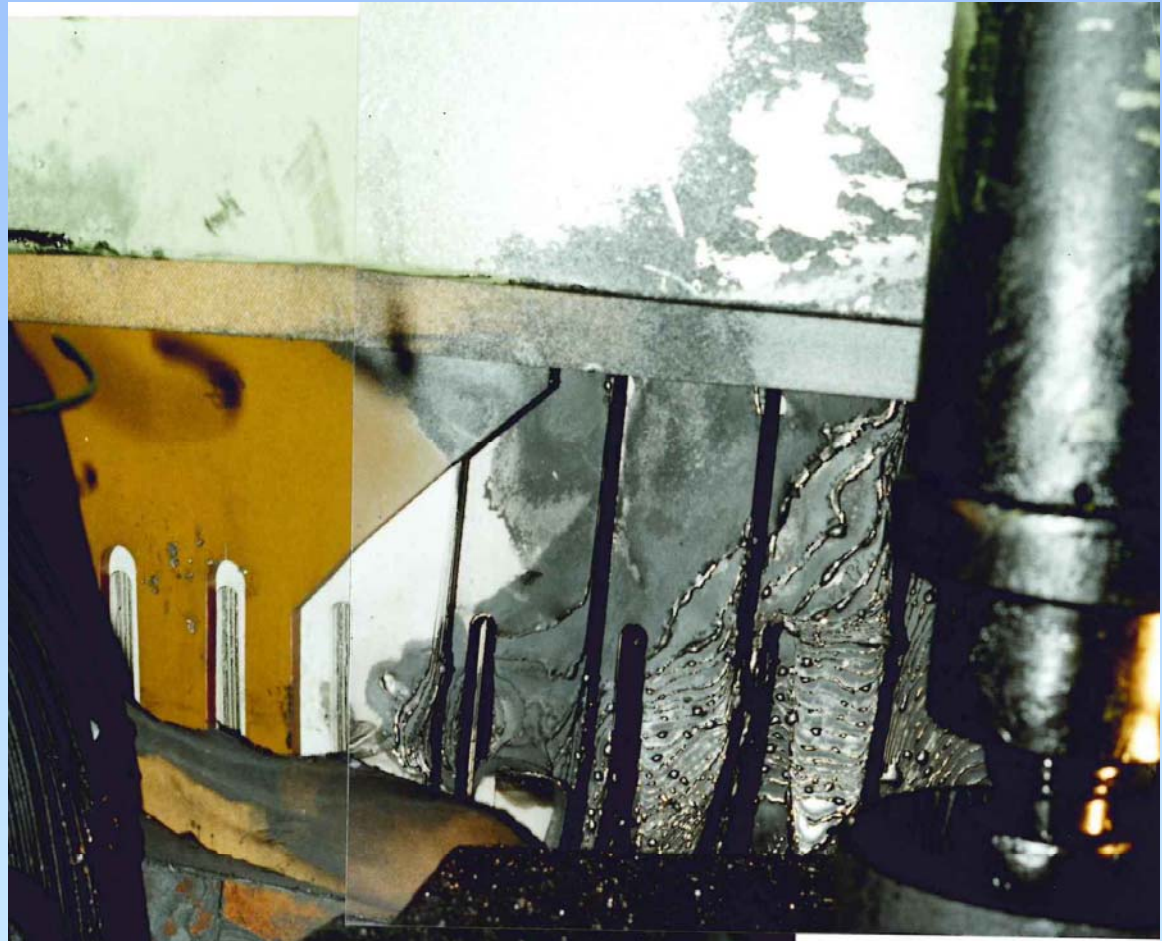
- Damage to Core laminations from hot plasma gas emanating from below

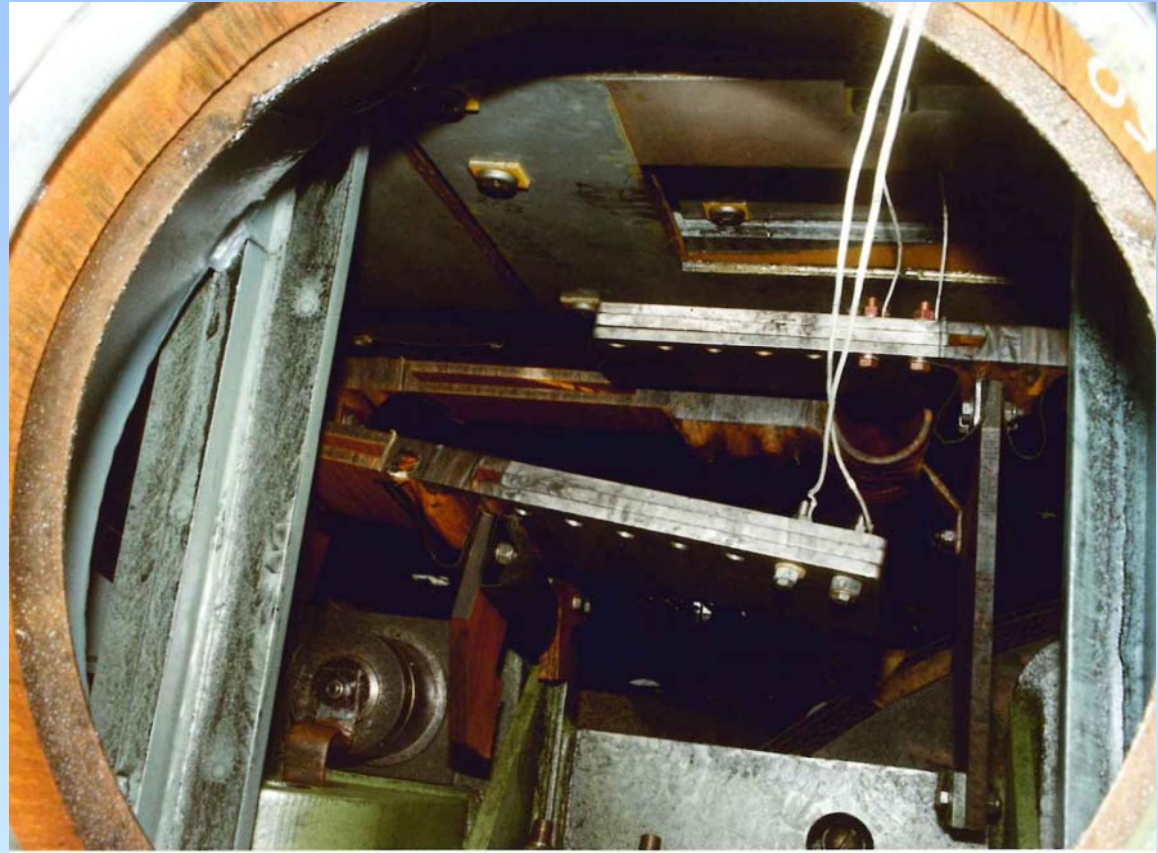
- LV busbars of end phase, forced apart by short circuit forces

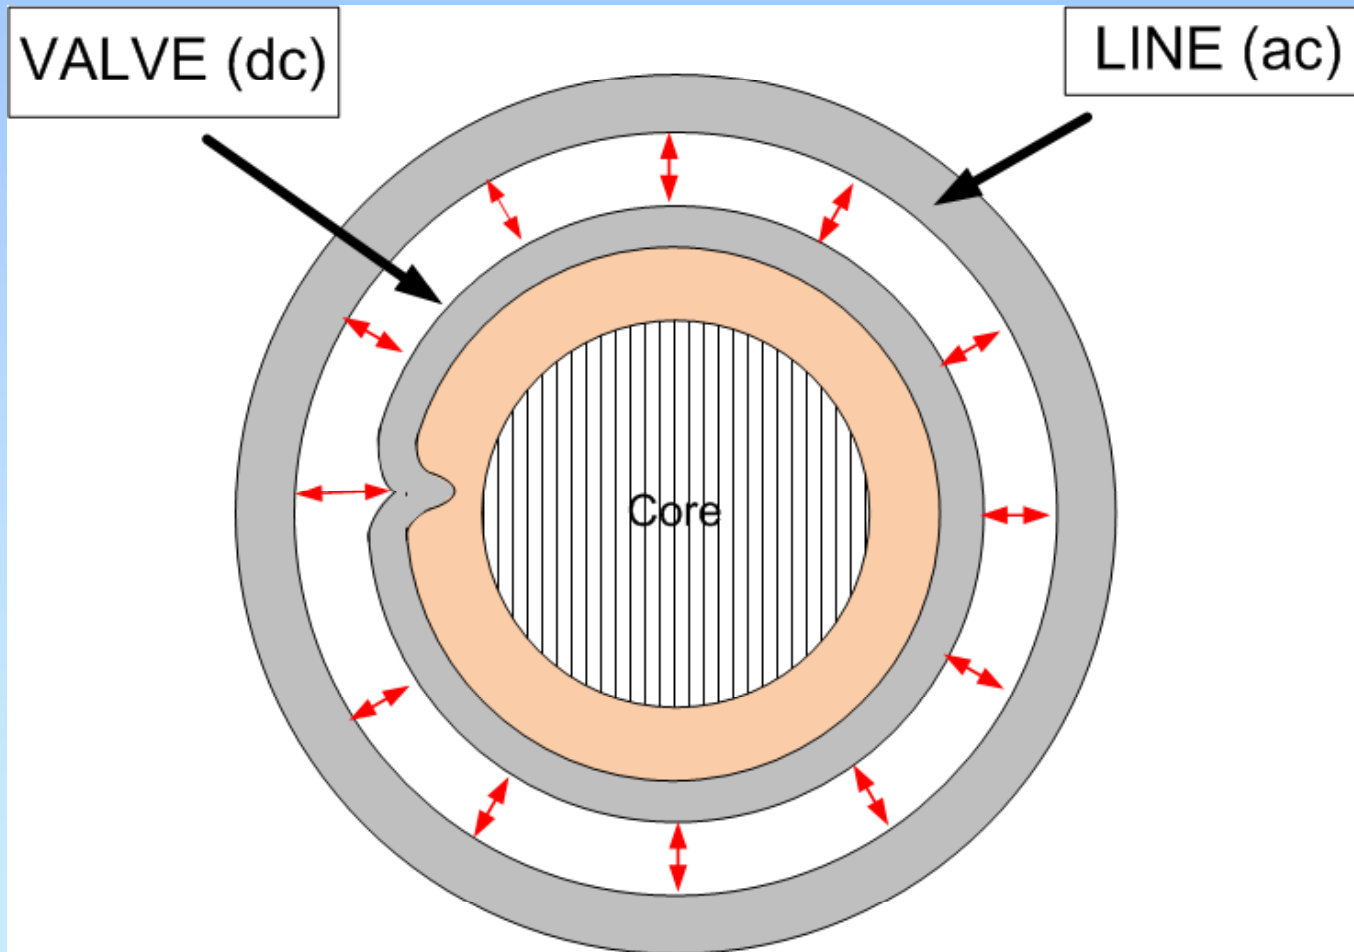
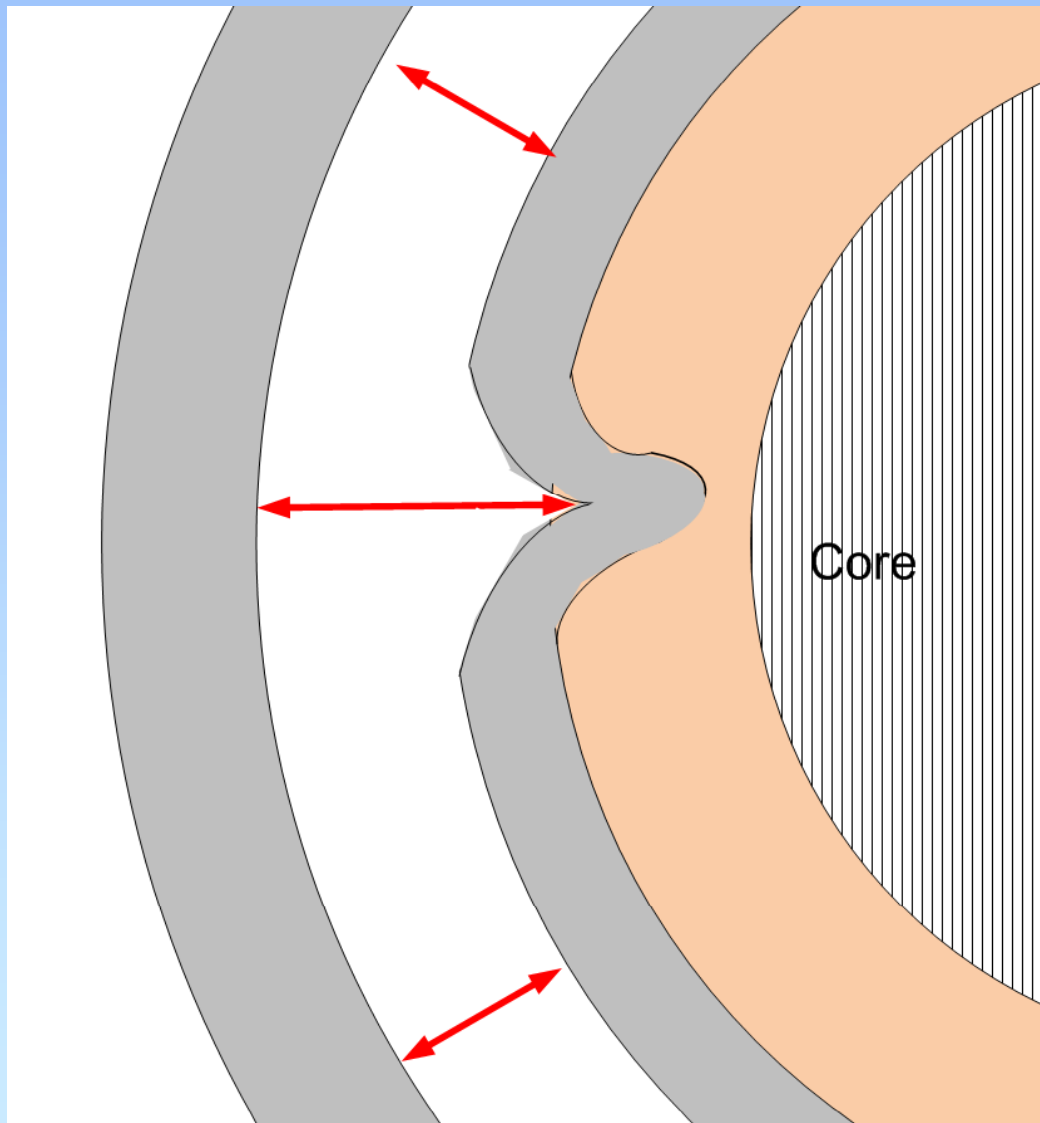
Collapse of a converter transformer valve winding

The Valve Winding Collapsed into the supporting insulation

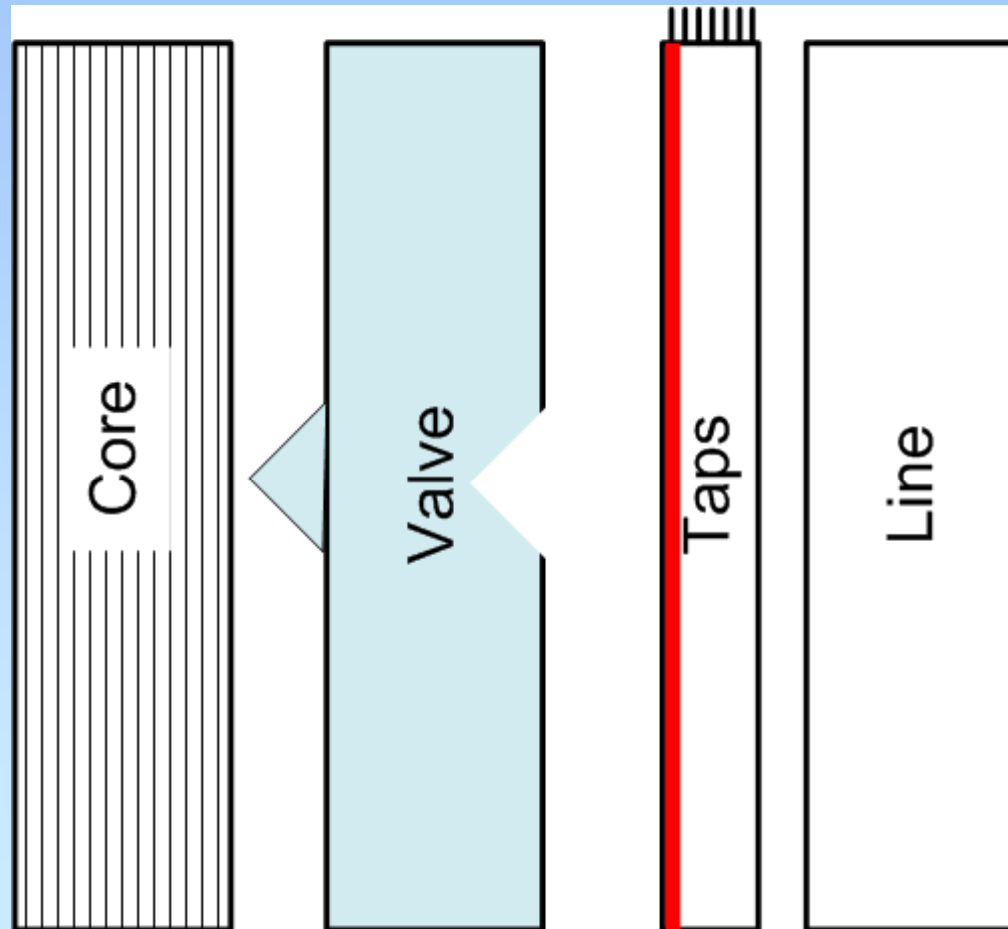
Impedance valve to tap section on partially collapsed phase lower
