Fifty Years of Transformer Problems

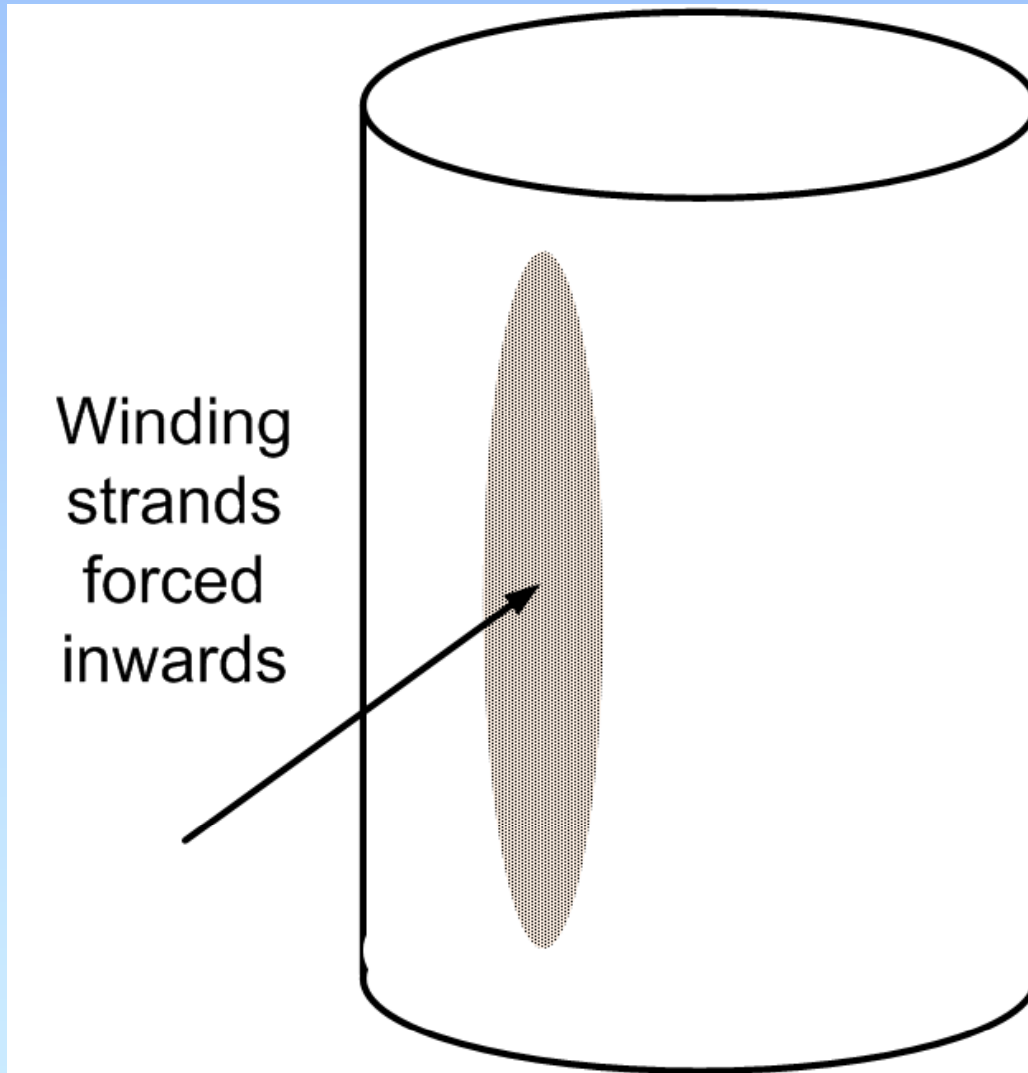
When stripped down another phase of the transformer showed signs of initial collapse

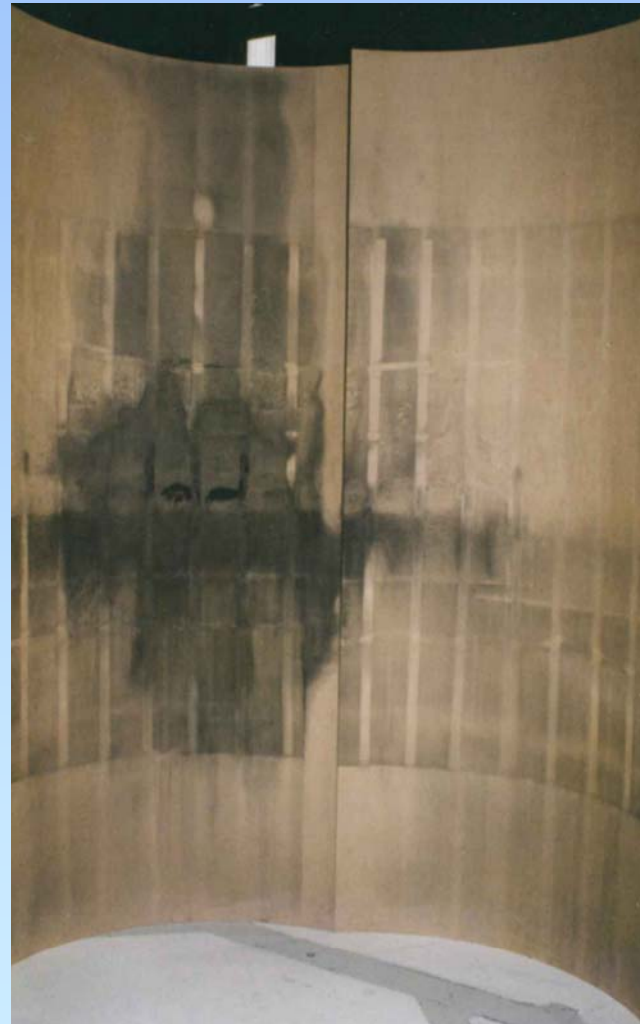
Insulation damage inside LV

Harmonic Flux overheated end turns on LV's to over 150°C
