Seismic Qualification of Krohne Flowmeter

RCM
Technologies
Canada
Corporation

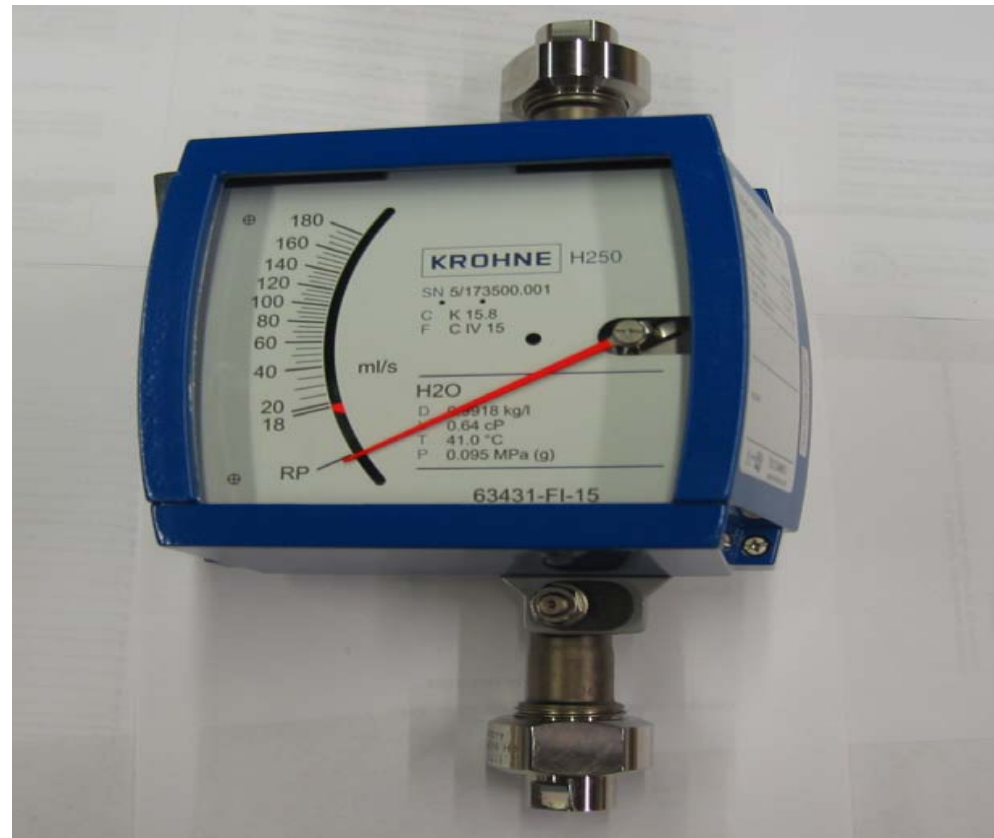
- Krohne Variable

Area

Flowmeter

Model No

H250/RR/M9/K1

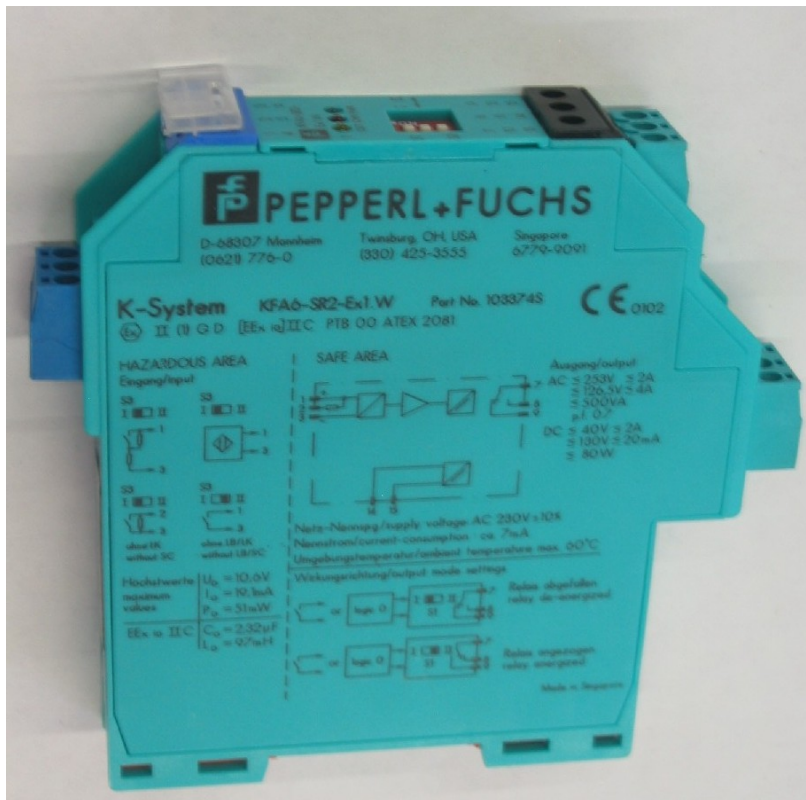
- Associated Isolated Output Relay Module

Model No.

KFA6-SR2-Ex1.W

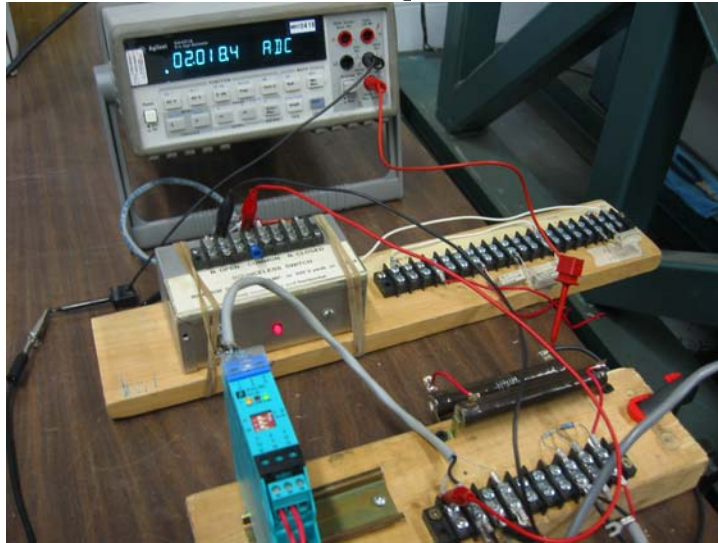
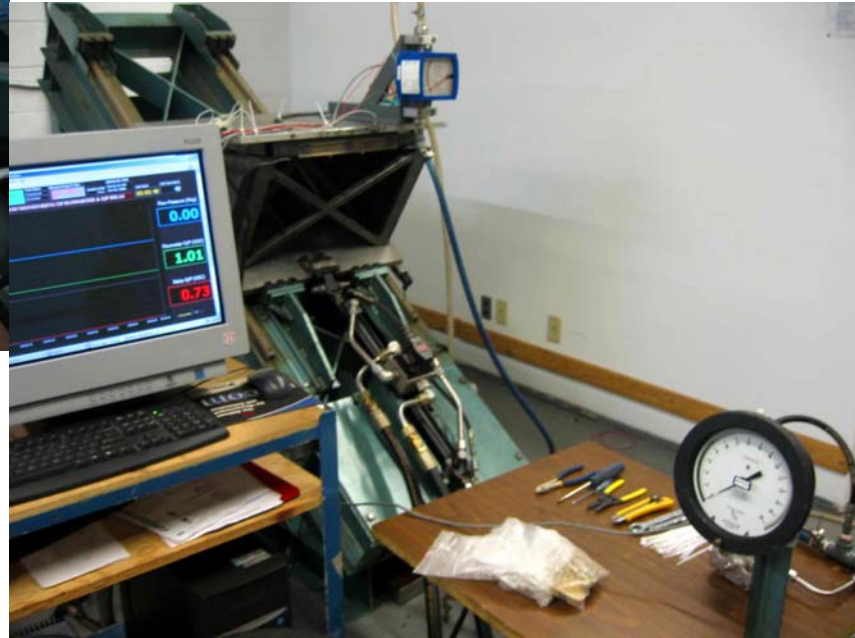
Function Tests

- Test Setups

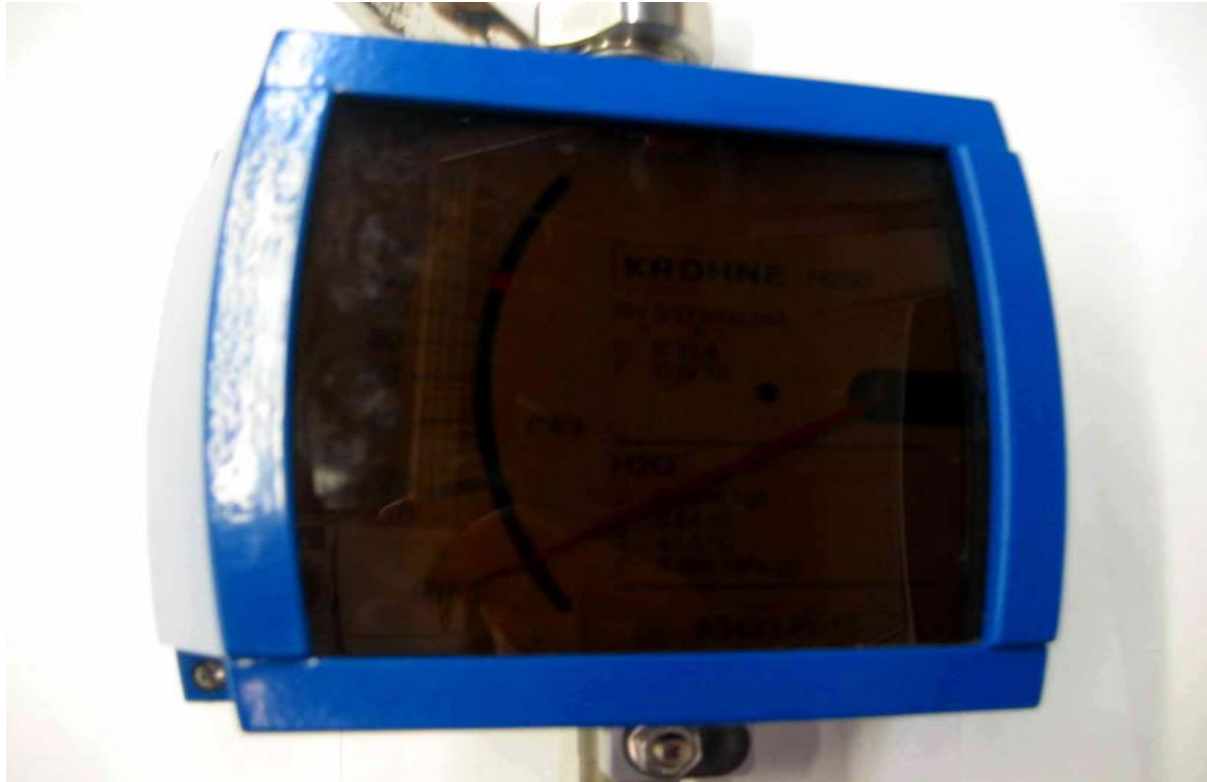
Radiation Aging

- Flow Meter after Radiation Aging

- Darkened glass indication cover after Radiation Aging.
- Performance deterioration after Thermal Aging.
- Deflection of needle indicator during Seismic Testing.

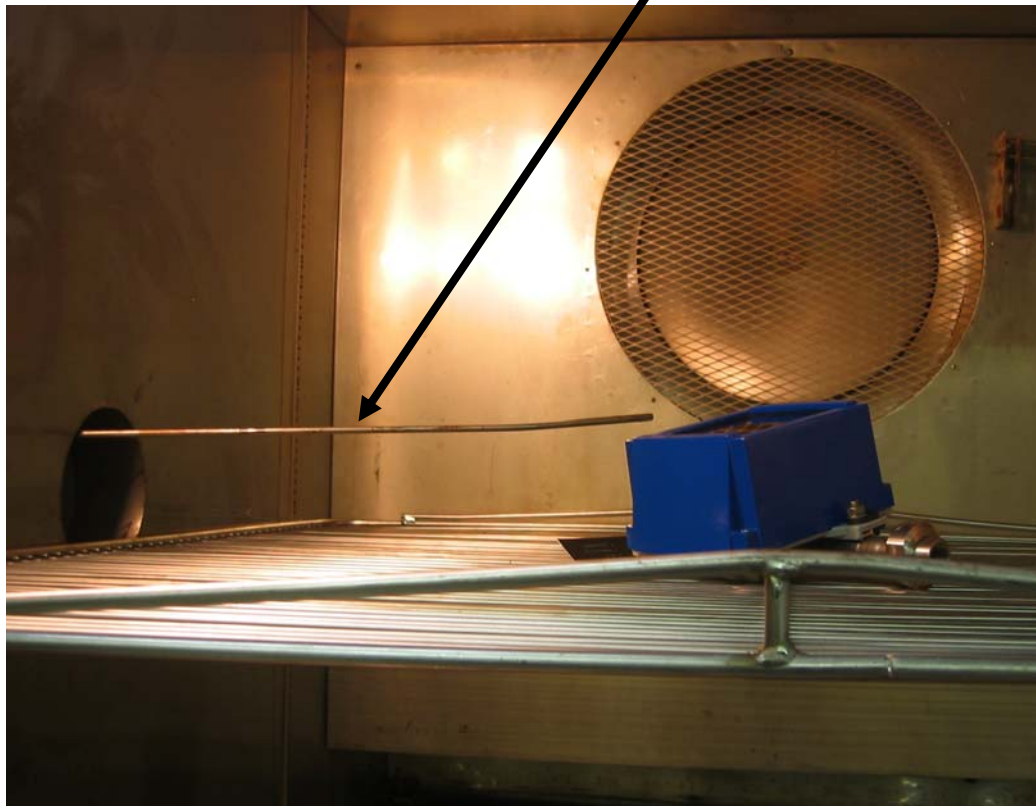
Thermal Aging

- Flowmeter inside oven thermocouple

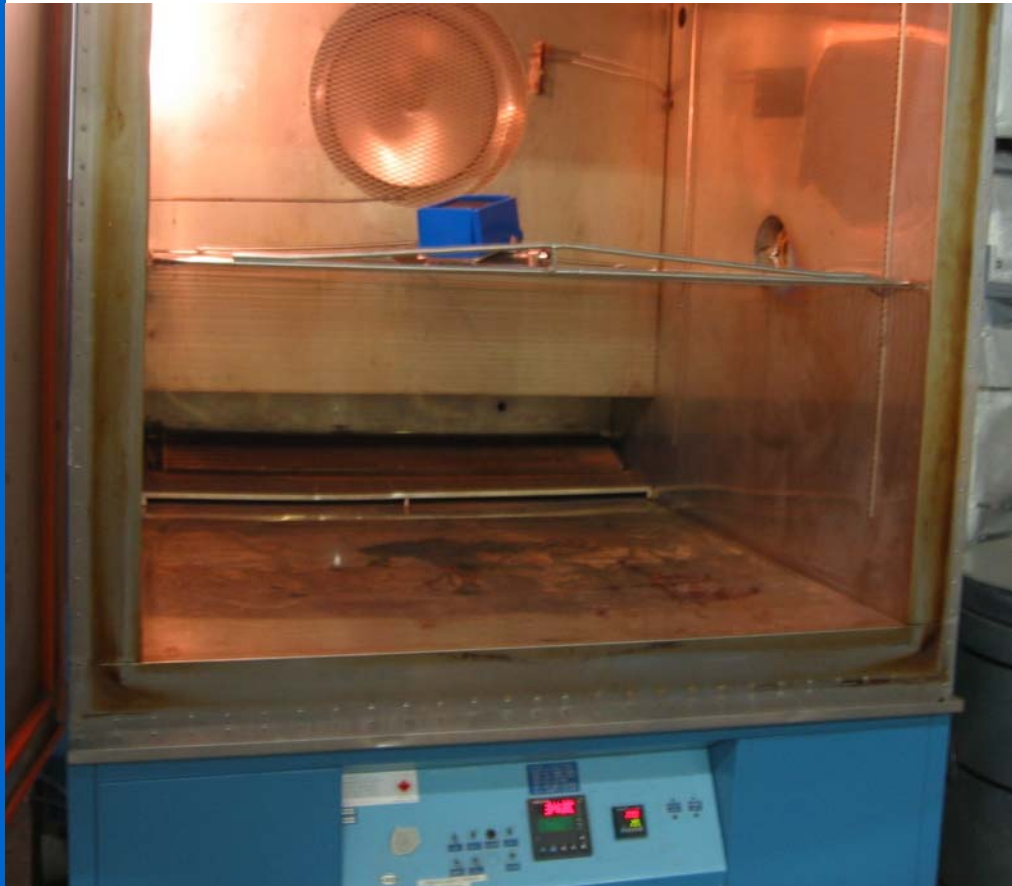
- Overview of oven

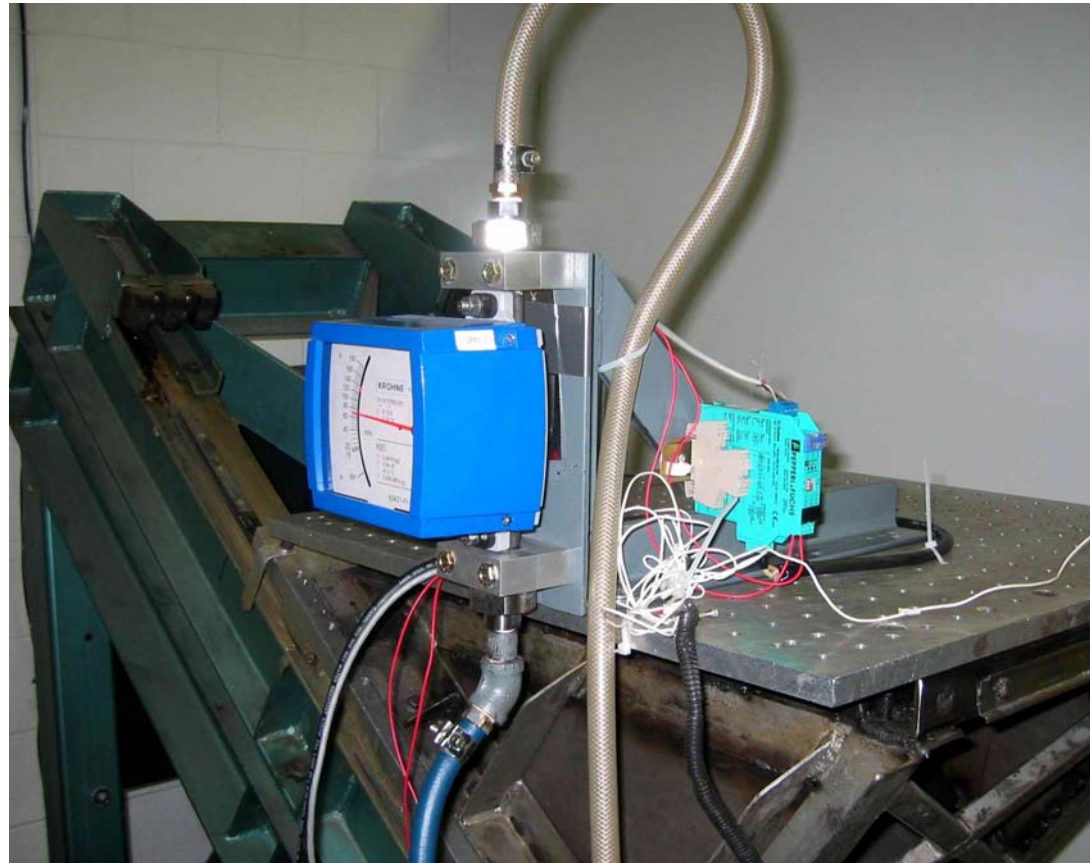
Seismic Testing

- Test set up

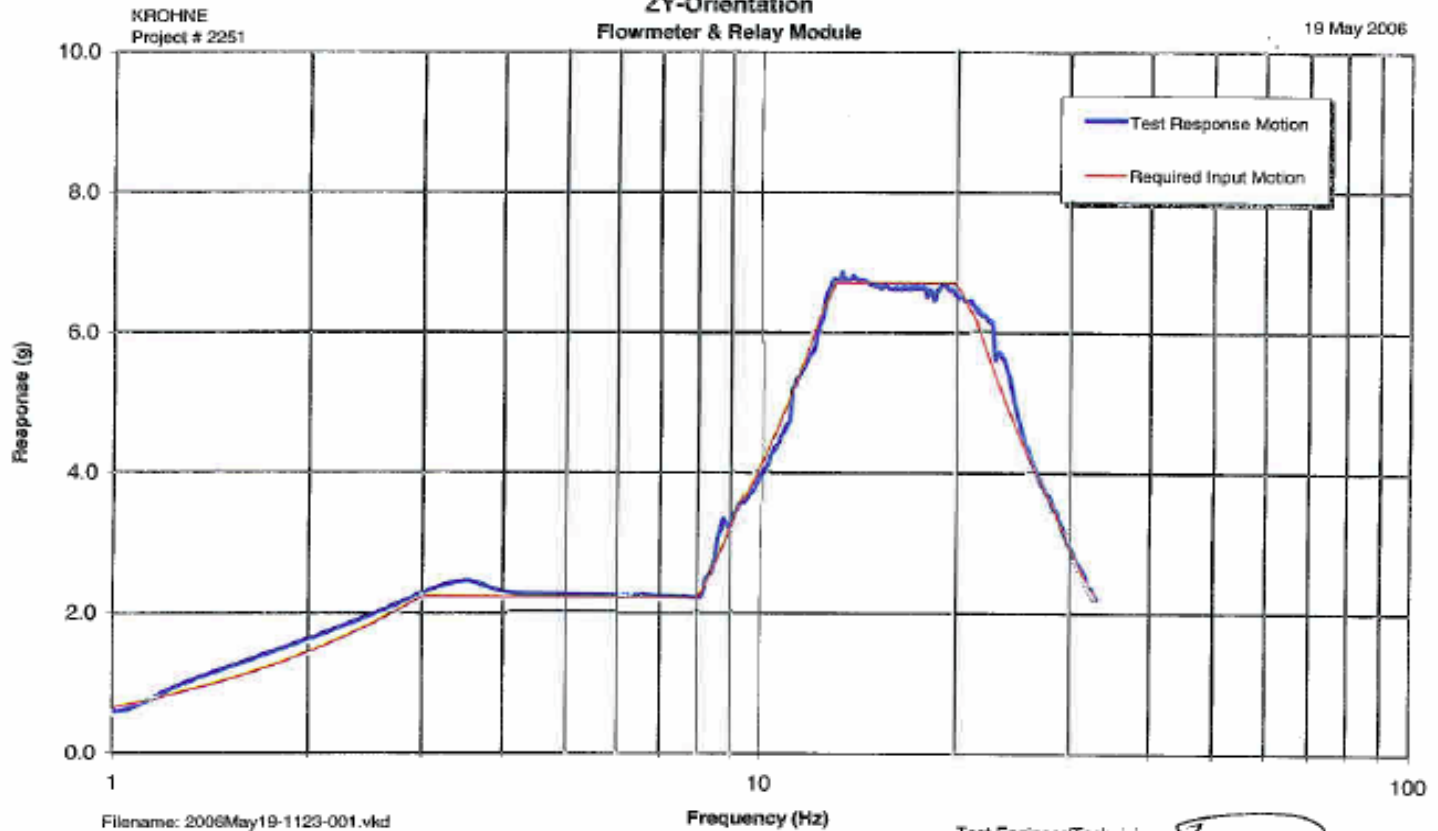
FIGURE D52
Sine Sweep Seismic Testing
ZY-Orientation
Flowmeter & Relay Module

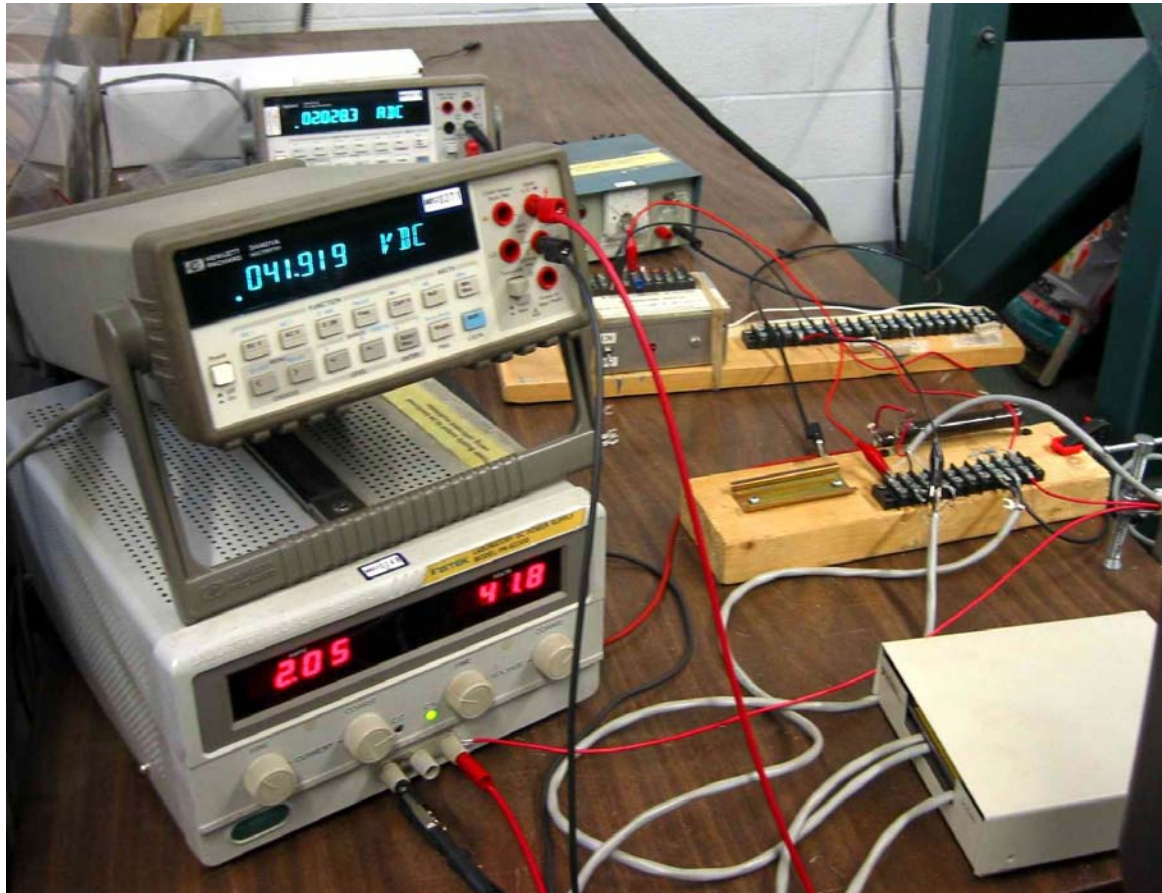
- Equipment monitoring

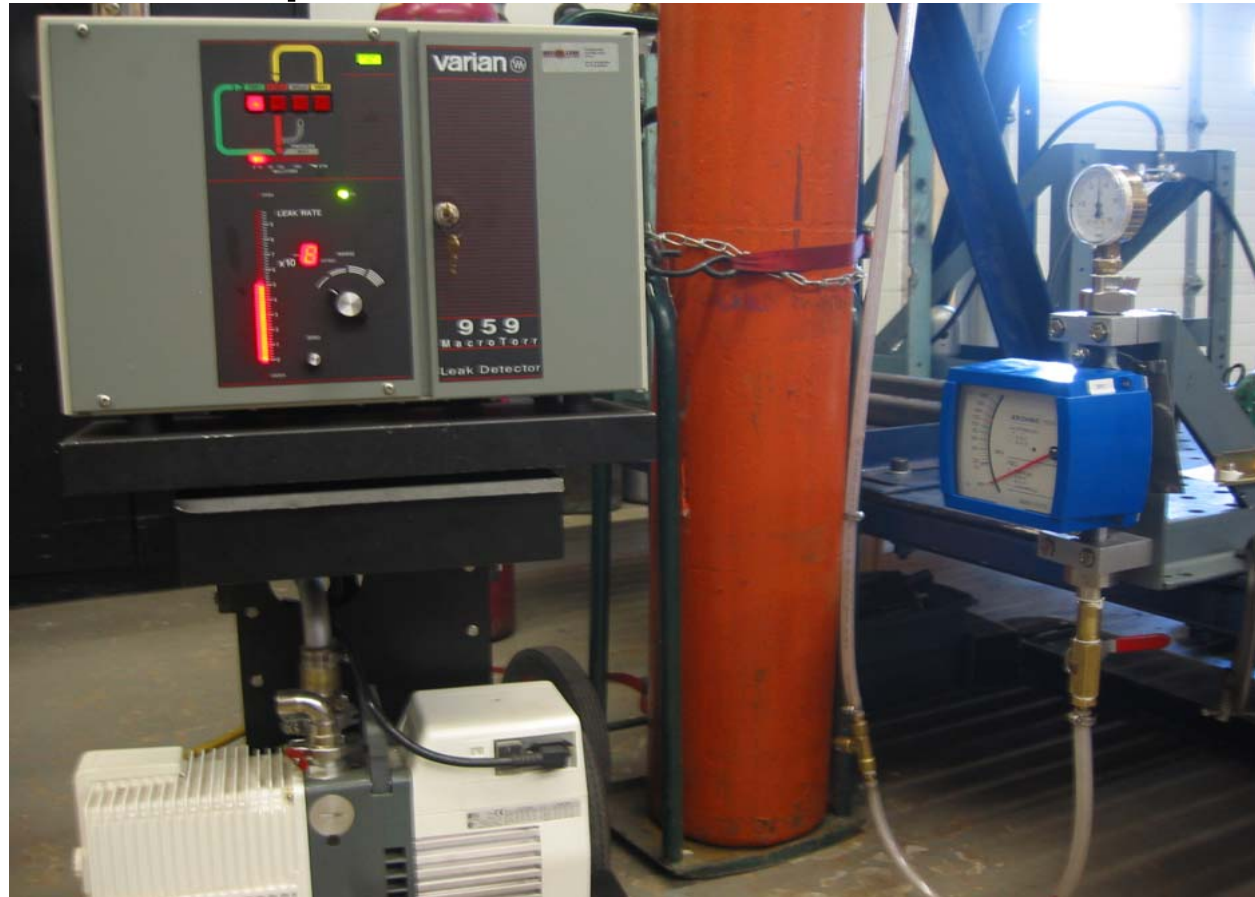
Helium Leak Test

- Test set up
