A Transmission Island Sustained by a Distribution Solar Farm

Documented Field Experience of an Unintended DER Island
Ontario, Canada

Chester LI and Mike Vickers, Hydro One

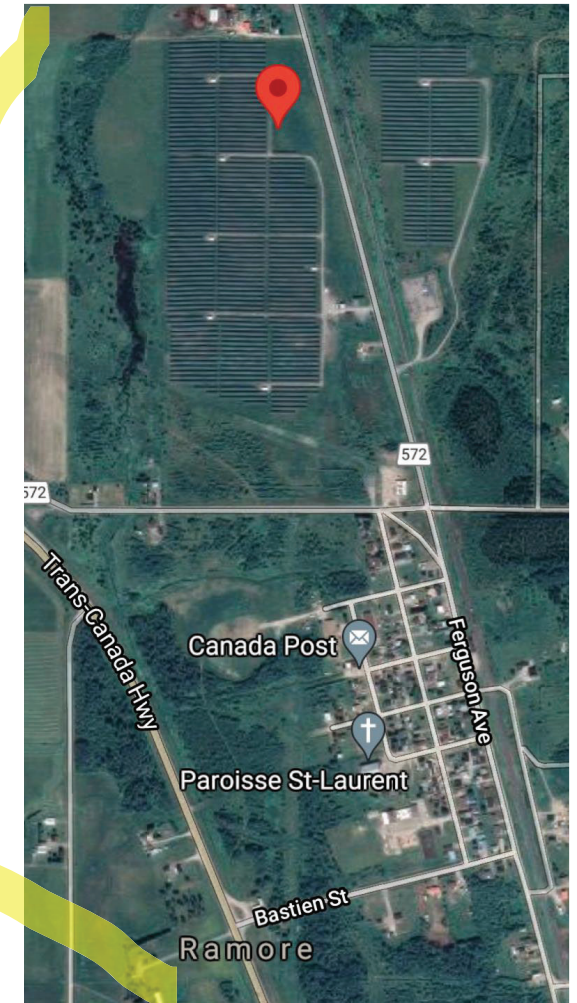
8 MW Solar Plant at Ramore

- Kirkland Lake: Pop. 8,000- 55km away
- Iroquois Falls (Ansonville): Pop. 4,500- 50km away
- Timmins: Pop. 40,000- 90km away

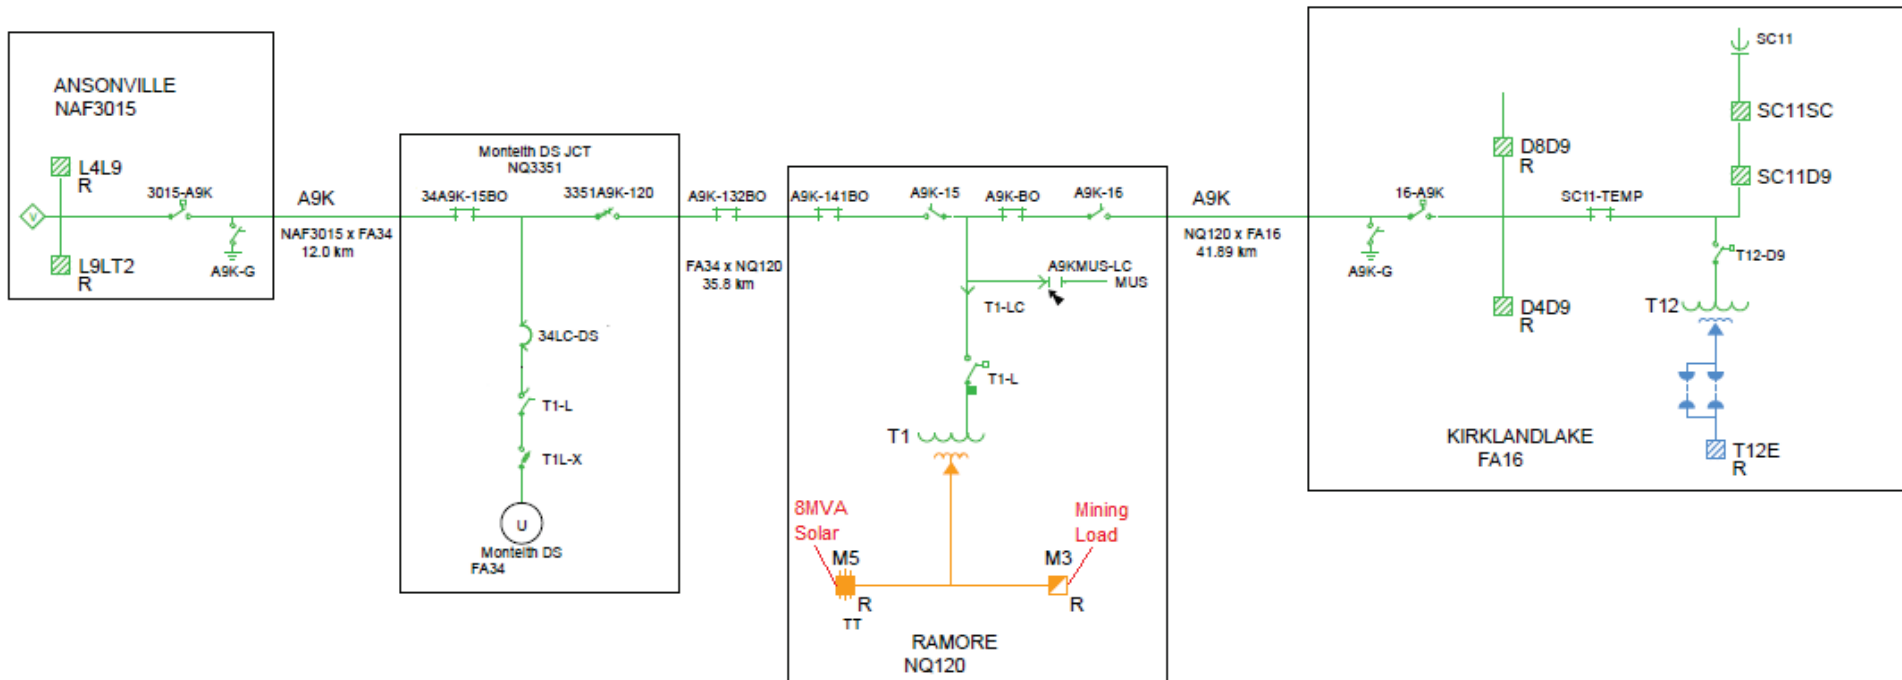
Transmission Circuit Overview (115kV)

- Circuit A9K is a ~90km 2-ended between Ansonville and Kirkland Lake Substations
- In between, the Ramore Trans Sub serves a 27kV distribution feeder with primarily mining load and PV generation.

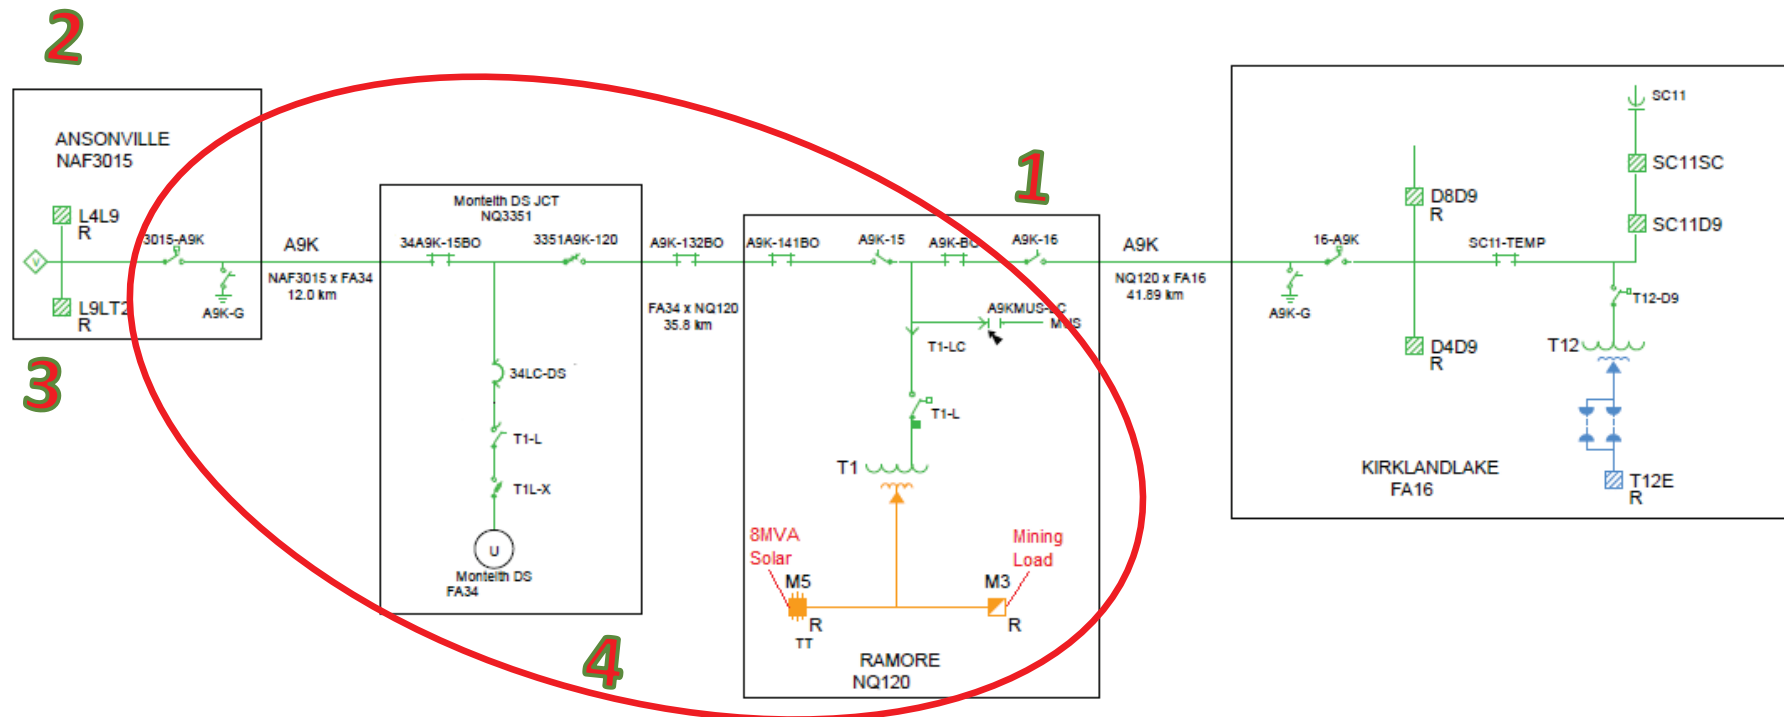
Island Scenario and Timing

1. At ~9:17 work the crew manually opened A9K-16 instead of A9K 15
2. At 09:21, control room operated one of two Ansonville breakers
3. At 09:22, control room opened the second Ansonville breaker as planned
4. Island forms and is undetected by transfer trip logic because A9K-16 was a manual disconnect

1. This island condition was caused by an error in switching.
2. Because of the error, there was no automatic Transfer Trip initiated to the 8MVA Solar DER.
3. Voltage and frequency at the inverter and the intertie protection location did not reach the trip threshold.
4. On-board active islanding detection at the PV site may have been hampered by the motor load and transmission line var sourcing.
5. For the 8-minute duration of the island, the DER active anti-islanding algorithms did not detect the system was disconnected from the grid.

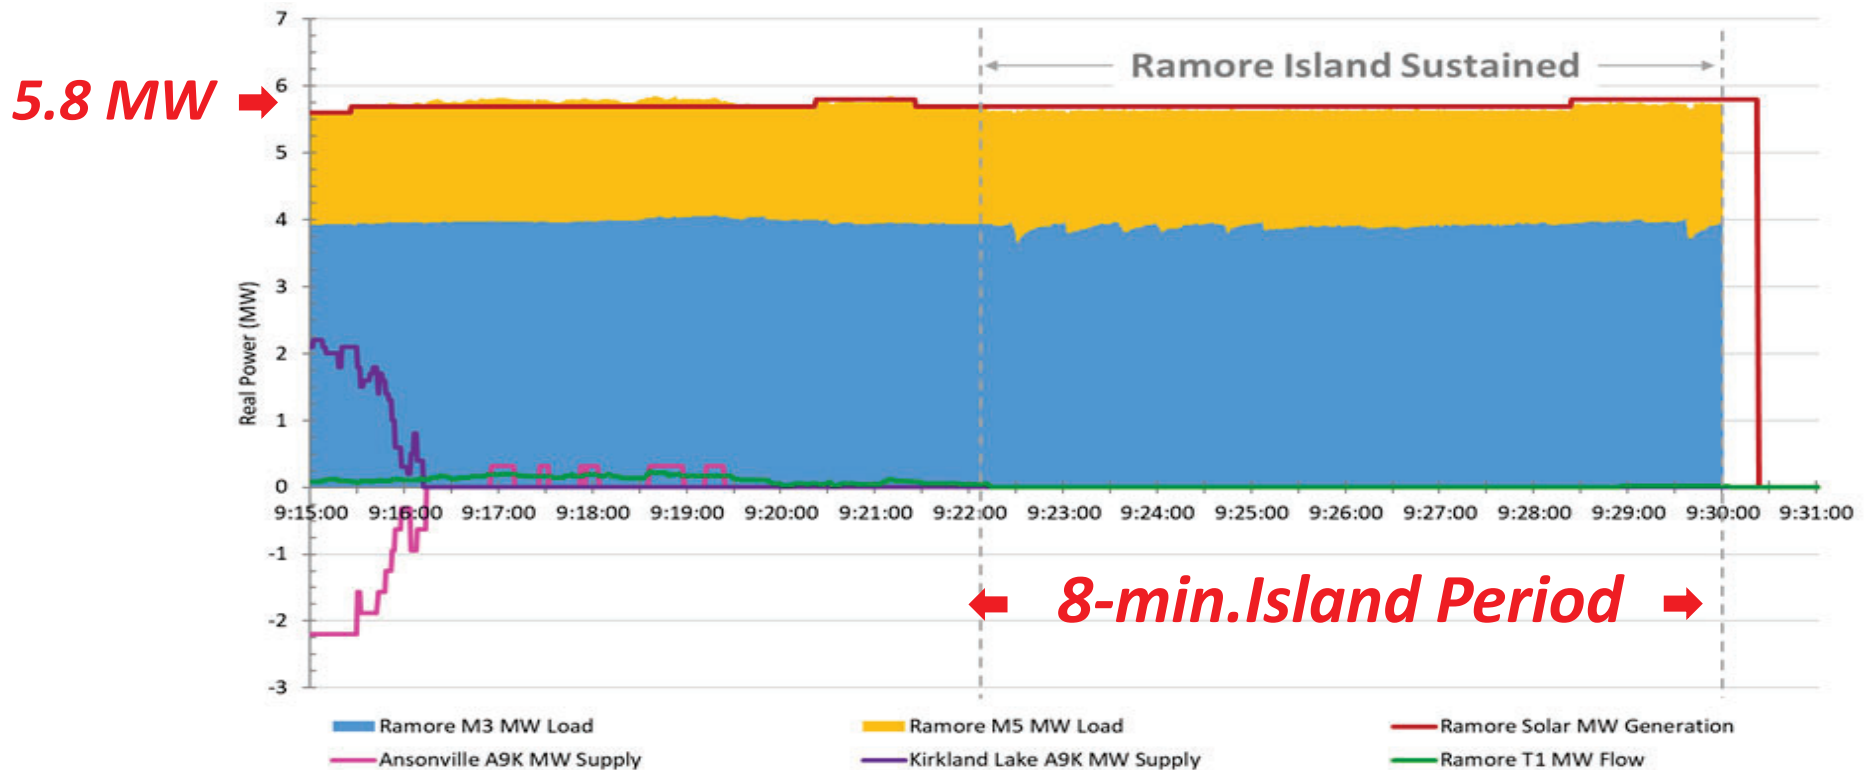
Real Power 6-ways (MW), see legend

- Prior to island, loading from A9K through Ramore T1 was at negligible levels- Solar DER output closely matched M3 + M5 loads (~5.8MW). Remained steady during island.

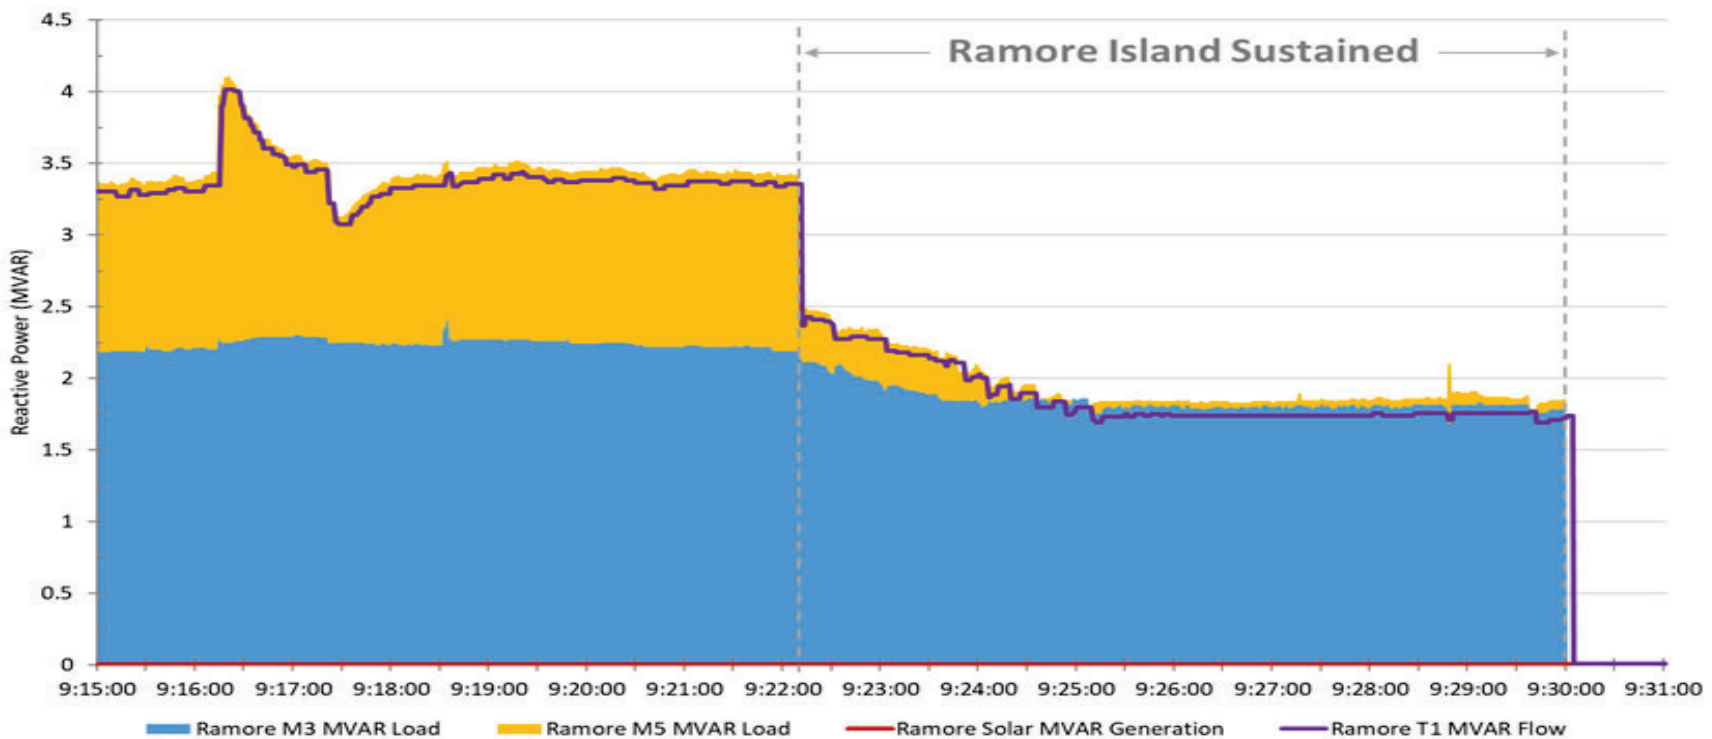
Reactive Power 4-ways (Mvar)

- When island was established, VAR demand from Arsonville dropped by approx. 1Mvar
- Charging admittance from open transmission line to Arsonville (A9K) supplied Mvars post-island

Reactive Power Demand Pre-Event and During Islanding

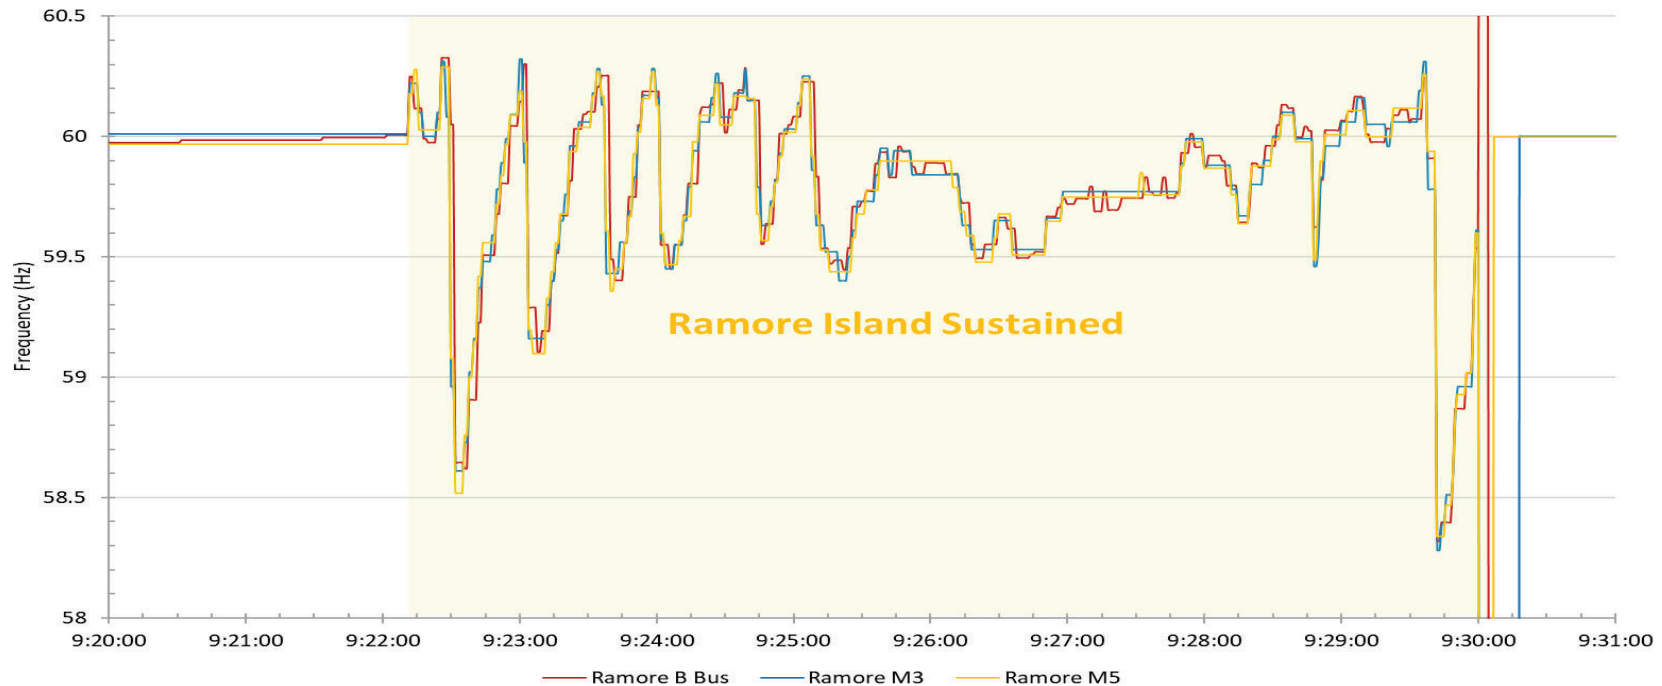
Island Frequency Plots

- During islanded condition, a sawtooth pattern was initially seen in the frequency, followed by a slightly varying pattern between 59.5 and 60.3Hz.
- **Speculations:** oscillations caused by inverter active anti-islanding and damping from induction motor load on M3

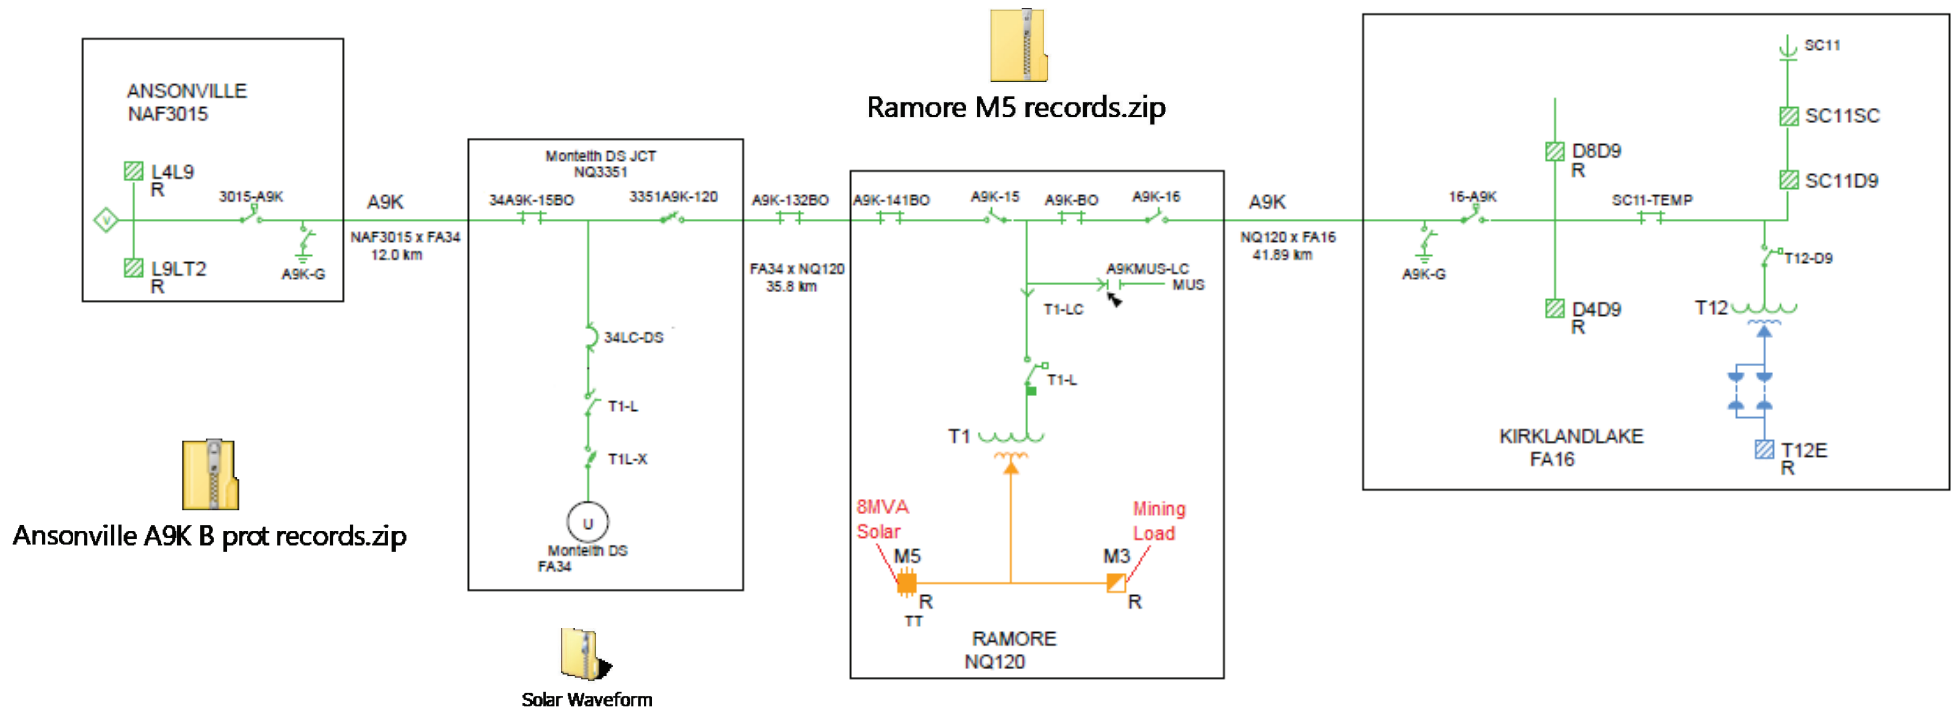
Waveforms Observed

- When the island condition was ended, oscillographies were triggered on the Ramore Line Backup Protection, the Ansonville A9K 'B' Line Protection, and at the Solar DER Site.

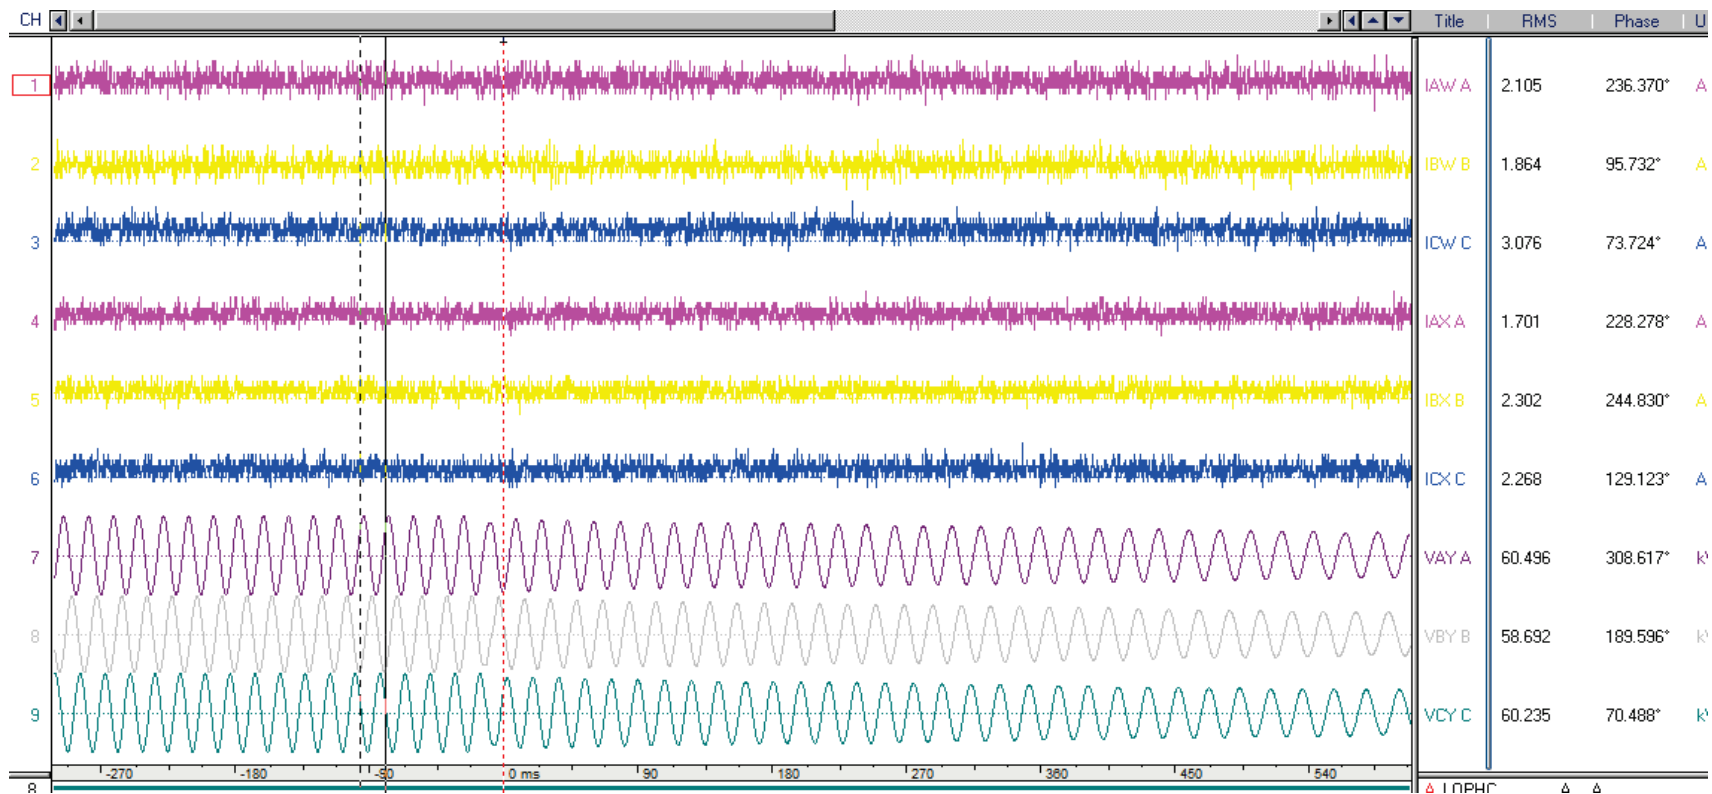
Island Voltage and Current at Arsonville

- Island is tripped off near the red dashed line.
- Voltage dissipates slowly, possibly due to spinning inertia of Ramore M3 mining motor load

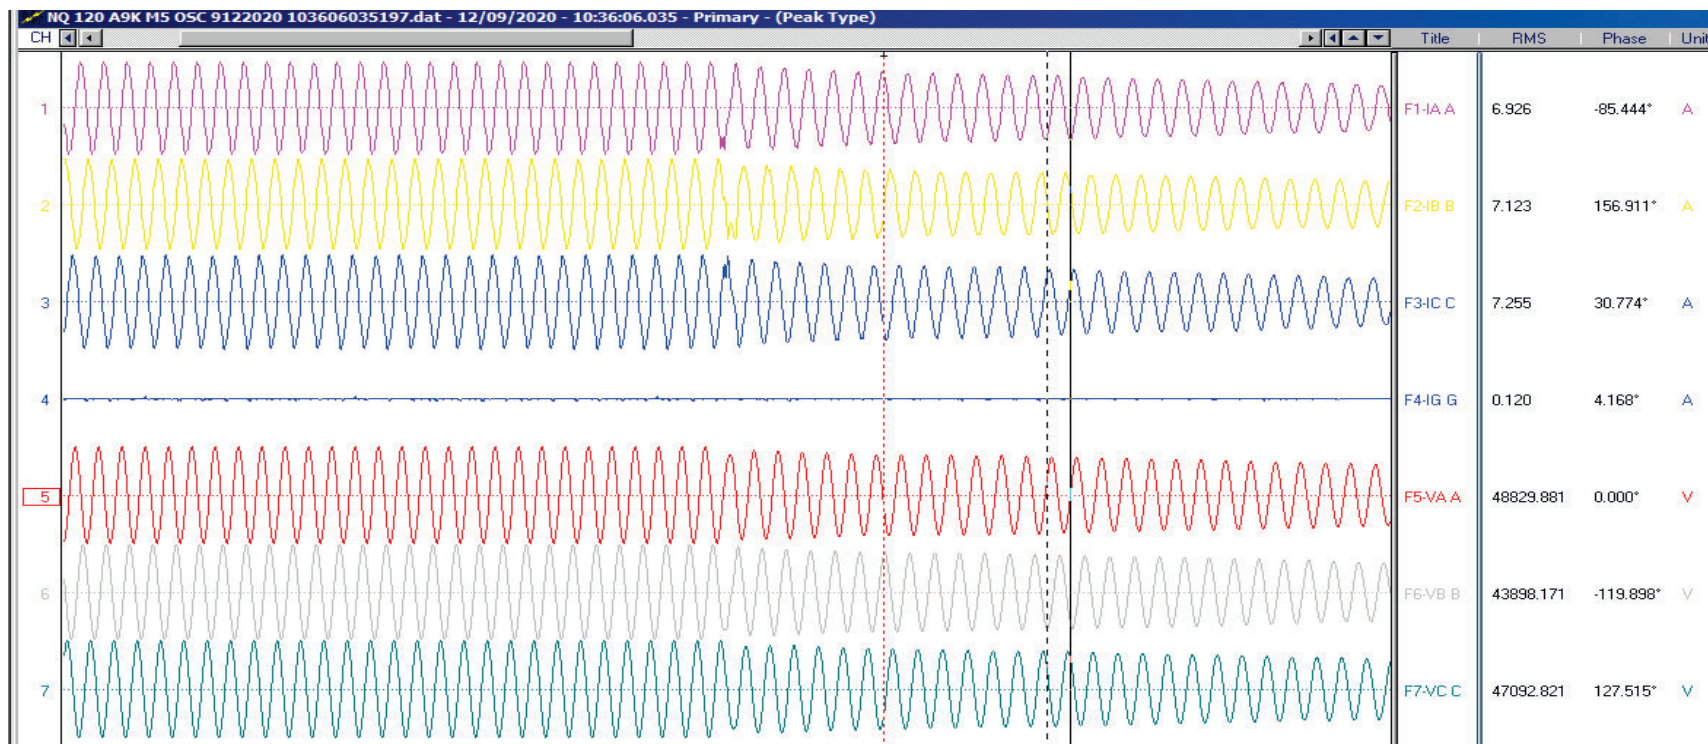
Island Voltage and Current at Ramore

- Voltage dissipates slowly, possibly due to spinning inertia with M3 mining load
- Note motor back emf during rundown after tripping of PV plant

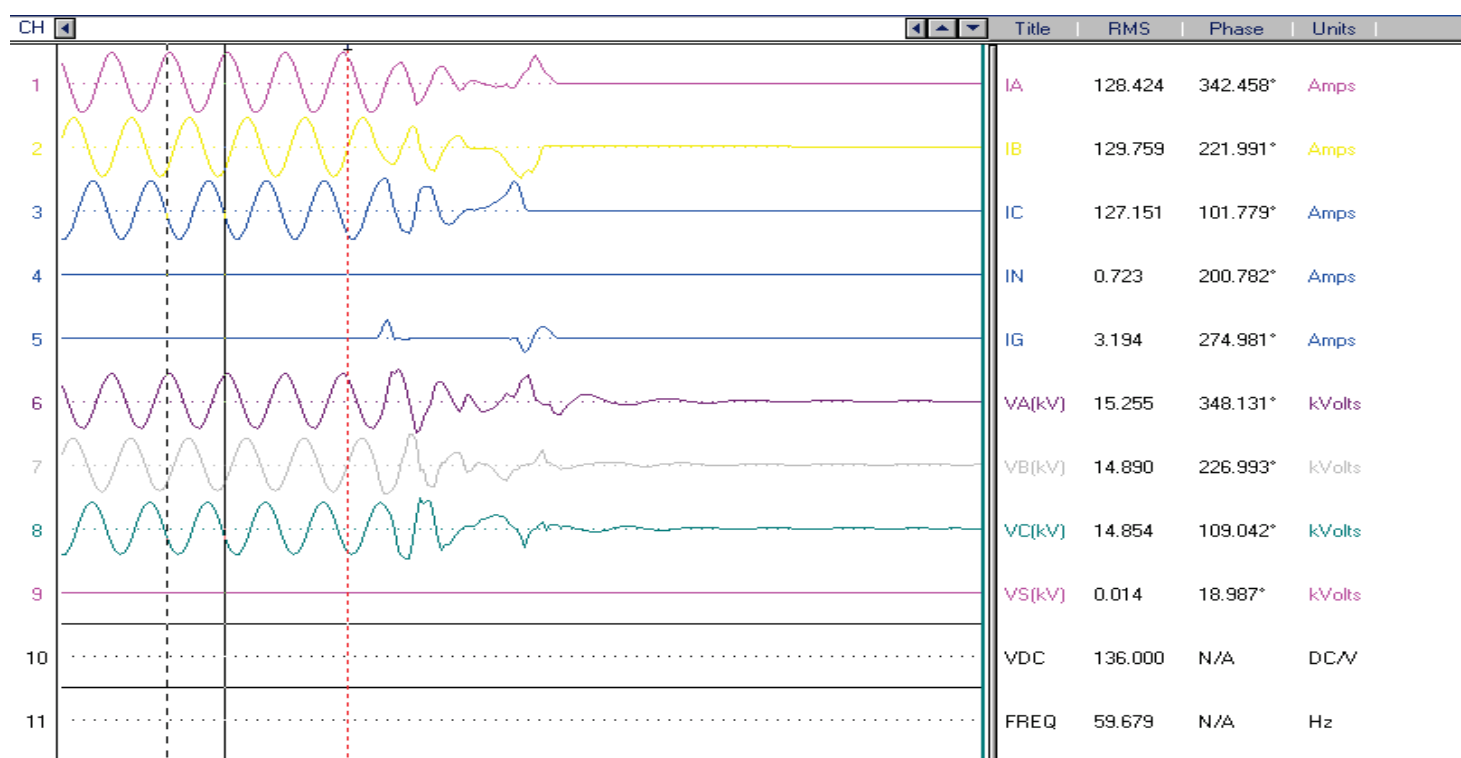
Island Voltage and Current at DER

- Prior to the M5 trip, voltage is ~14.9kV (0.93pu) and frequency is 59.7Hz.
- Island ends when Ramore M5 is opened activating transfer trip.
