Overview of Fukushima accident

**Nov. 9, 2011
Orland, Florida**

Main Sequence of the accident of Unit1, Unit2 and Unit3 of Fukushima Dai-ichi NPS

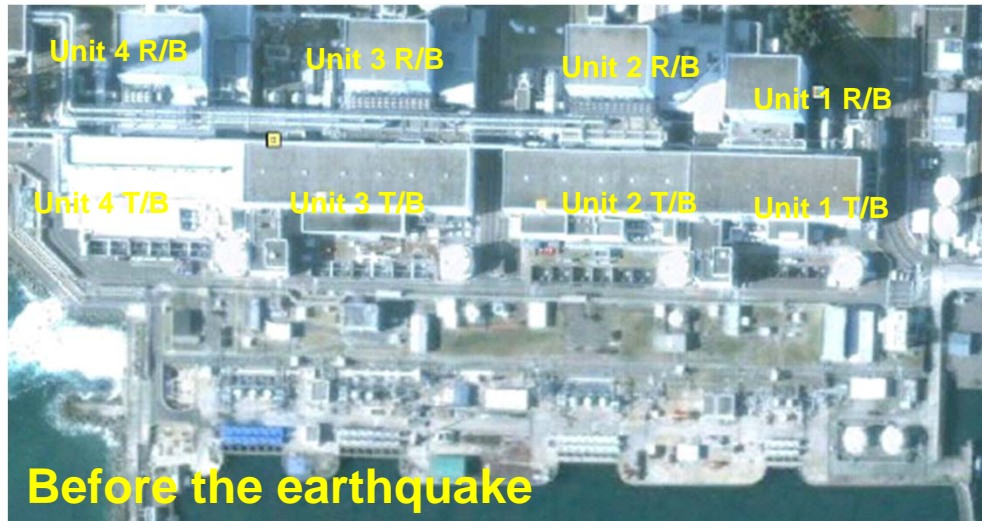
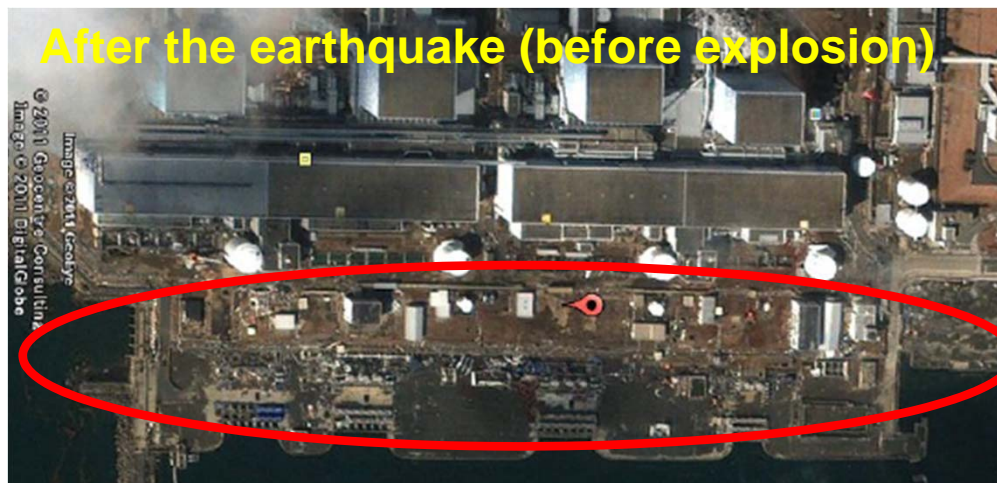
Satellite view of Fukushima Dai-ichi NPS

- Many components installed near the sea were destroyed
- Seawater pumps for ultimate heat sink and fuel tanks for emergency diesel generators were washed away

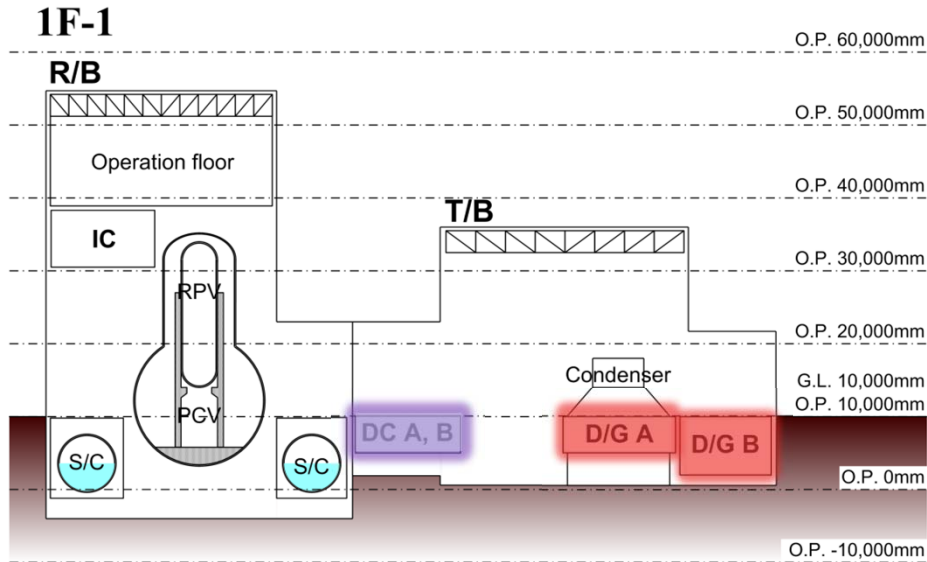
Elevation of DGs and DC batteries

Unit 1, 2, 3 and 4

- Elevation of the ground is 10m
- The Emergency Diesel Generators and Metal Clad Switchgear installed in the basement floor of the reactor buildings and the turbine buildings were flooded

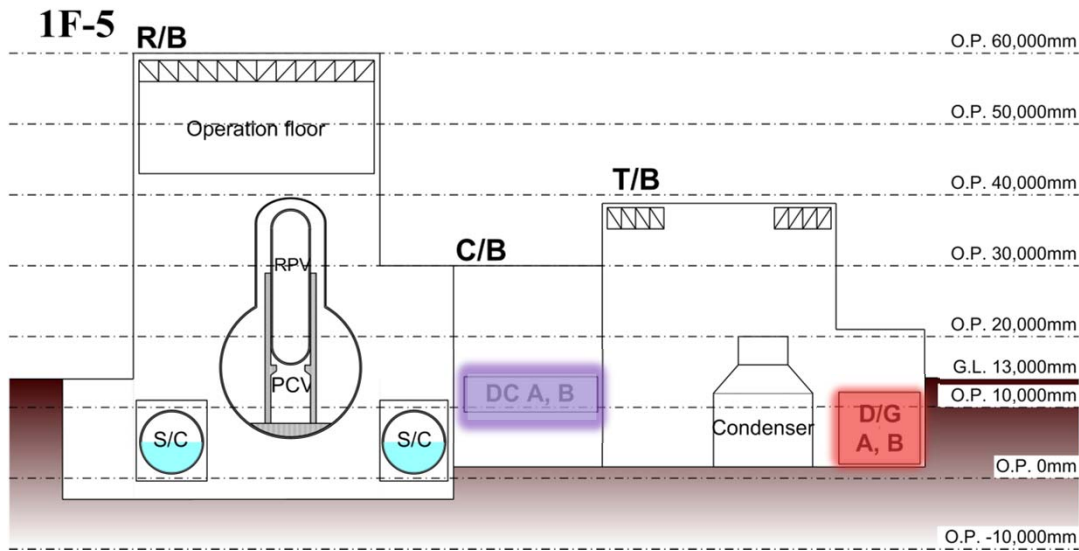
Elevation of DGs and DC batteries

Unit 5 & 6

- Elevation of the ground is 13m
- One air-cooled EDG of Unit 6 which is located on the ground level and Metal Clad Switchgear were not lost
- Temporary sea water pump installed after the earthquake was operable, making use of power source from survived EDG

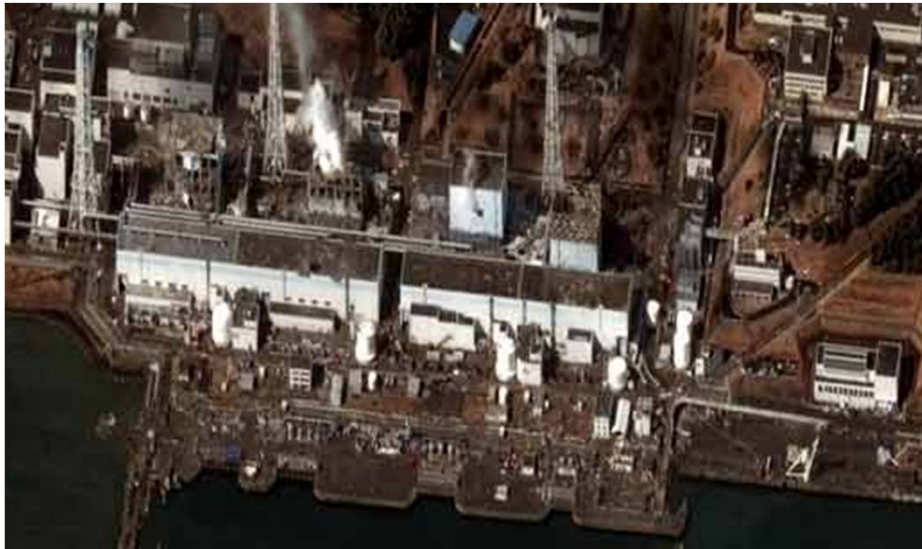
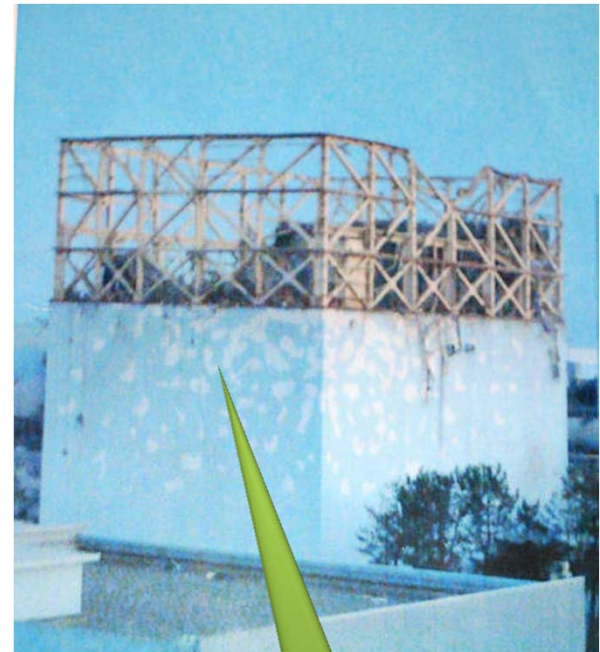
Damage of reactor buildings

Unit 3

Unit 1

Unit 4
