LOCA and Post-LOCA Qualification of PEEK insulated cables

Sven-Olof Palm, Forsmarks Kraftgrupp AB

2015-04-17, IEEE SC2, Sand Key, Florida

The success story about an EPA qualification

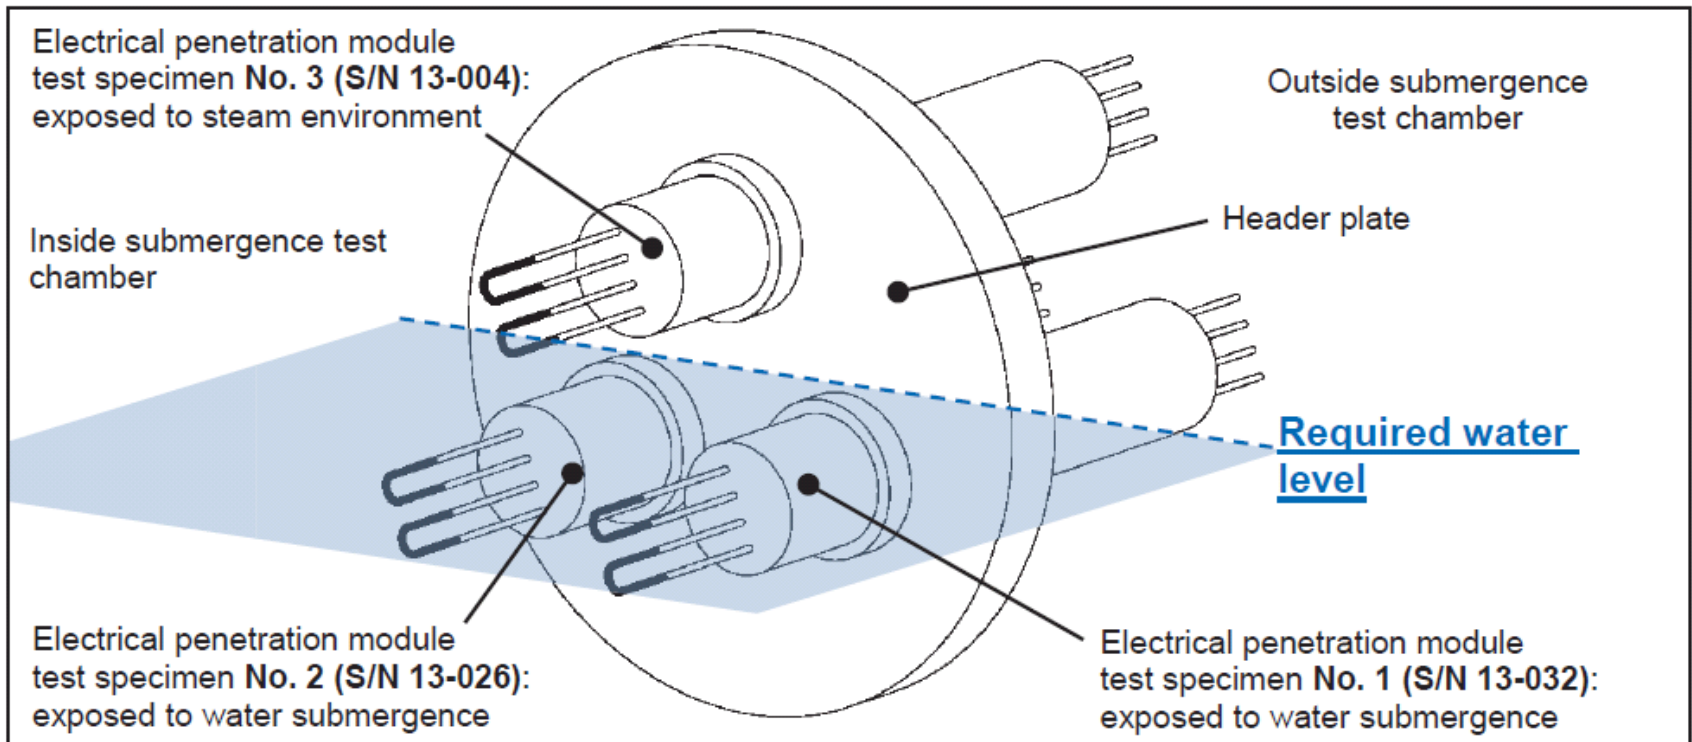
Combined Steam and Submergence test

Problem started to occur at submergence

- **Fluctuating leakage current after submergence**
- **For 660 V the problem started immediately after submergence**
- **For 250 V the first problem occurs later**
