*A Computer Vision Early-Warning Ice
Detection System for the Smart Grid*

Presented by: J.S. Stoezel, P.Eng

February 28, 2012 IEEE PES Luncheon Meeting

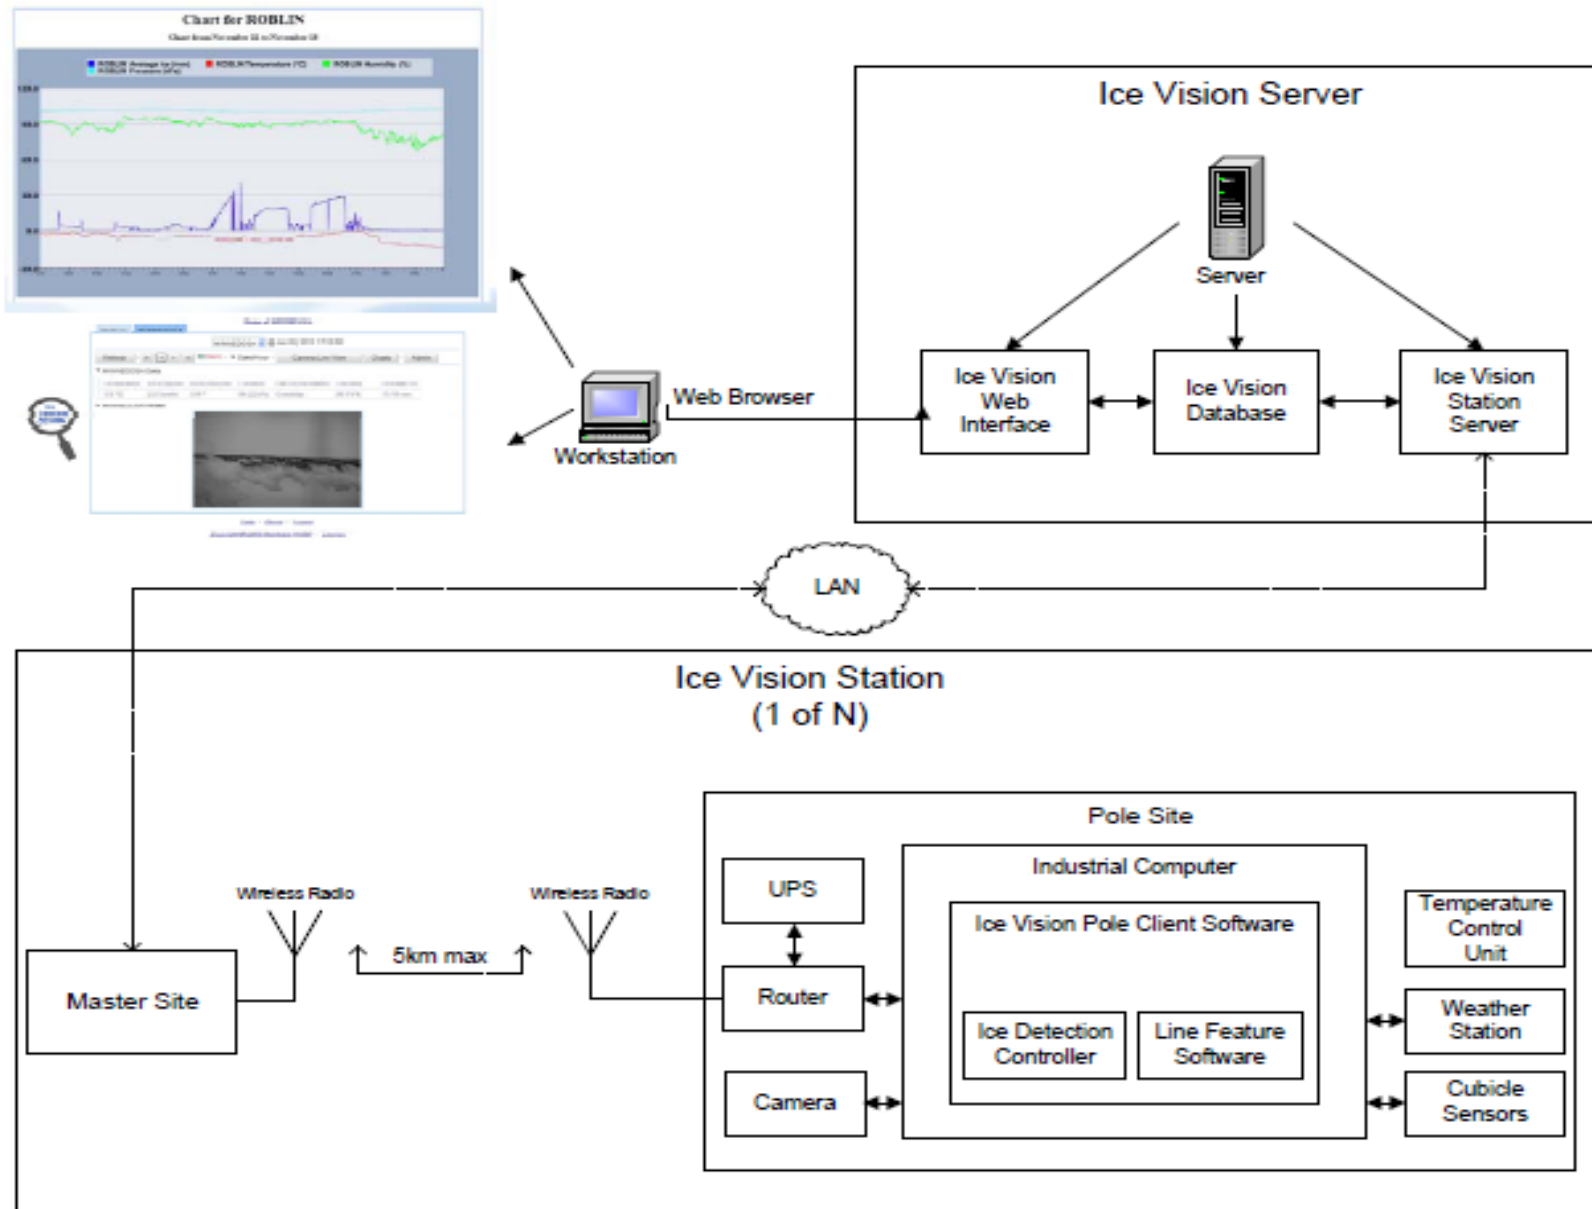
Ice Vision System Block Diagram

- Accurate measurement of ice profiles directly on live conductors, automatically and autonomously
- Collection of weather data including: temperature, wind (speed and direction), humidity, precipitation, atmospheric pressure
- Wireless communication for remote access, control and configuration of system
- Central storage of information and web-based data presentation
- Alarms via email or SMS text messaging. Alarms also Interfaced into MH Supervisory Control Centre SCADA.
- Real time picture of the conductor
- Graphing and trending of historical data

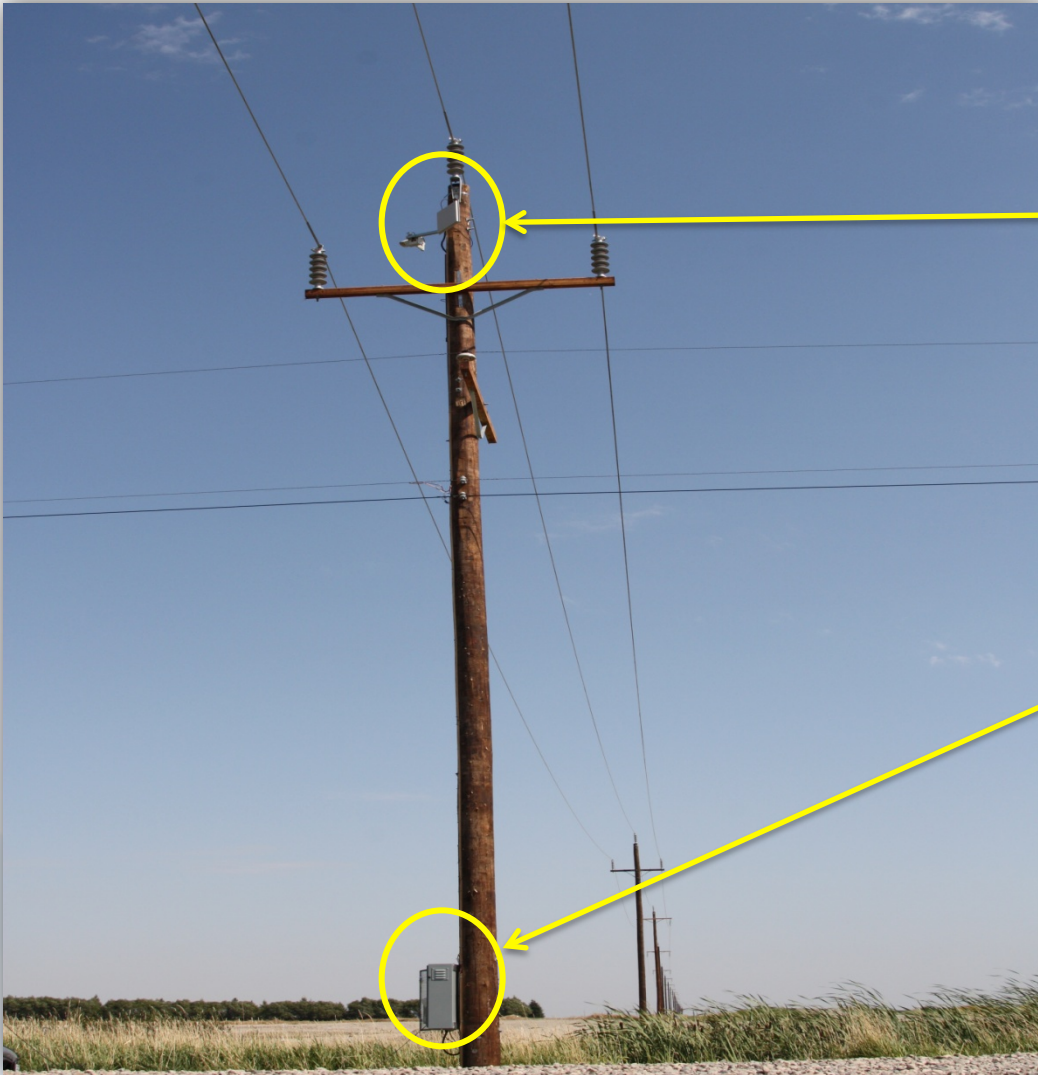
IDS Overview: Pole Equipment

As installed near St. Leon

Digital camera, Antenna
and Weather station

Electronics cubicle

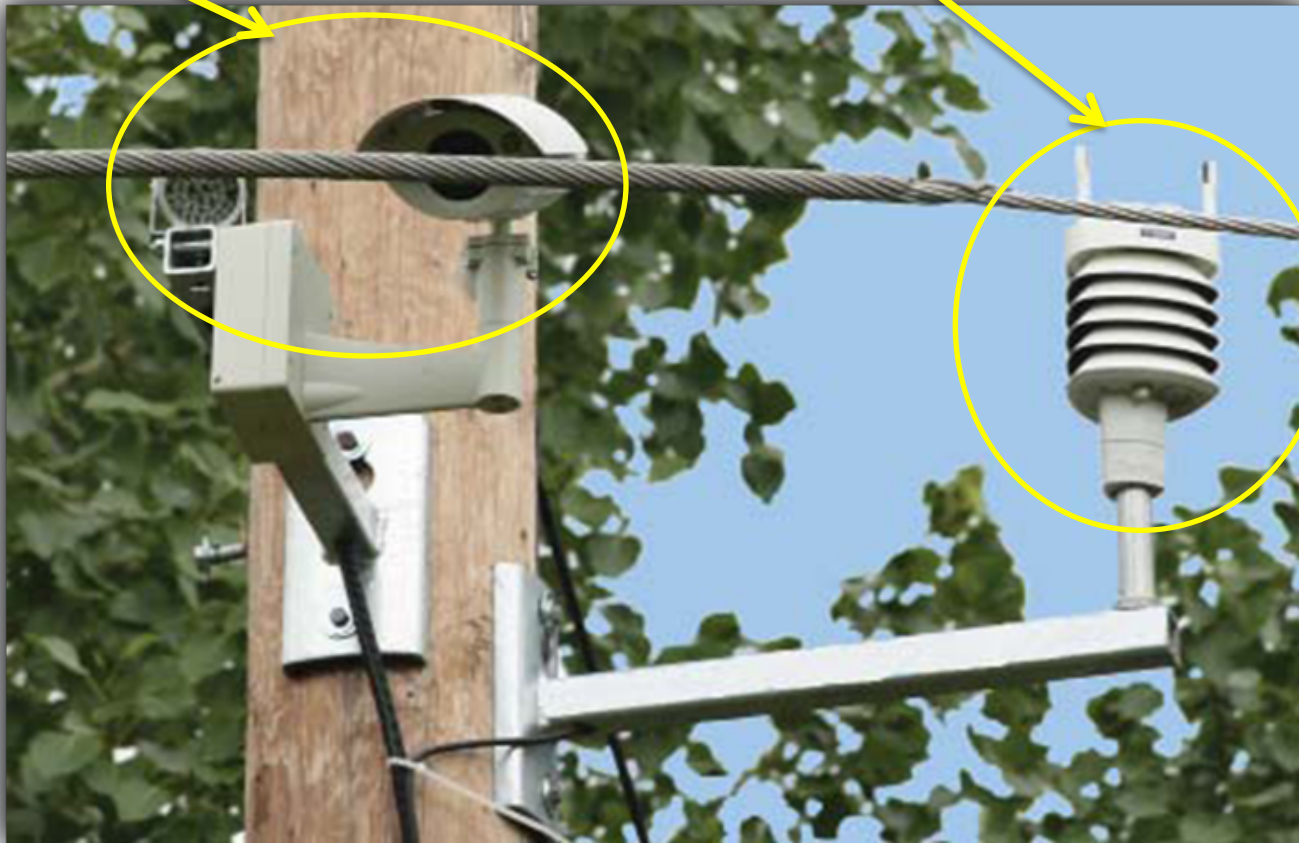
IDS Overview: Pole Equipment

Digital Camera

Weather Station

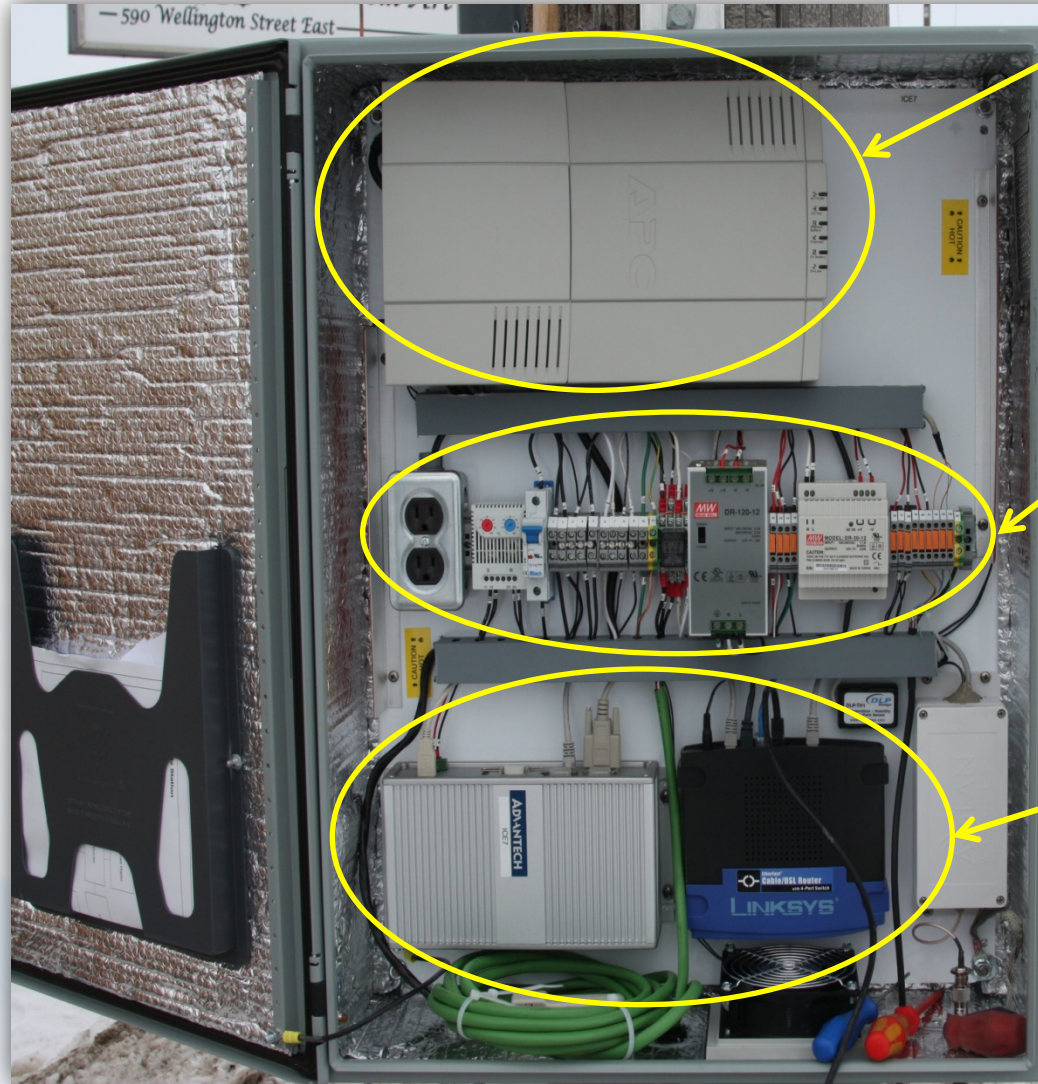
IDS Overview: Pole Equipment

UPS
(Uninterruptible Power Supply)

Wiring, Power supply
cabinet temperature

CPU, Router, &
wireless
communications

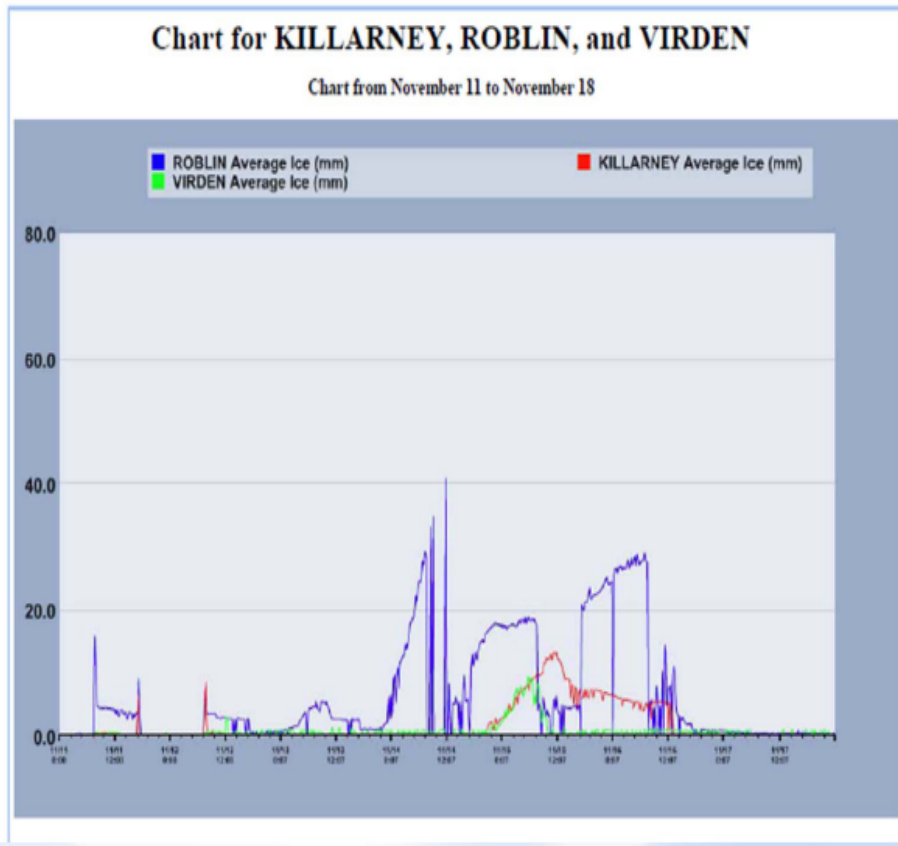
IDS Overview: Web Server Charting

Roblin Station

Manitoba Hydro 66kV Line

From: 05:30am, November 11, 2011

To: 12:52pm, November 17, 2011

Hoar Frost/Ice Formation

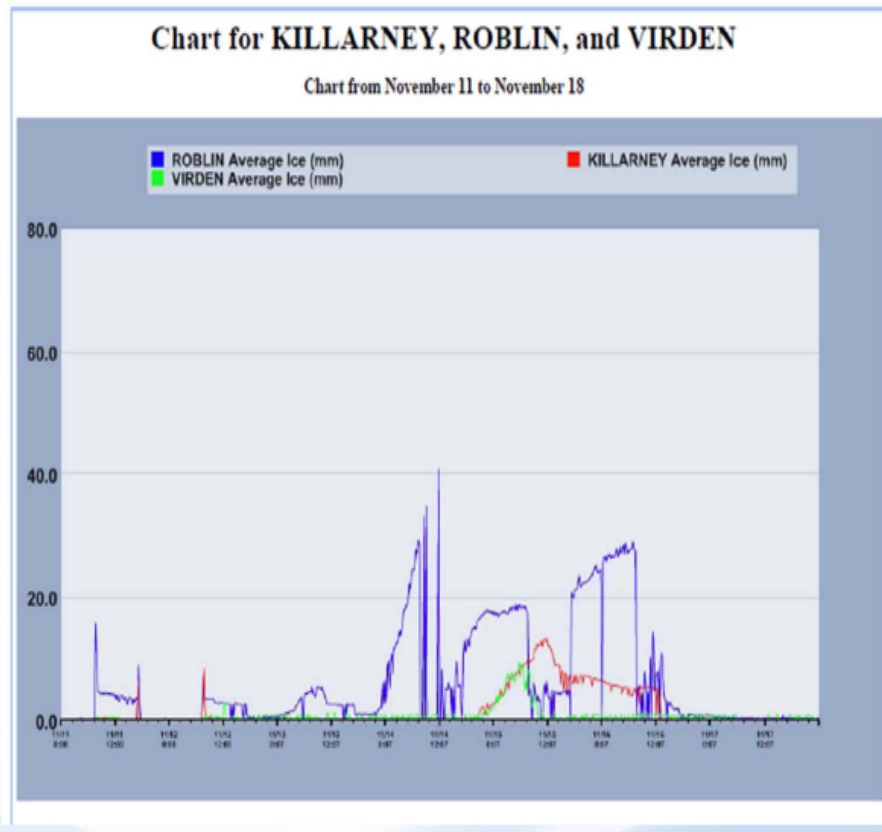
IDS Overview: Web Server Charting

Virден Station

Manitoba Hydro 66kV Line

From: 12:14am, November 14, 2011

To: 11:59pm, November 17, 2011

Hoar Frost/Ice Formation

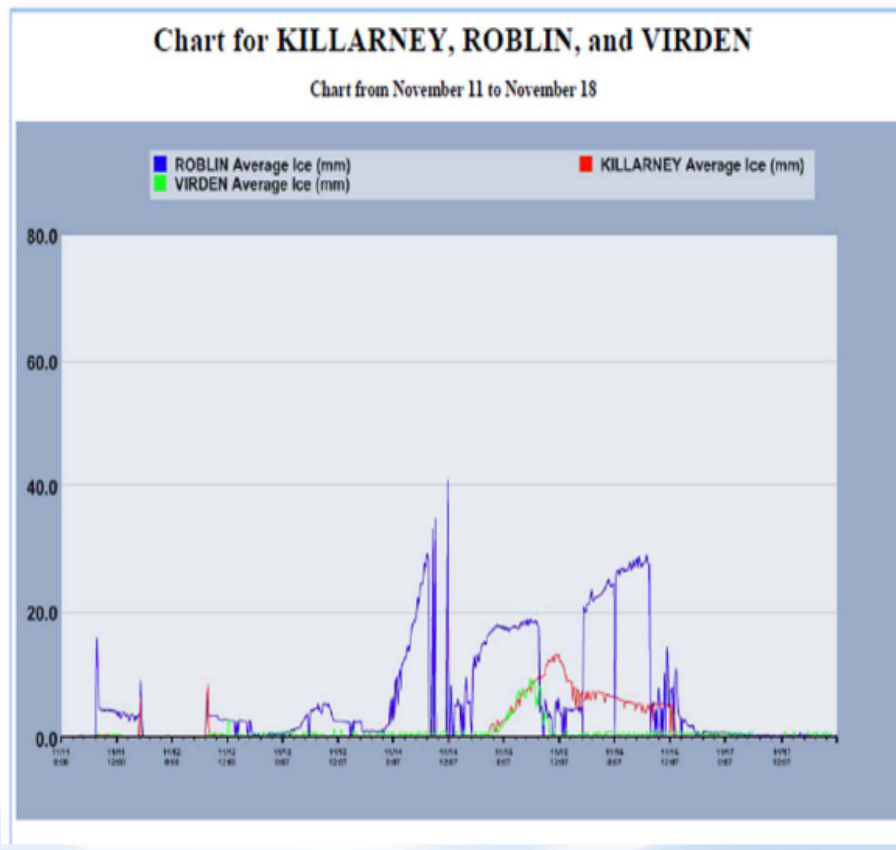
IDS Overview: Web Server Charting

Killarney Station

Manitoba Hydro 66kV Line

From: 12:12am, November 14, 2011

To: 11:57pm, November 17, 2011

Hoar Frost/Ice Formation

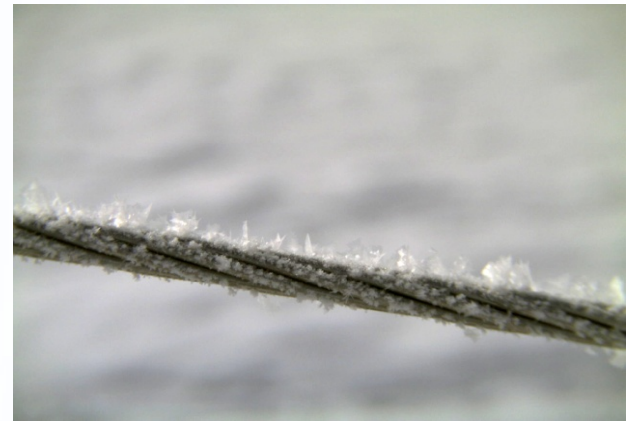
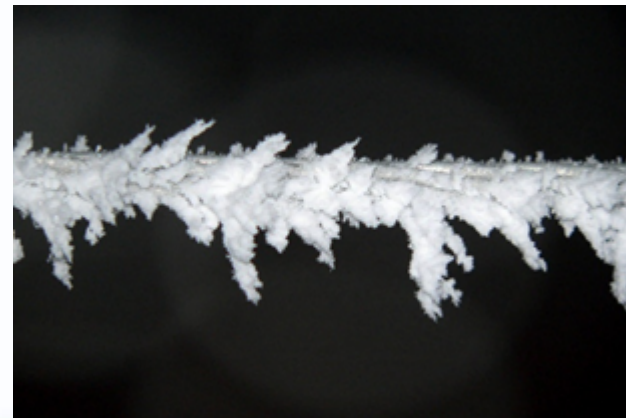
Hoarfrost Detection

- Hoarfrost is lighter and more fragile than Ice BUT: it can turn into ice very quickly (much heavier)
- MH needs to identify rapid changes for deployment of ice mitigation procedures.
- CEATI funded project to investigate detection of hoarfrost to ice conversion.

- **Principle**
 - Hoarfrost is an amalgamation of snow flakes (sharp edges)
 - Hoarfrost outline is more complex than ice
- **Compactness Factor**
 - Ratio between surface area and image perimeter
 - Helps assessing the complexity of shapes

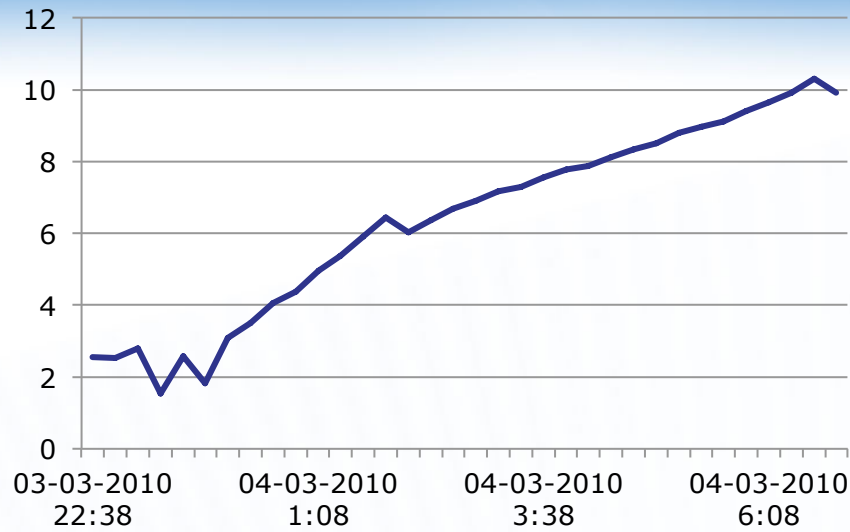
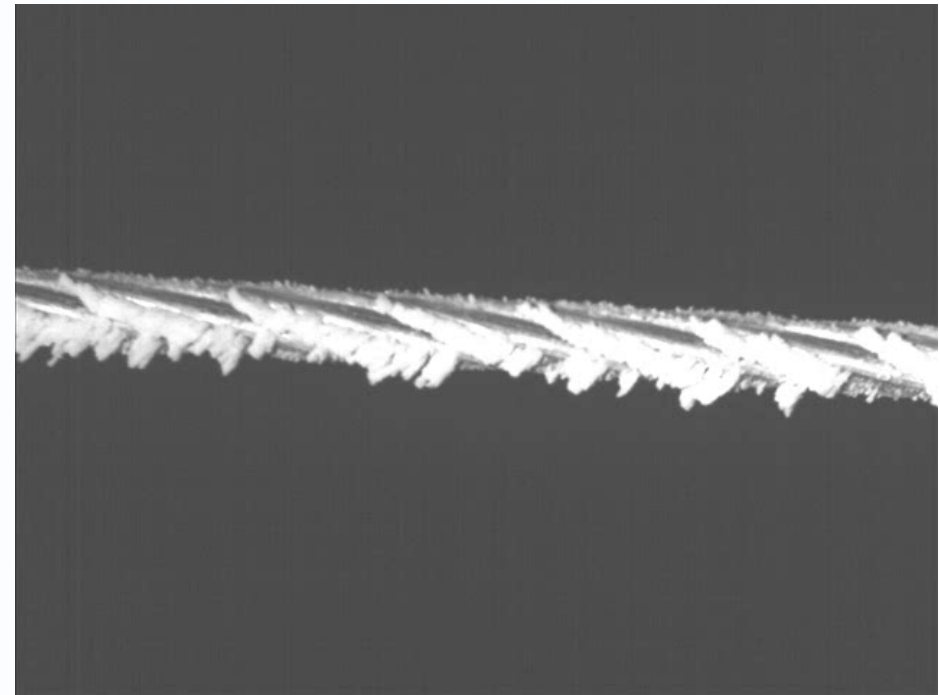
Hoarfrost Frost Indicator

Average Hoarfrost (mm)

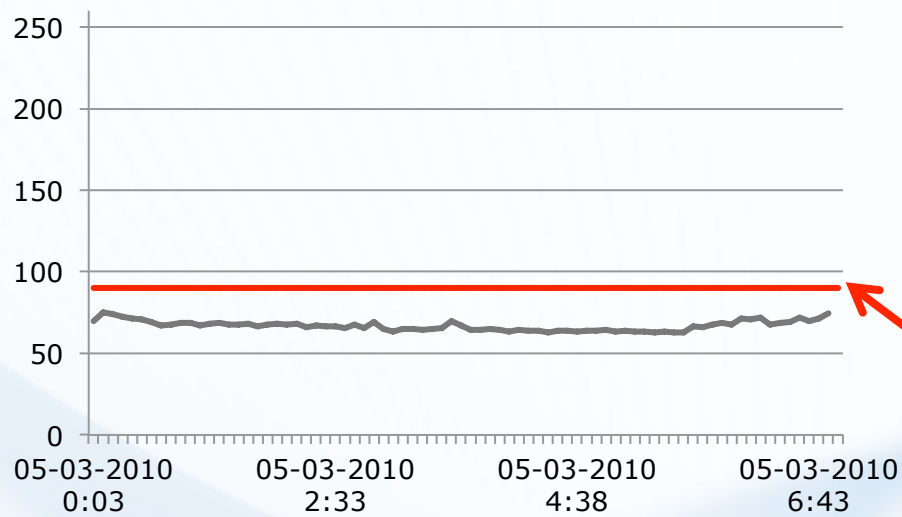
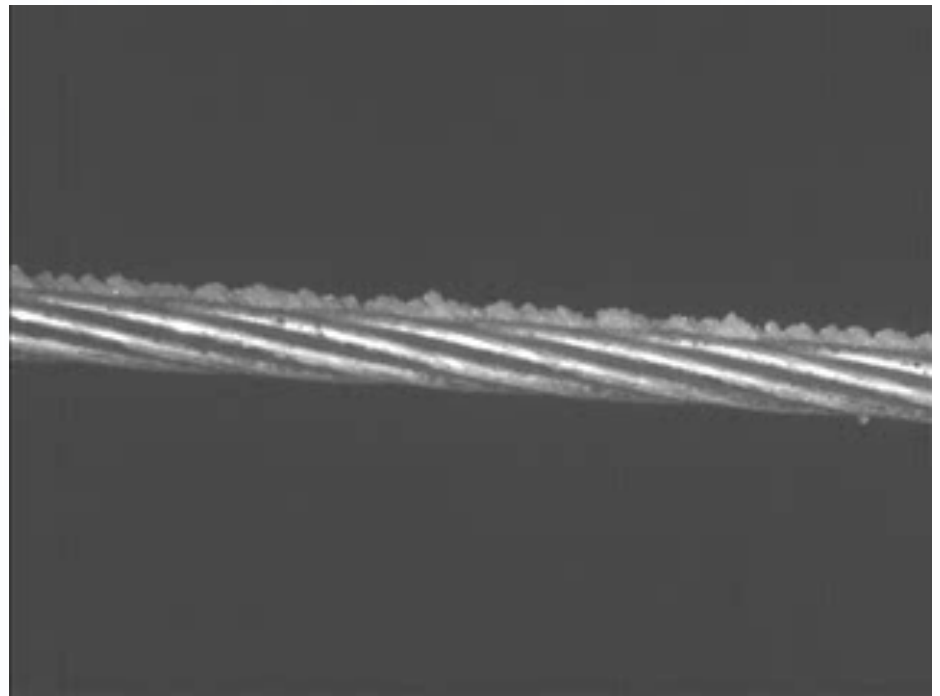
Hoarfrost Frost Indicator

Hoarfrost Threshold
