Fifty Years of Transformer Problems

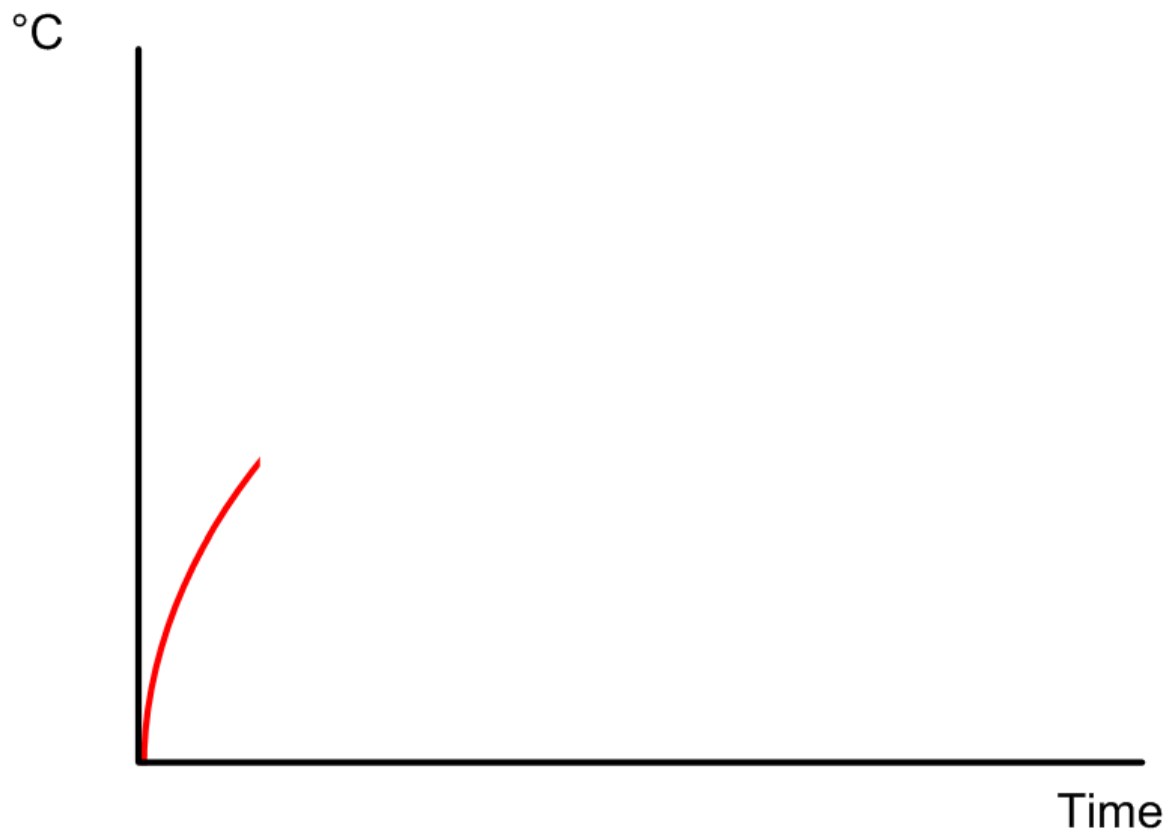
Dielectric losses were present because of poor impregnation

Model confirmed that if dielectric loss high, very high temperatures possible
